### EXECUTIVE ORDER NO. 5 OF 2012

## Building Conditions Assessment

28 Market Street  
Poughkeepsie, NY 12601

RE: 28 Market Street  
Poughkeepsie, NY  
Structural Conditions Survey  
RSA Project #: 14361.00

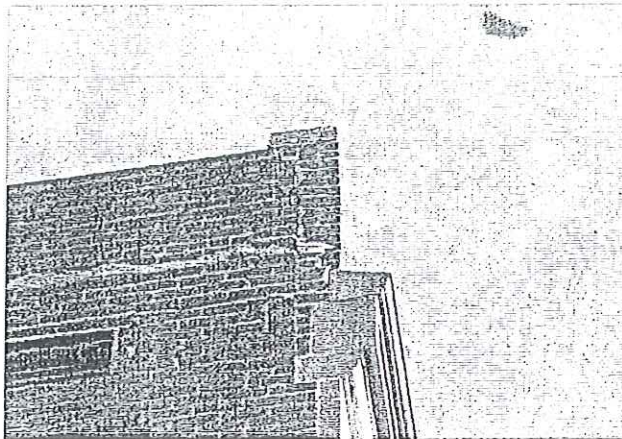
The parapets and copings protecting the top of the parapet walls are displaced, cracked, and spalled in some locations. Continued exposure to weather will, eventually, cause the parapets to fail. (See Photos 04 through 06.)

Photo 04: Prior repairs and displacement of parapet at the southeast corner of Nelson House Annex.

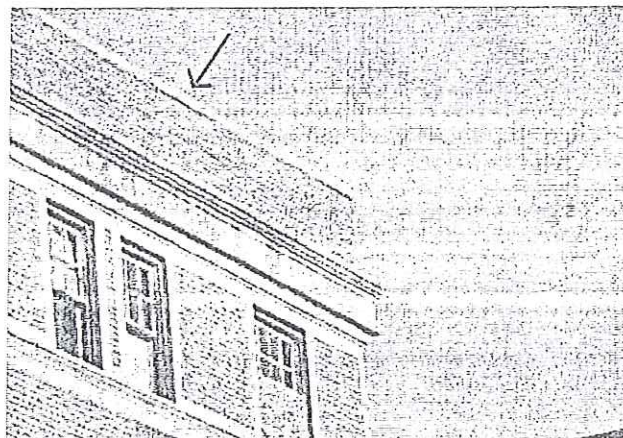
Photo 05: Displaced and spalled coping stone (arrow) at the north end of parapet at east façade of Nelson House Annex.

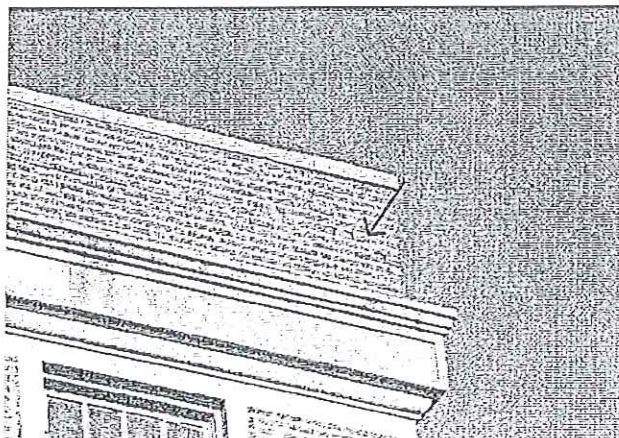
Photo 06: Crack in the parapet (arrow) at the north end of the parapet at the east elevation of the Nelson House Annex.

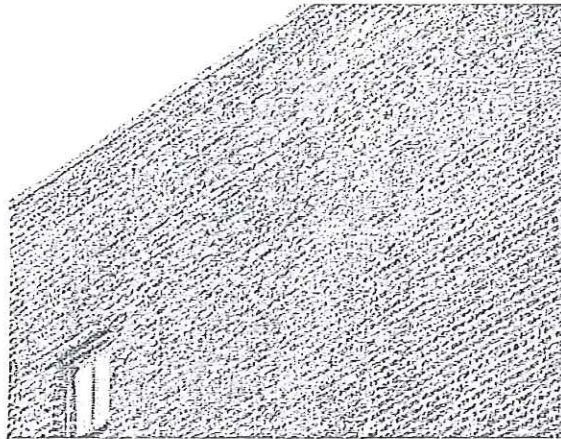
Photo 07: Wet areas of brick (darker vertical streaks) on the south wall of the Nelson House Addition are the result of a failed roofing membrane and broken and/or plugged internal roof drains.

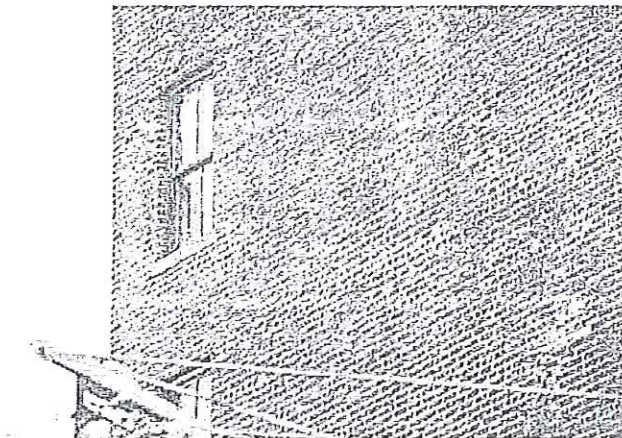
Photo 08: The damp brick areas extend down the west end of the south wall several stories.

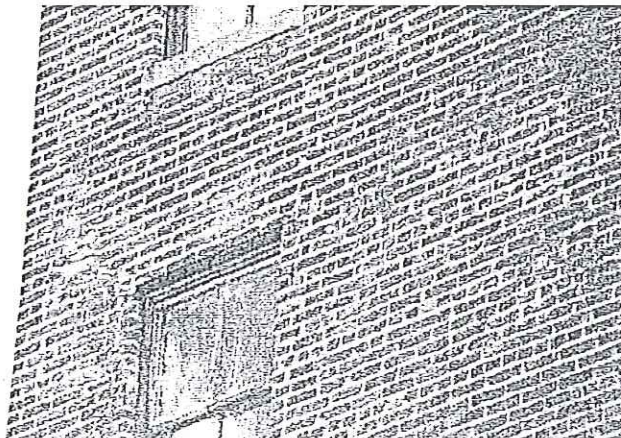
Photo 09: Efflorescence, salt crystallizing on the surface of the masonry is evident at the periphery of the damp areas of brick. Corrosion of the steel lintel of the window opening is also evident.

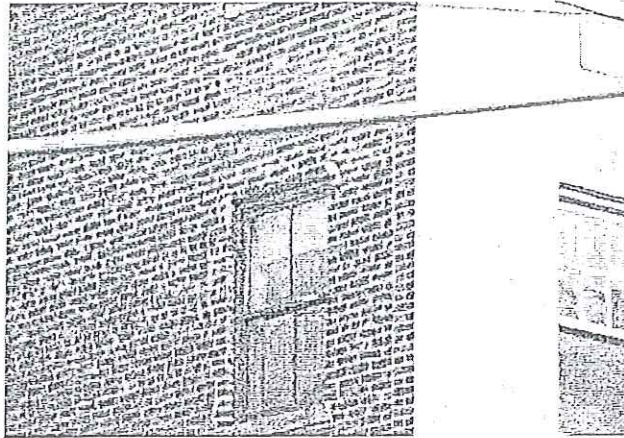
Photo 10: Cracks at the jambs of this window at the east end of the south wall of the Nelson House Addition are likely caused by corrosion of the steel lintel spanning the window opening. This condition, which can be dangerous, hasn't become endemic, but will the longer the building remains unoccupied.

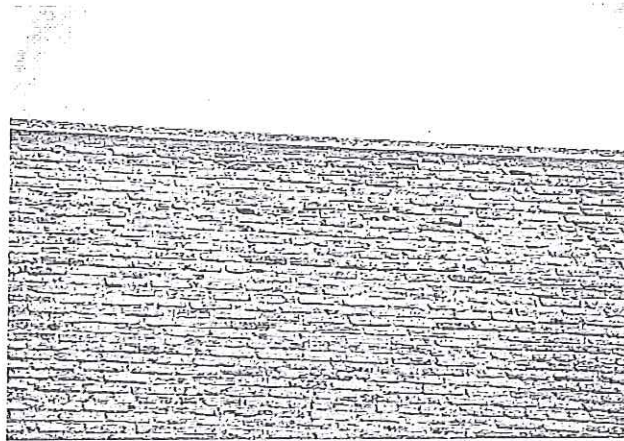
Photo 11: Spalling and erosion of the brick along the parapet at the west elevation of the Nelson House Annex. Spalling is typically evidence of freeze-thaw cycling or efflorescence – both resulting from chronic or periodic wetting of the brick. Over time, freeze-thaw cycling and efflorescence can reduce the section of the masonry wall assembly to the point where it becomes unstable.

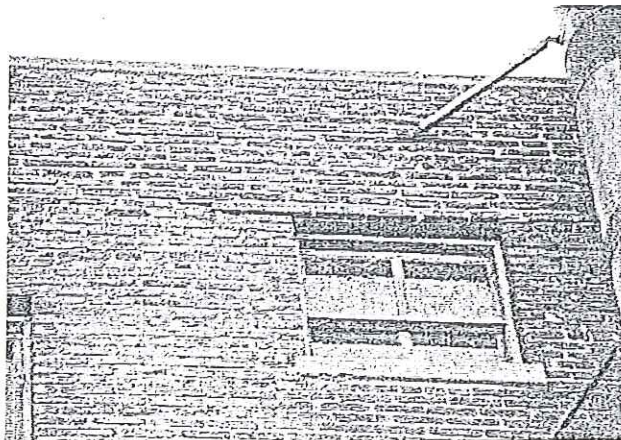
Photo 12: Displaced masonry and corroded lintel at the parapet of the west elevation of the Nelson House Annex.

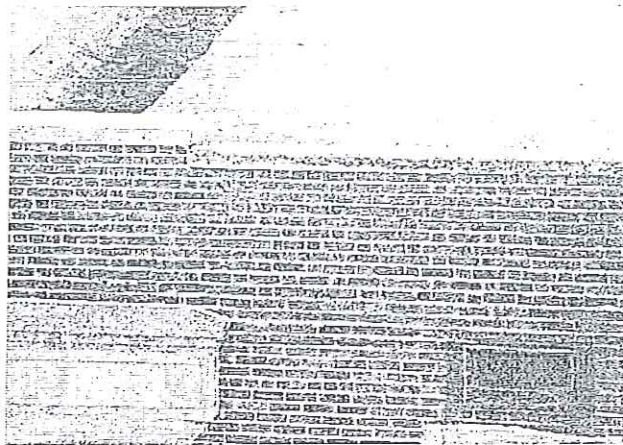
Photo 13: Upper portion of a crack that may be associated with deterioration of spandrel beams or lintels at the top floor of the Nelson House Annex. This view is of the east end of the north wall.

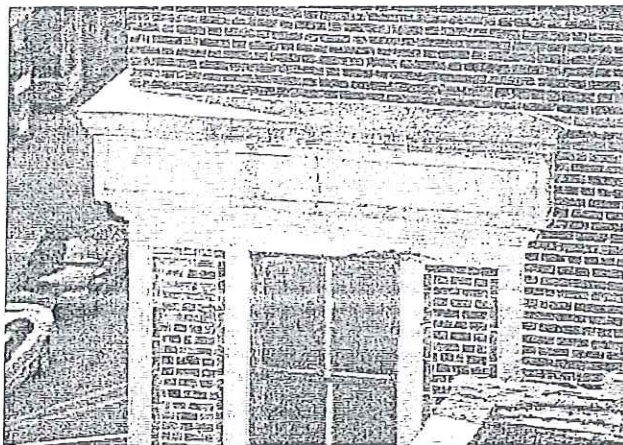
Photo 14: A large spall at the limestone cornice / watertable at the north wall of the Nelson House Annex. See Photo 13 for additional information.

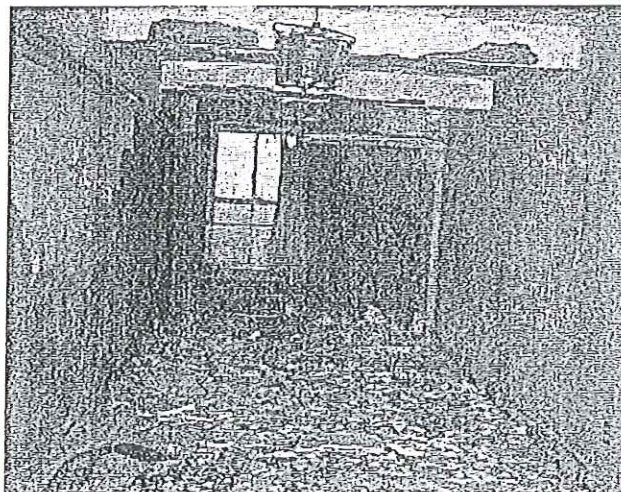
Photo 15: The finishes and concrete slab at the southwest corner of the building are saturated at the upper floors. The areas of saturation are smaller on lower floors, but are generally still present. Continued exposure to water will, ultimately, lead to corrosion of the steel reinforcing in the concrete, corrosion of the steel frame, and a reduction in the capacity of the structure to carry load. Freeze-thaw damage may also occur as the building is unoccupied and unheated

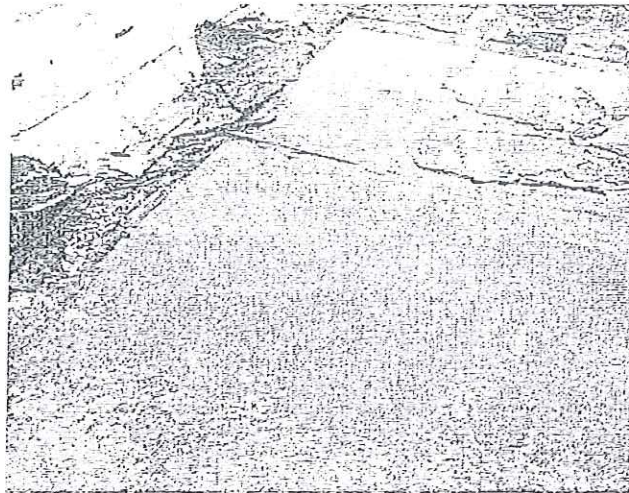
Photo 16: The roof membrane is missing and the roof drain is plugged at the southwest corner of the roof at the Nelson House Annex. This condition will lead to deterioration of the concrete and steel frame (see caption for Photo 15). In the near term, the plugged drain may lead to accumulation of water and/or snow on the roof that will exceed the capacity of the concrete or steel structure, leading to a local collapse of the roof.

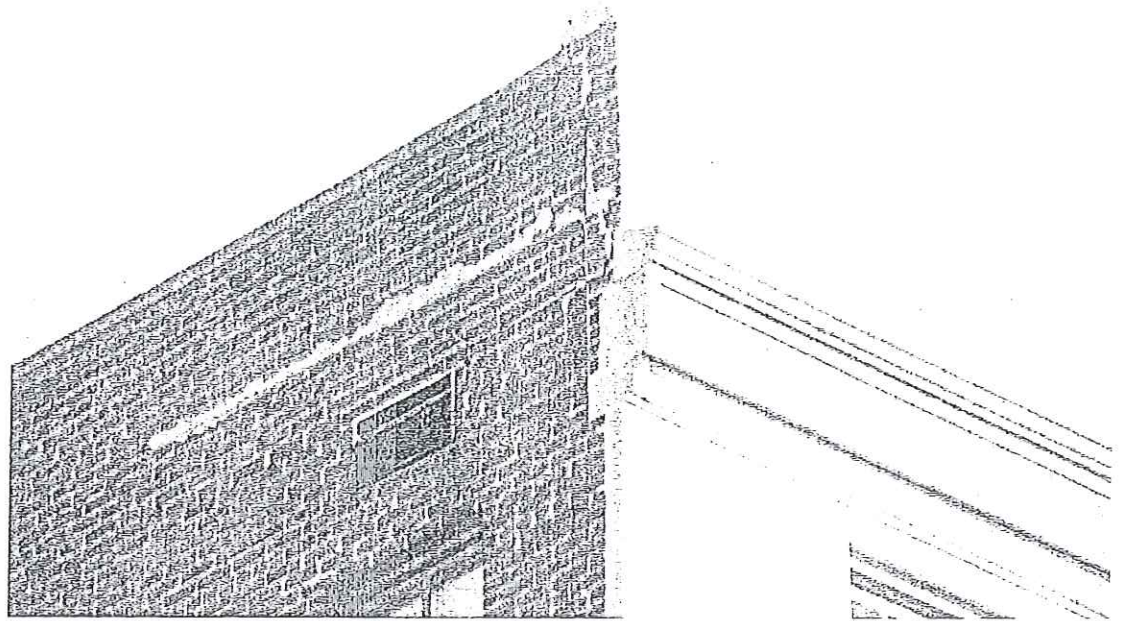
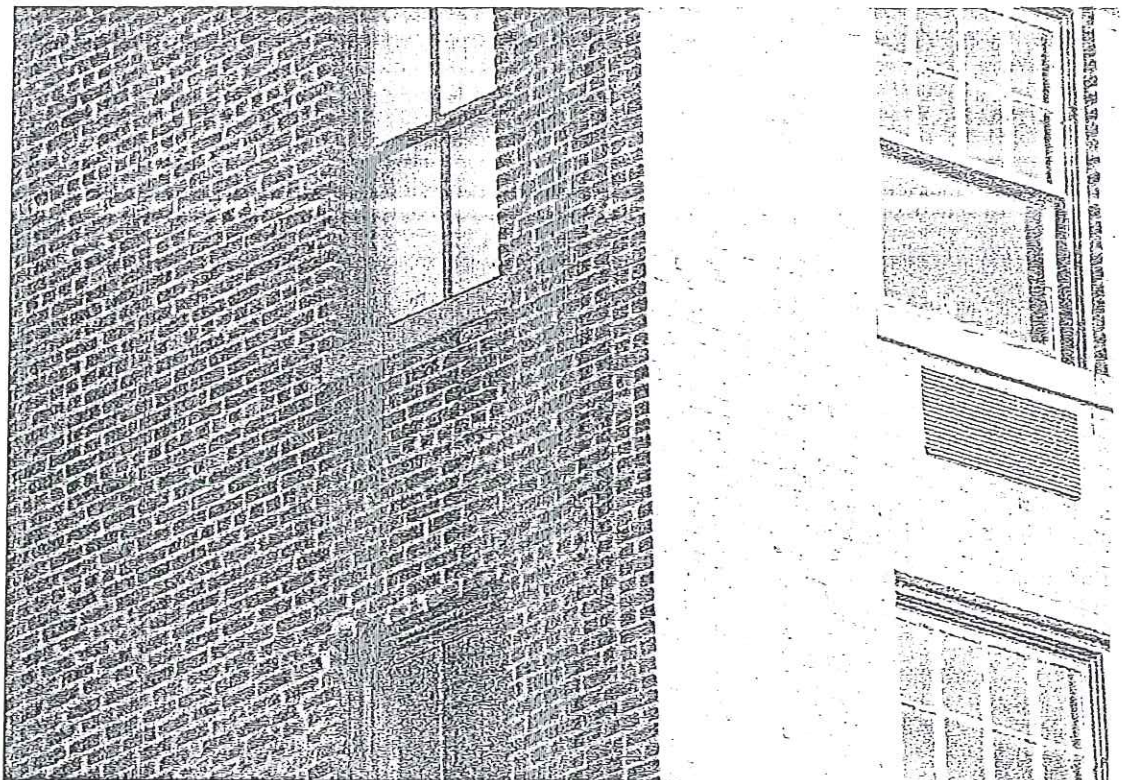
MASONRY CRACKS AT PARAPET AND WINDOW HEADS

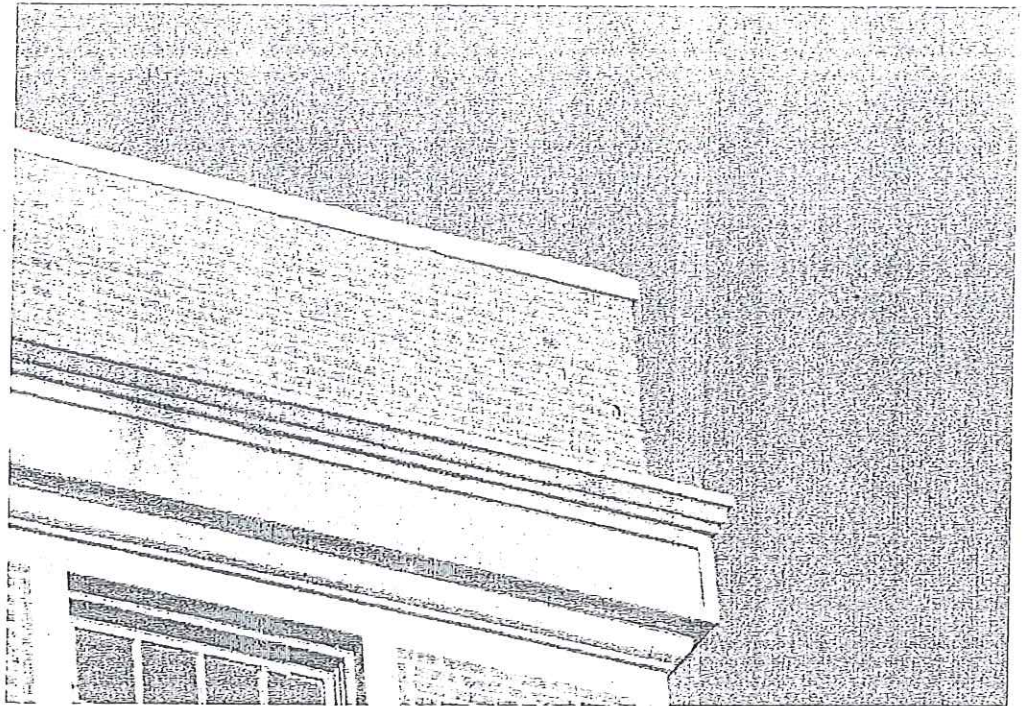
MASONRY CRACKS AT PARAPET

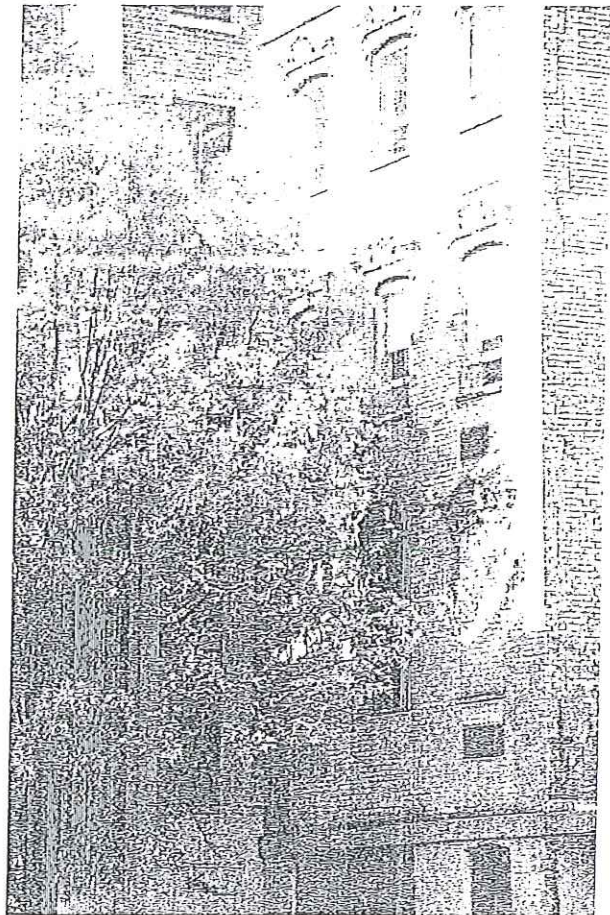
MASONRY CRACKS AT BUILDING CORNERS

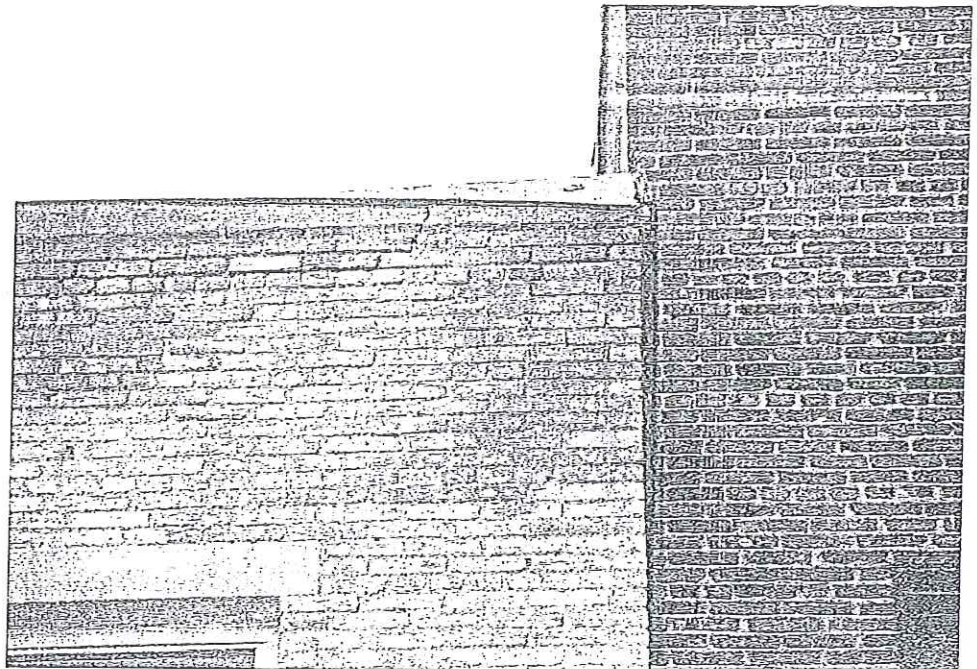
MASONRY CRACKS AT PARAPET

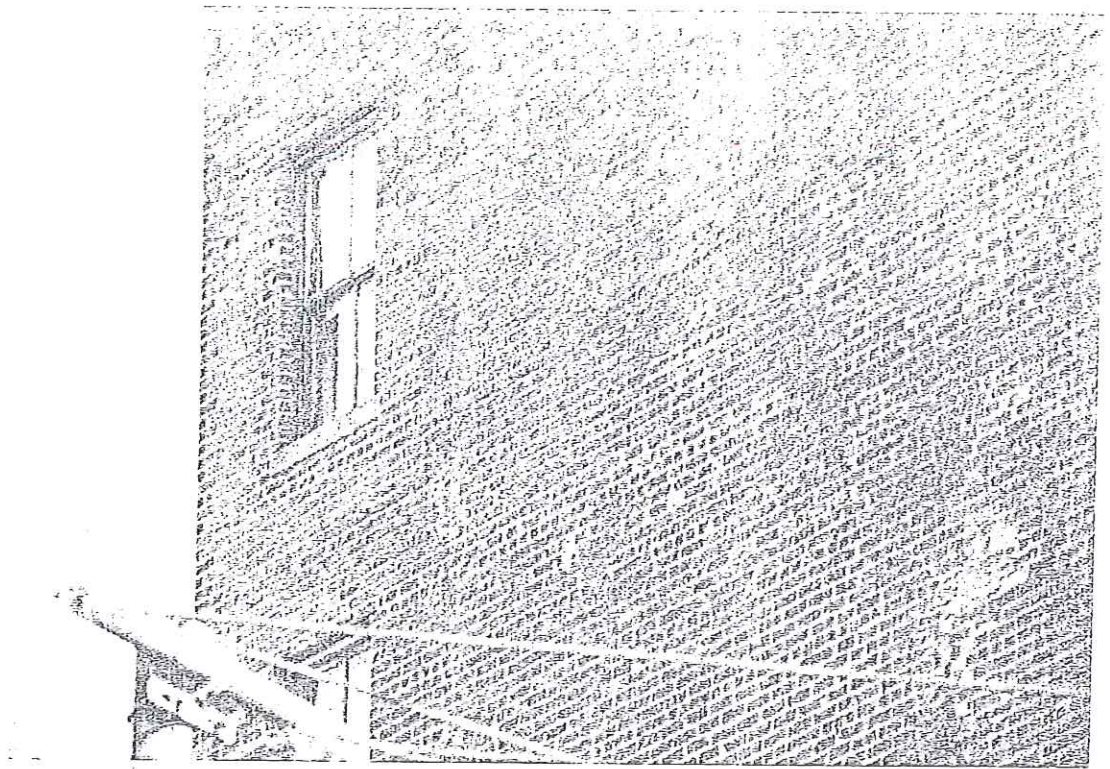
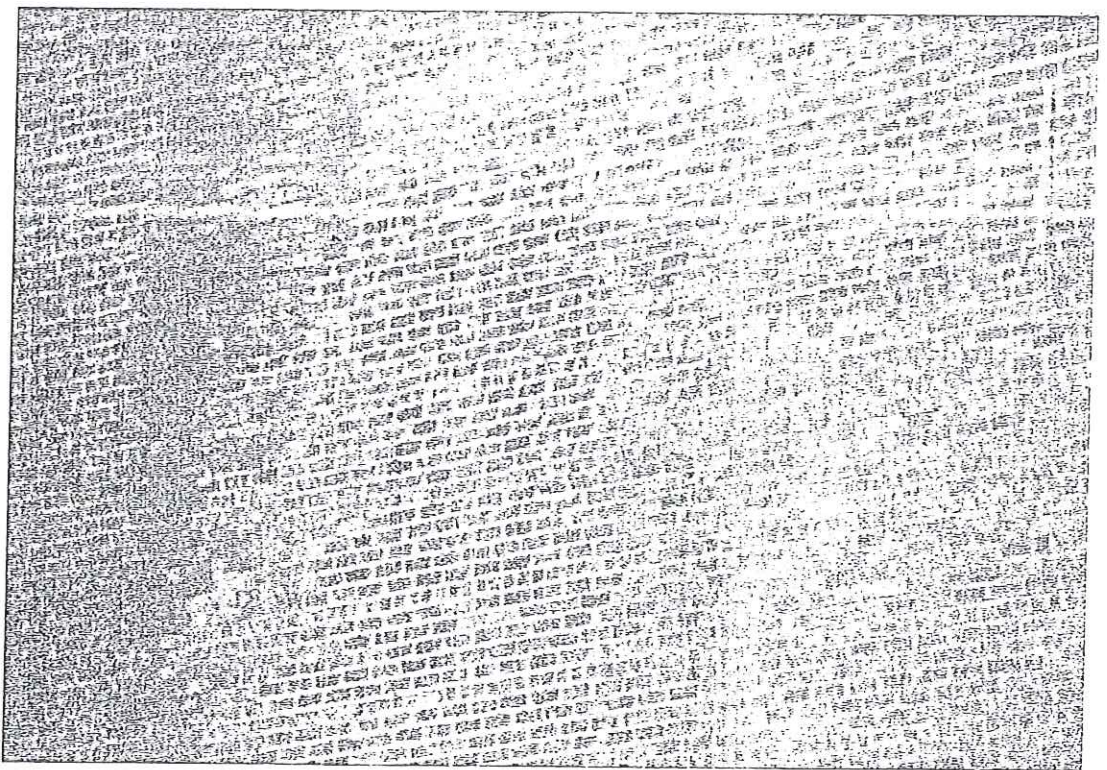
The South facade is the worst effected. A large section of the masonry wall appears to be saturated, visible by its overall deep color tone. This could be due to several reasons - parapet wall leakage, roof leakage, thru slab internal waterfall damage leading to water running into the

wall from inside. There is a serious risk, due to freeze/thaw cycles that the masonry may dislodge and fall off.

VIEWS OF SATURATED EXT MASONRY WALL AT SOUTH FACADE

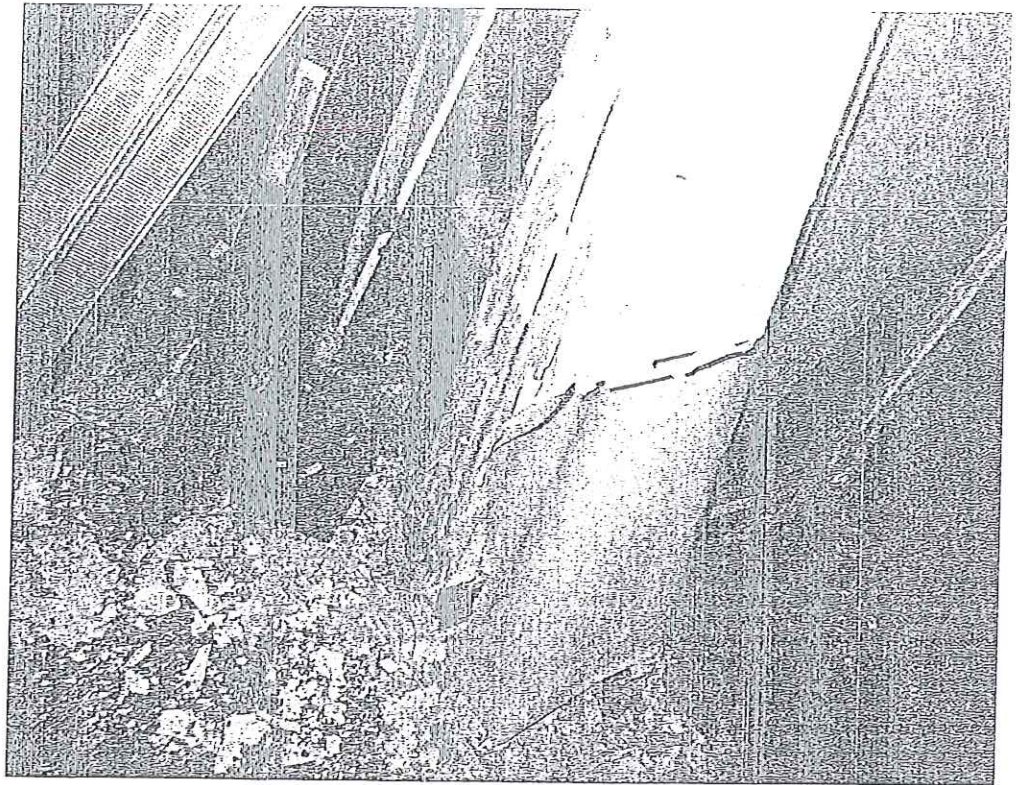
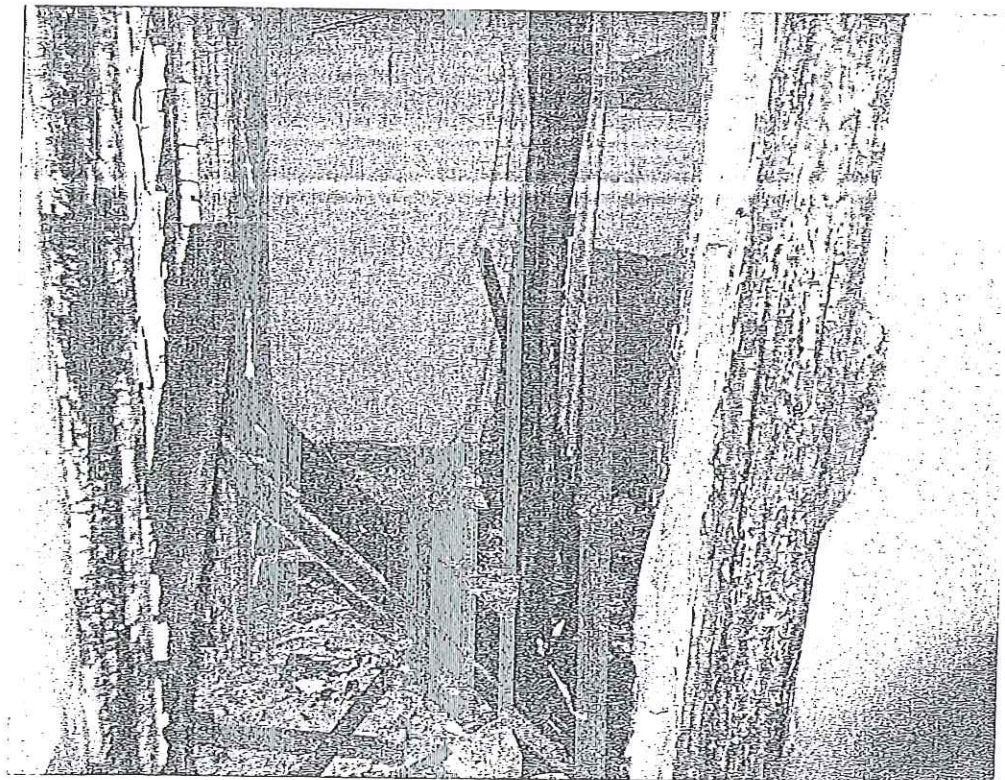
INTERIOR VIEWS INDICATING TYPICAL POOR CONDITION

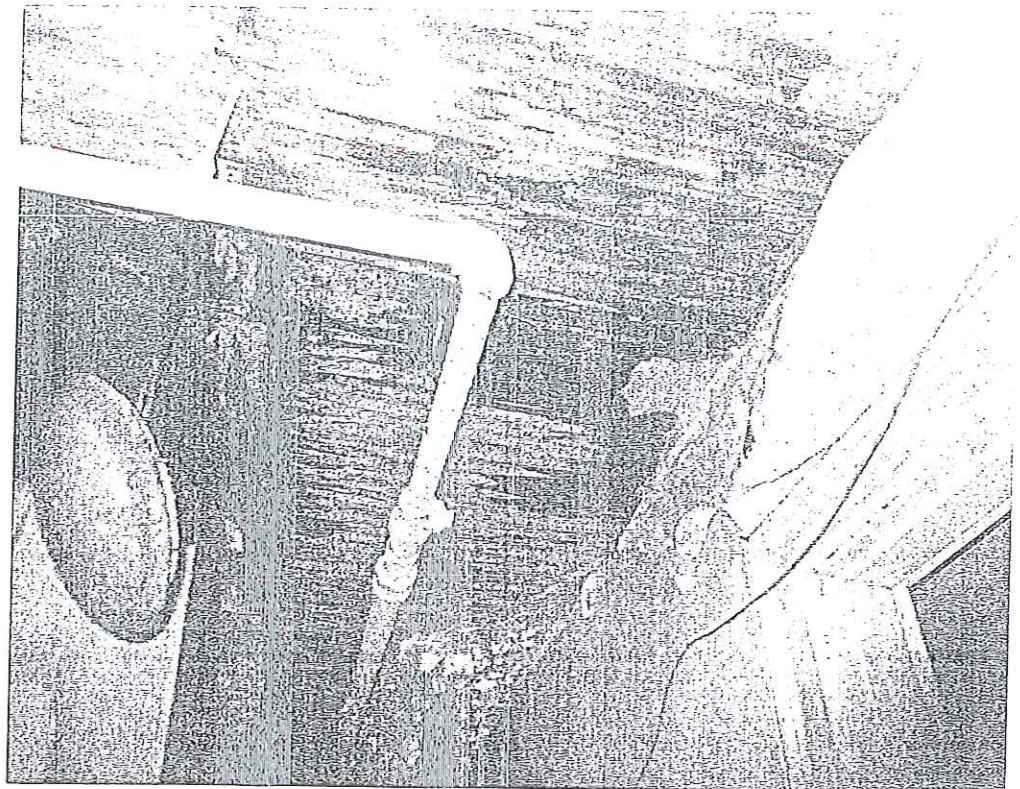
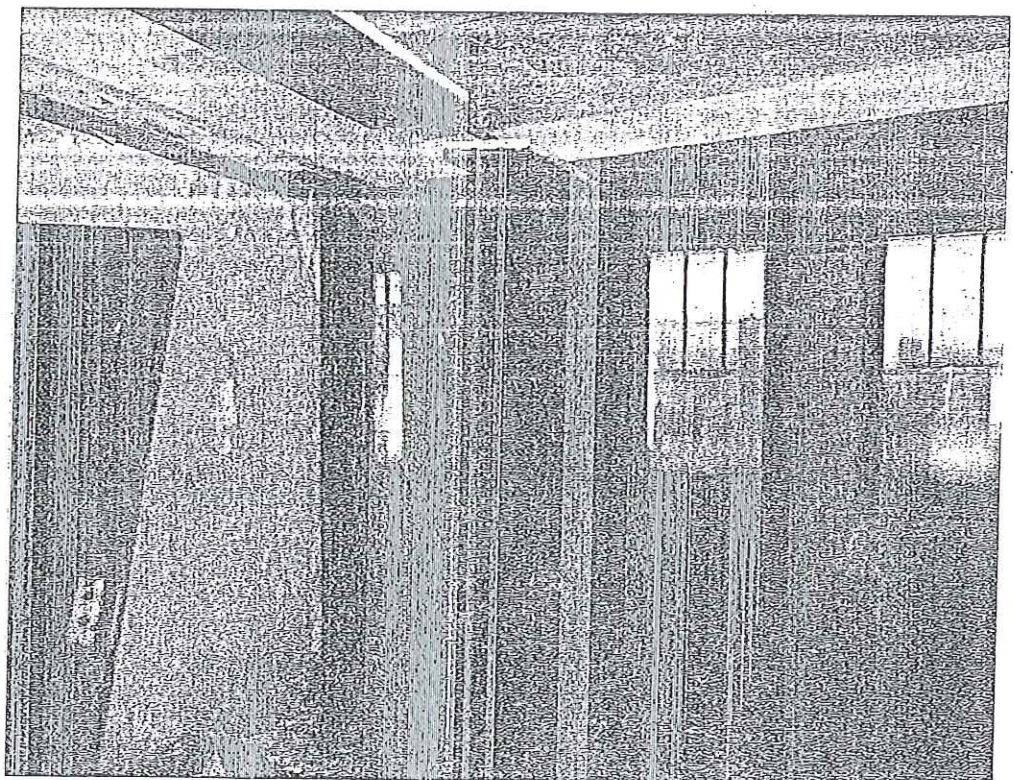
INTERIOR VIEWS INDICATING TYPICAL POOR CONDITION

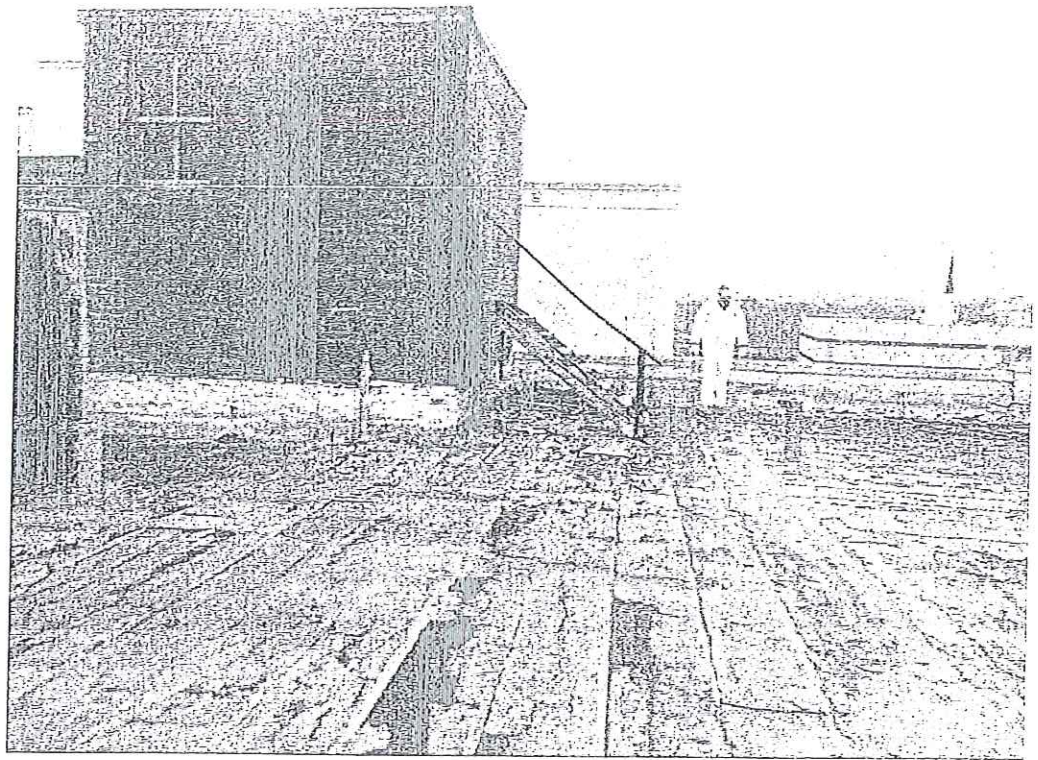
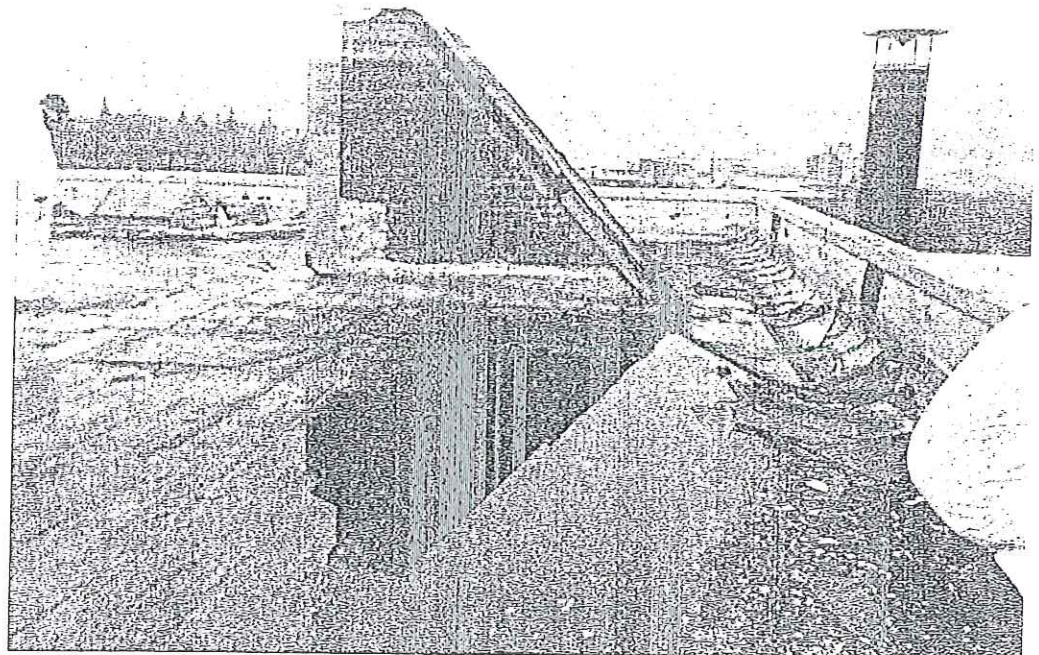
The roof of this structure is in total disrepair. The plys of the roofing are peeling off, the drains are non-existent (covered up and not visible), severe water ponding at various locations, base flashing at parapet walls are peeling, and cap flashing at parapet walls are missing.

WATER PONDING AND DELAMINATING LAYERS AT EXISTING ROOF
