CR 19 (Slate Quarry Rd) Safety Assessment

NYS Route 9G to White Schoolhouse Rd, Town of Rhinebeck

The Poughkeepsie-Dutchess County Transportation Council (PDCTC) conducted a Safety Assessment (SA) of CR19 (Slate Quarry Rd) from NYS Route 9G to White Schoolhouse Rd in support of its goal to improve transportation safety in Dutchess County. The SA is intended to provide the facility owner, Dutchess County, with a list of opportunities for low-cost, short-range safety improvements, and if warranted, more expensive and/or longer-range improvements. The PDCTC, in consultation with the Dutchess County Department of Public Works (DCDPW) and the Town of Rhinebeck, selected the assessment location based on a county-wide analysis of crash data from 2009-2013.

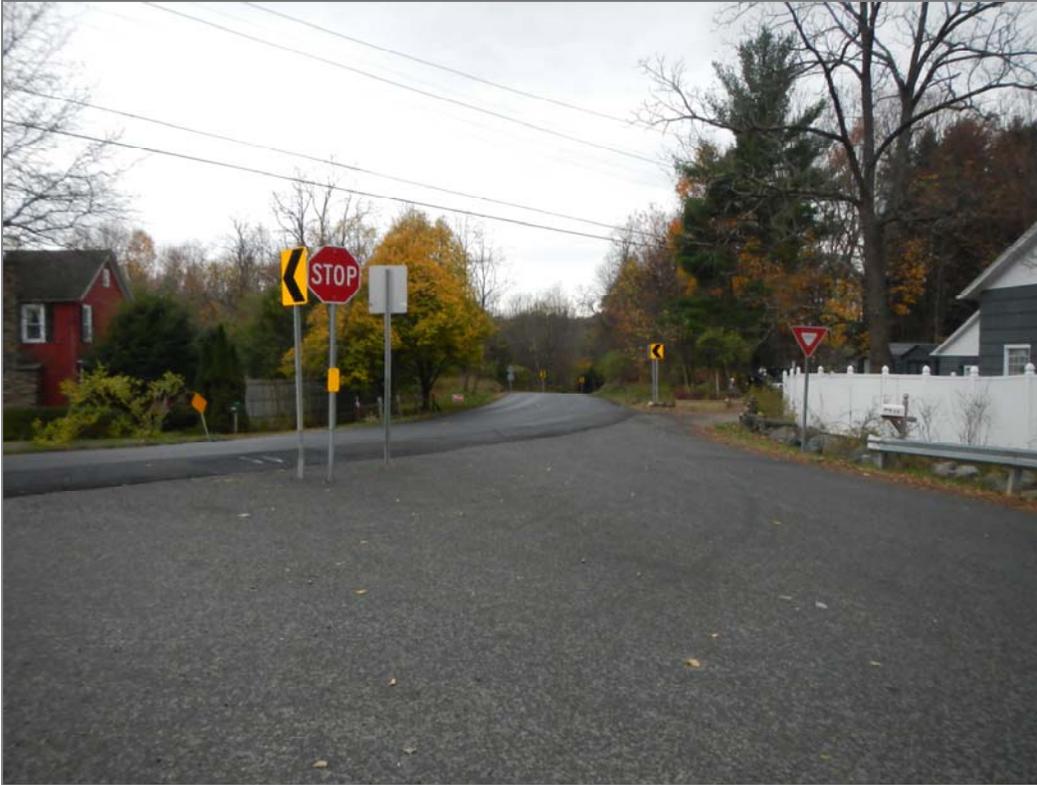
Figure 5. The intersection of Slate Quarry/White Schoolhouse Rd, looking west. The width of the intersection, coupled with the STOP and YIELD signs, creates a confusing situation for drivers.

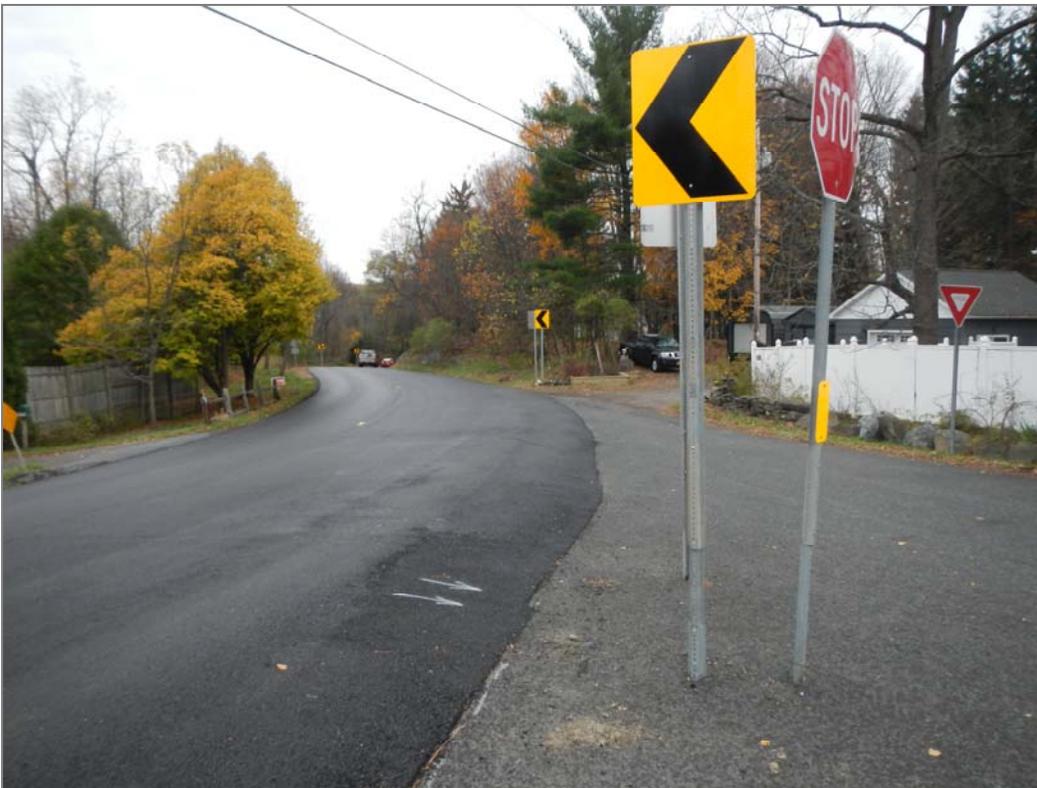
Figure 6. The width of the White Schoolhouse Rd approach to Slate Quarry Rd necessitates the placement of sign posts in the middle of the intersection.

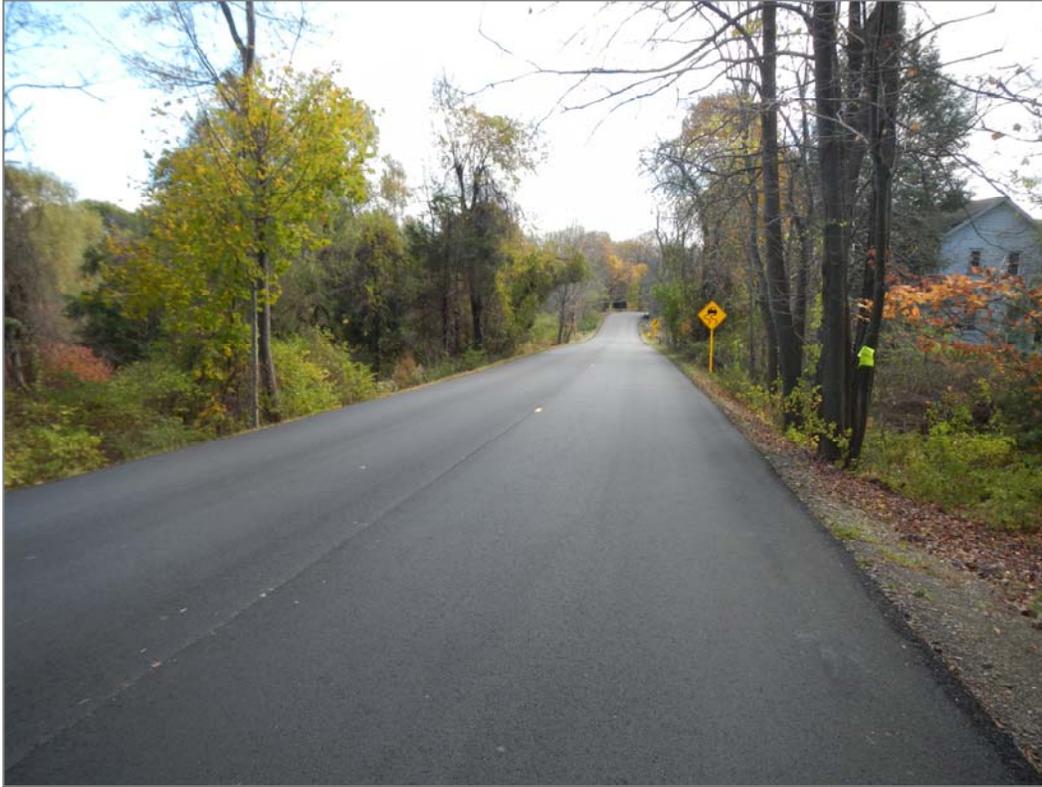
Figure 7. Slate Quarry Rd, recently repaved, looking east. At the time of the Safety Assessment, lane markings had not yet been added.

Observations: During the field visit, SA team members noted that the newly paved roadway did not have lane markings, nor were there any warnings to drivers that lane markings were not present. The SA Team discussed the possibility of using a 6 inch edge lines (versus the standard 4 inch edge); however, since these are can become slippery when wet, the Team determined that a 4 inch width was best. [Note: DCDPW subsequently added lane markings on Slate Quarry Rd.]

Risk Analysis: The temporary lack of lane markings may lead to driver confusion and increase the risk of crashes, especially during dark conditions.

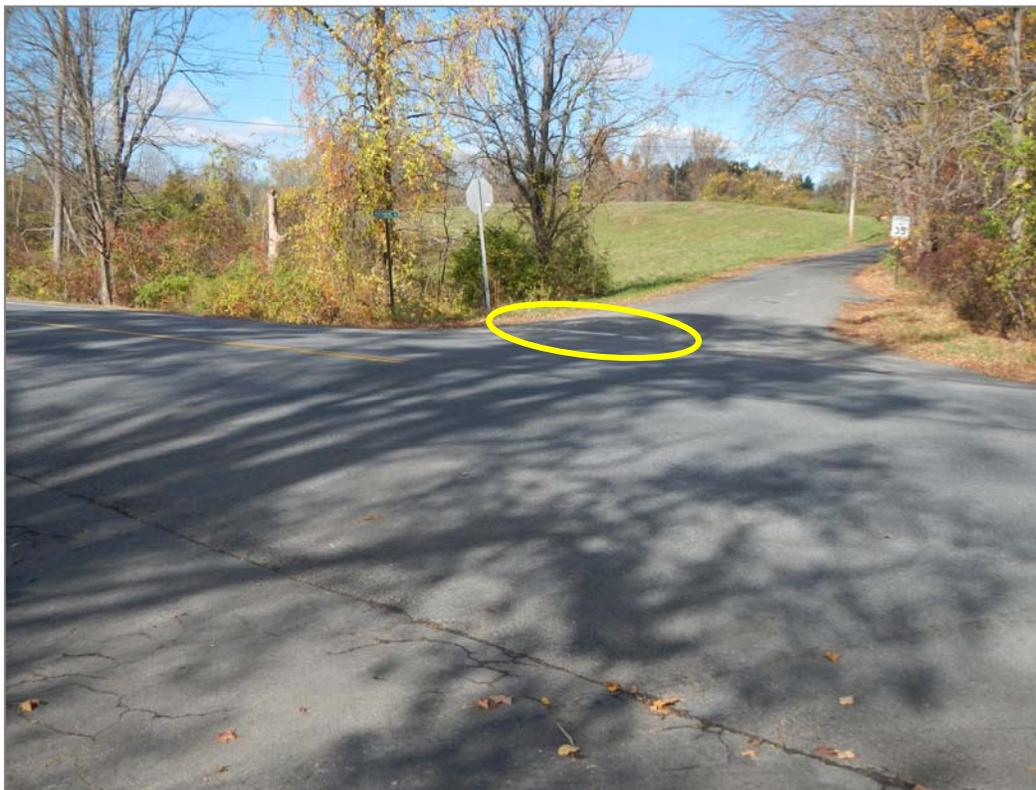
Figure 10. A second view of the Slate Quarry Rd/Wurtemberg Rd intersection looking north. Notice the faded stop line on Wurtemberg Rd (highlighted).

Observations: A large tree partially obscures the STOP sign on northbound Wurtemberg Rd as it approaches Slate Quarry Rd. The SA Team also noted that the stop lines on both approaches to Slate Quarry Rd were faded. Stop lines help motorists recognize the need to stop and designate proper positioning for optimal sight distance prior to entering the intersection. See Figure 28.

1. Move the STOP (R1-1) sign post away from the large tree at the southeast corner of the intersection.
2. Consider the use of a vertical retro-reflective strip on the STOP (R1-1) sign support to enhance visibility.
3. Install a new pictorial STOP AHEAD warning sign (W3-1) on Wurtemberg Rd to warn drivers of the upcoming STOP sign. [Note: this was subsequently installed].
4. Consider restriping the stop lines on both Wurtemberg Rd approaches to Slate Quarry Rd, using the NYSDOT recommended standard width of 18 inches or the wider 24 inches, which would provide an additional cue to drivers.

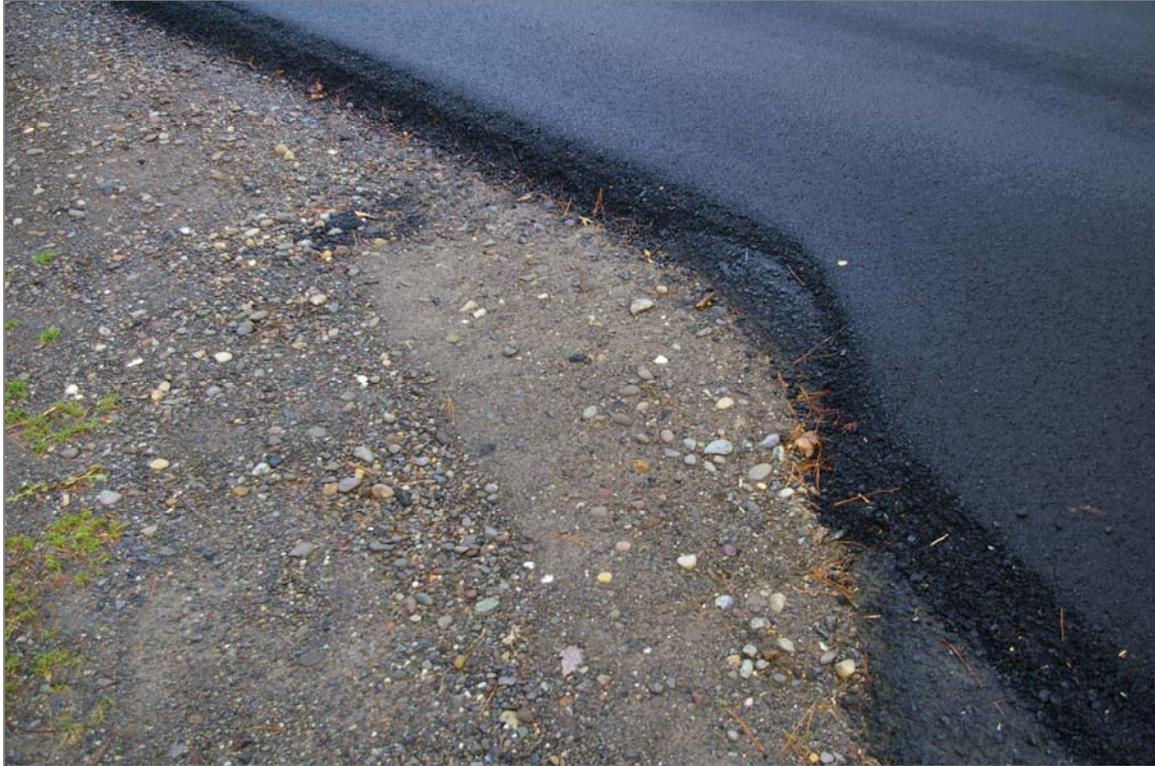
Observations: Given that travel lanes will be 11 feet wide, the resulting paved shoulders will vary from 2 to 3 feet in width, with an additional 2 to 4 feet of unpaved shoulder. In many cases, these paved shoulders drop off substantially at the edge and thus represent a hazard to all users, including those walking and biking along the road. DCDPW indicated that these shoulder drop-offs would be backfilled, and that pavement at entrances to the residential driveways would be blended with the new pavement height to remove any abrupt dips. See Figures 11-12.

Risk Analysis: Steep edge drop-offs can cause loss of control when a vehicle drifts towards the shoulder. If a driver attempts a sudden correction to regain control, the vehicle can become destabilized, resulting in a crash. The lack of adequate clear areas and relatively high operating speeds along the road increase the chances of a severe crash.

Figure 11. Due to the recent repaving, the shoulders along Slate Quarry Rd have steep drop-offs, which can destabilize errant vehicles.

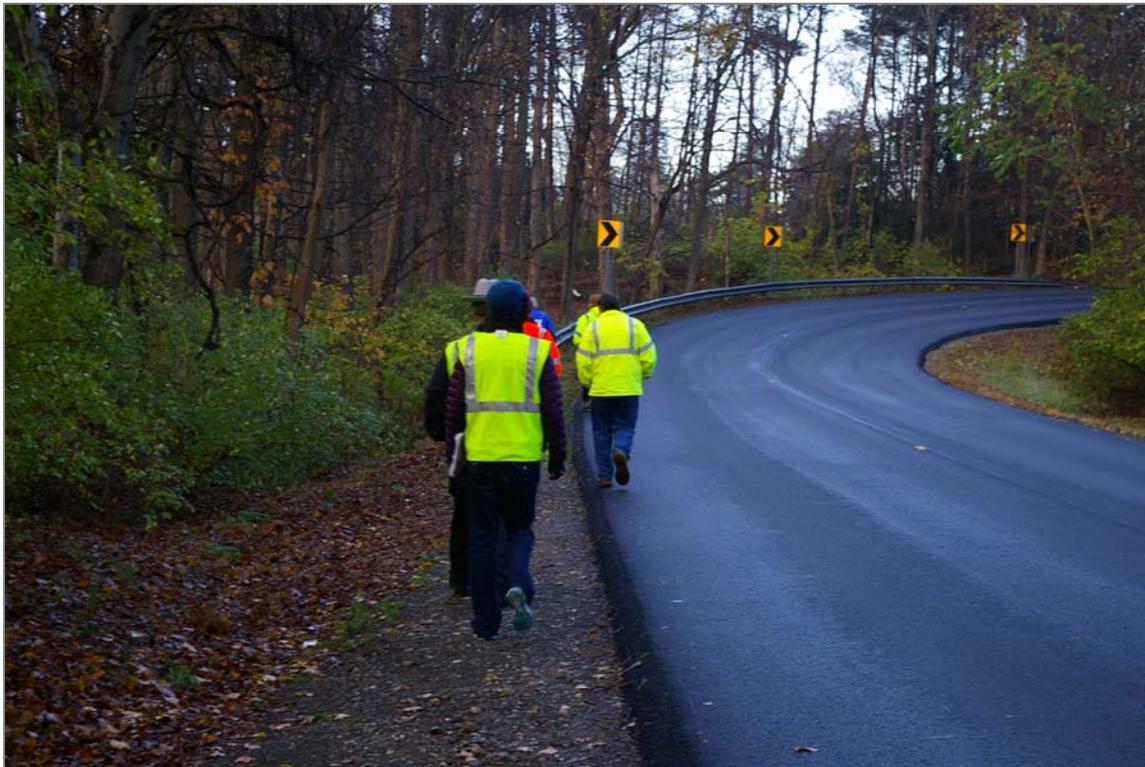
Figure 12. The steep pavement edges make it difficult to walk or bike along Slate Quarry Rd.

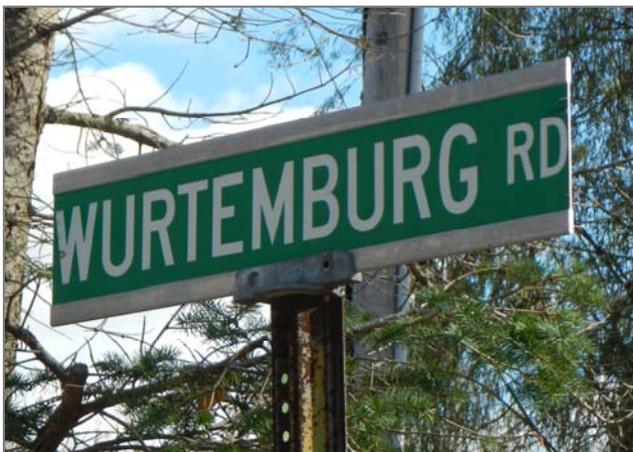
Risk Analysis: Lack of clear navigational information increases the risk of last minute decision making and maneuvers, which may in turn increase the risk of a collision. This condition would affect unfamiliar motorists to a greater extent than locals.

Figure 13. The street name signs in the study area (left) use the old lettering style that has now been superseded by a mixed-case style (above). Source: 2009 MUTCD.

Suggestion: Upgrade street name signs to meet the larger, mixed-case sign standard as per the 2009 MUTCD.

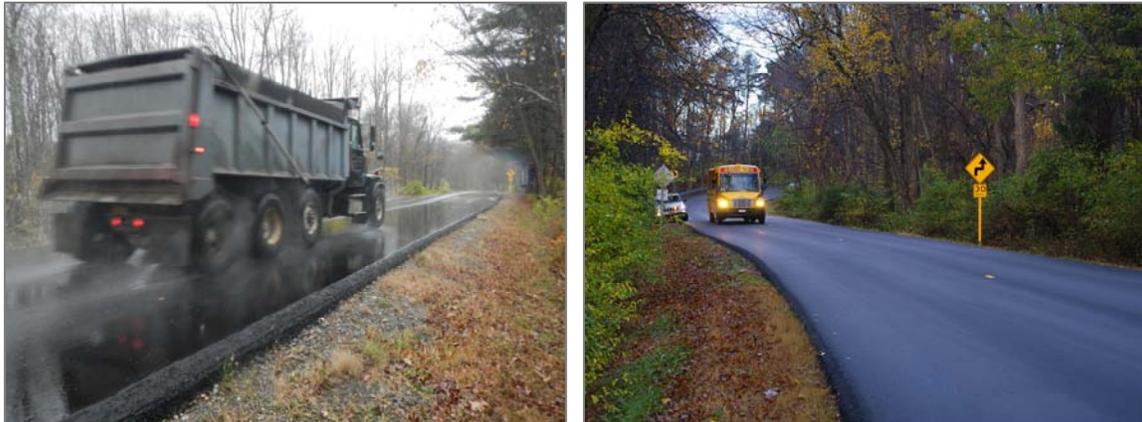
Observations: Based on field observations, numerous large, multi-axle trucks and buses travel through the corridor. School bus activity is especially high in the morning, while a variety of semi-trailers and dump trucks were observed in the morning and afternoon.

Risk Analysis: Heavy vehicles may cross over the centerline of Slate Quarry Rd in order to negotiate the curves, which could pose a safety hazard, especially under wet road conditions.

Figure 14. Heavy-duty vehicles use Slate Quarry Rd as an east-west connector through Rhinebeck to NYS Route 9G.

Suggestion: Ensure that road shoulders are maintained so that they can effectively accommodate large vehicles, especially if the quarry on White Schoolhouse Rd becomes fully operational or is expanded.

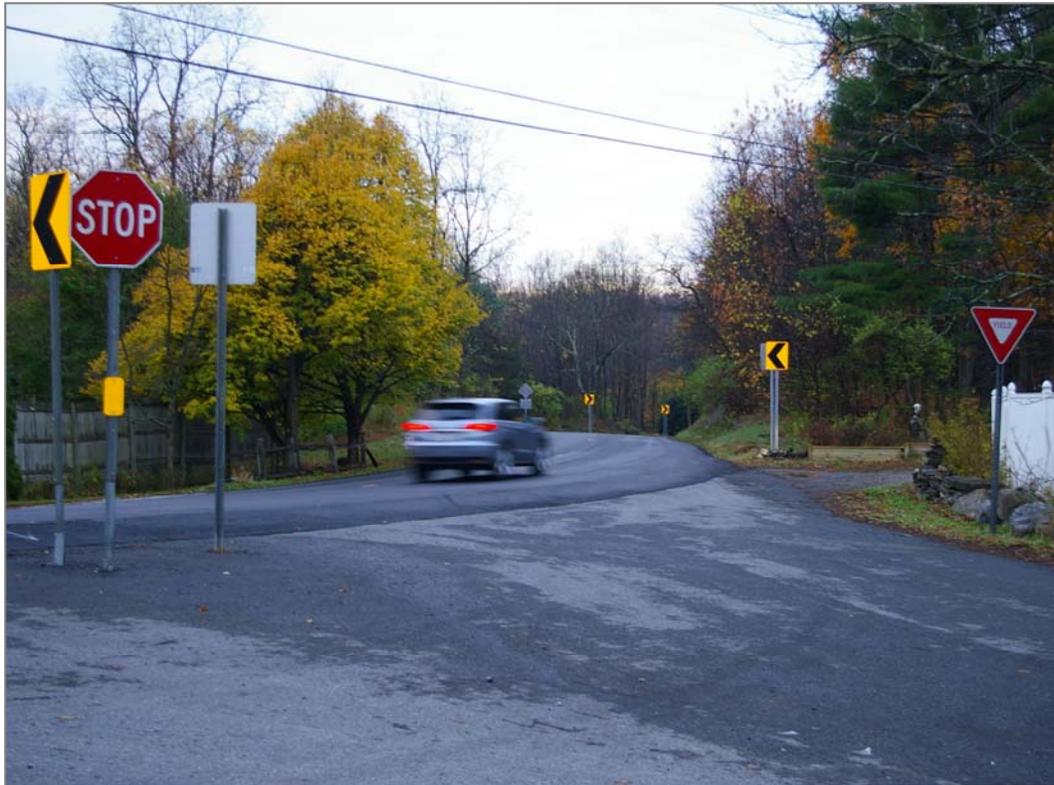
Figure 15. The Slate Quarry/White Schoolhouse Rd intersection looking west. Note the width of the intersection and contradictory STOP and YIELD signs.

Observations: The wide approach on White Schoolhouse Rd allows left and right turning vehicles to pull up side by side at the STOP/YIELD sign. This can result in poor sight lines for one of the turning vehicles, especially when one is a large SUV or heavy duty vehicle and the other is a passenger car. The SA Team recognized that the intersection should accommodate heavy duty vehicles, though this may not warrant the existing intersection width. The Team also observed some confusion among drivers on Slate Quarry Rd as where to enter White Schoolhouse Rd (i.e. to the left or right of the sign posts), though this may have been due to the number of SA Team vehicles in the area.

1. Remove the YIELD sign located on the northwest corner of the intersection and replace it with a STOP sign (R1-1).
2. Install a STOP sign (R1-1) sign on the northeast corner of the intersection.
3. Increase the size of both STOP signs from 30x30 inches to 36x36 inches.
4. Consider installing a STOP AHEAD warning sign (W3-1) on White Schoolhouse Rd for the southbound approach to Slate Quarry Rd.
5. Consider adding a stop line on White Schoolhouse Rd to position drivers at the optimal position to observe approaching vehicles on Slate Quarry Rd. This should be done in conjunction with the suggested intersection narrowing and added lane markings.

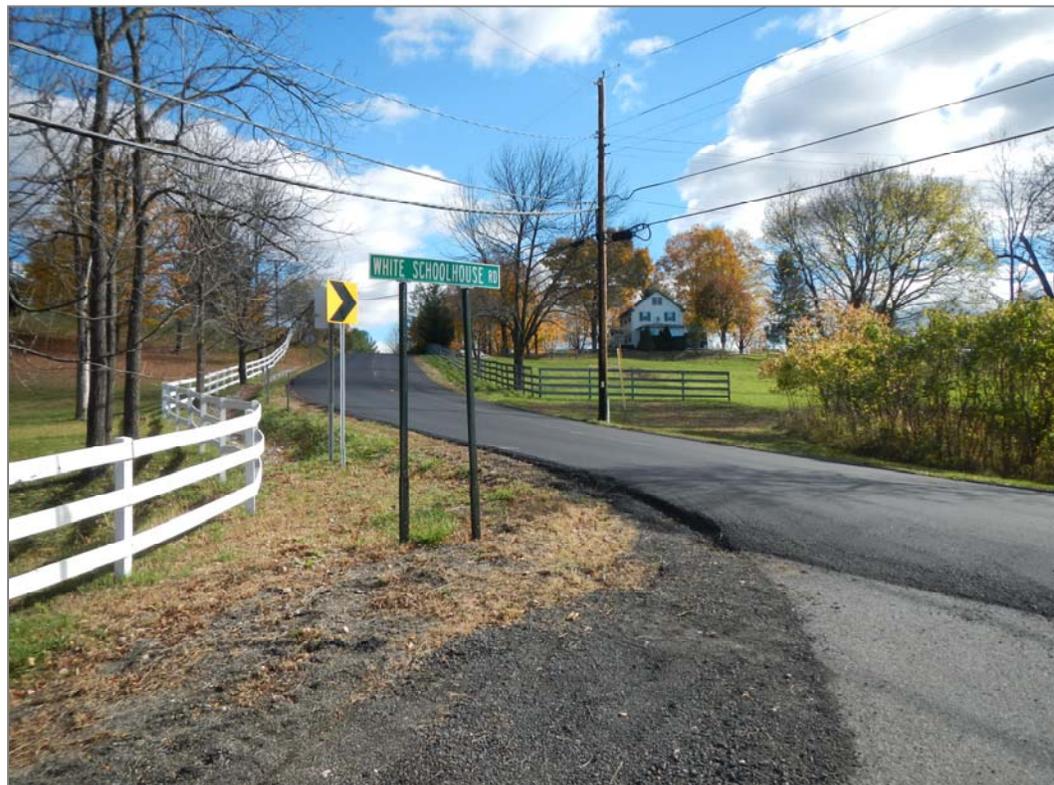
Figure 16. The Slate Quarry Rd/White Schoolhouse Rd intersection looking east, up the hill.

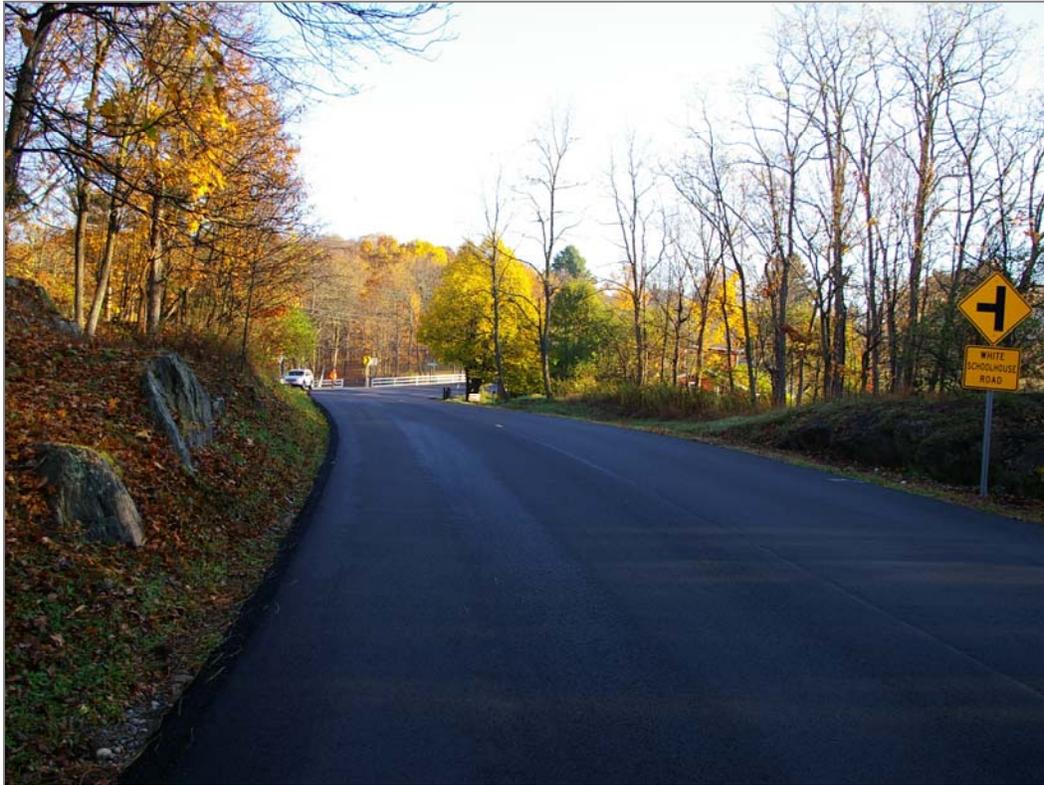
Observations: Drivers on Slate Quarry Rd have difficulty seeing vehicles approaching from the opposite direction as they reach White Schoolhouse Rd. Though the intersection itself is visible from Slate Quarry Rd, approaching vehicles in the opposite lane are masked by an outcrop of trees and bushes on the south side of Slate Quarry Rd, directly opposite White Schoolhouse Rd. These trees may prevent drivers from recognizing vehicles that intend to turn onto White Schoolhouse Rd, and in turn, make them lose valuable reaction time. In particular, the SA Team noted that the sight line for Slate Quarry Rd could be improved by removing the large tree located on the inside of the curve. DCDPW previously discussed removal of this tree with the landowner (220 Slate Quarry Rd), but no changes have been made. The SA Team reported that residents at 209 Slate Quarry Rd had also complained of poor visibility from their driveway, particularly looking east. Sight lines from White

Figure 17. Looking towards White Schoolhouse Rd from eastbound Slate Quarry Rd. Note the change in horizontal geometry towards the curve.

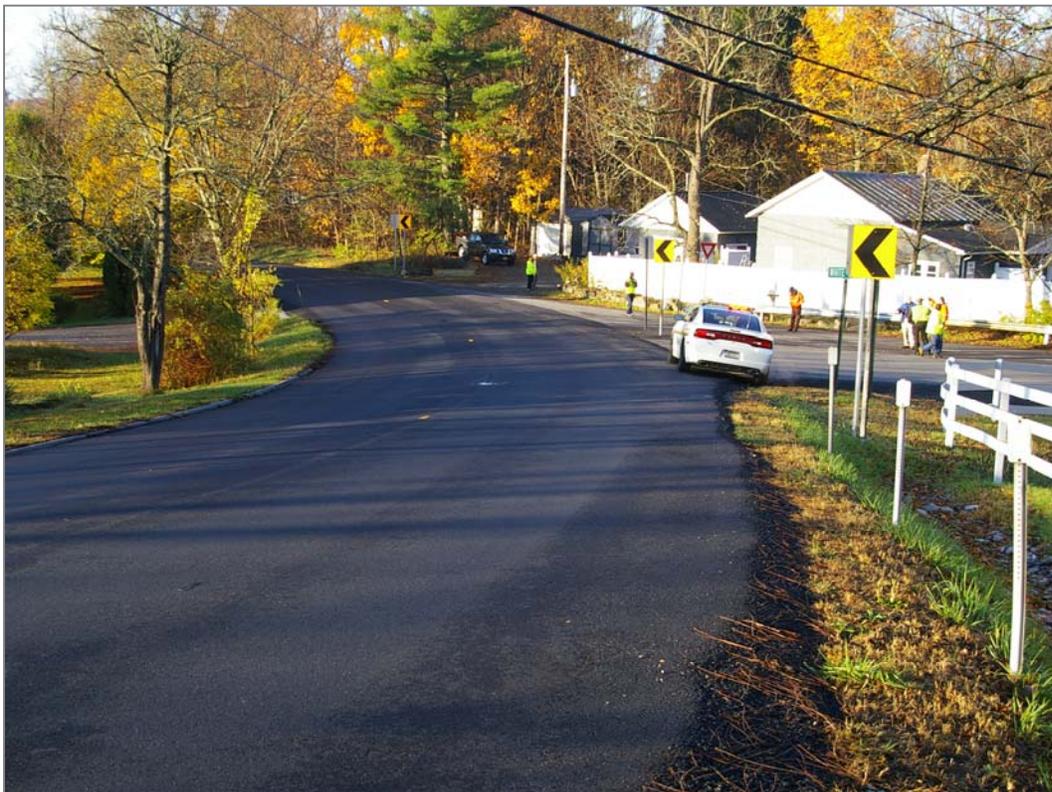
Figure 18. Looking towards White Schoolhouse Rd from westbound Slate Quarry Rd. The trees located to the left, inside the curve, obscure approaching vehicles.

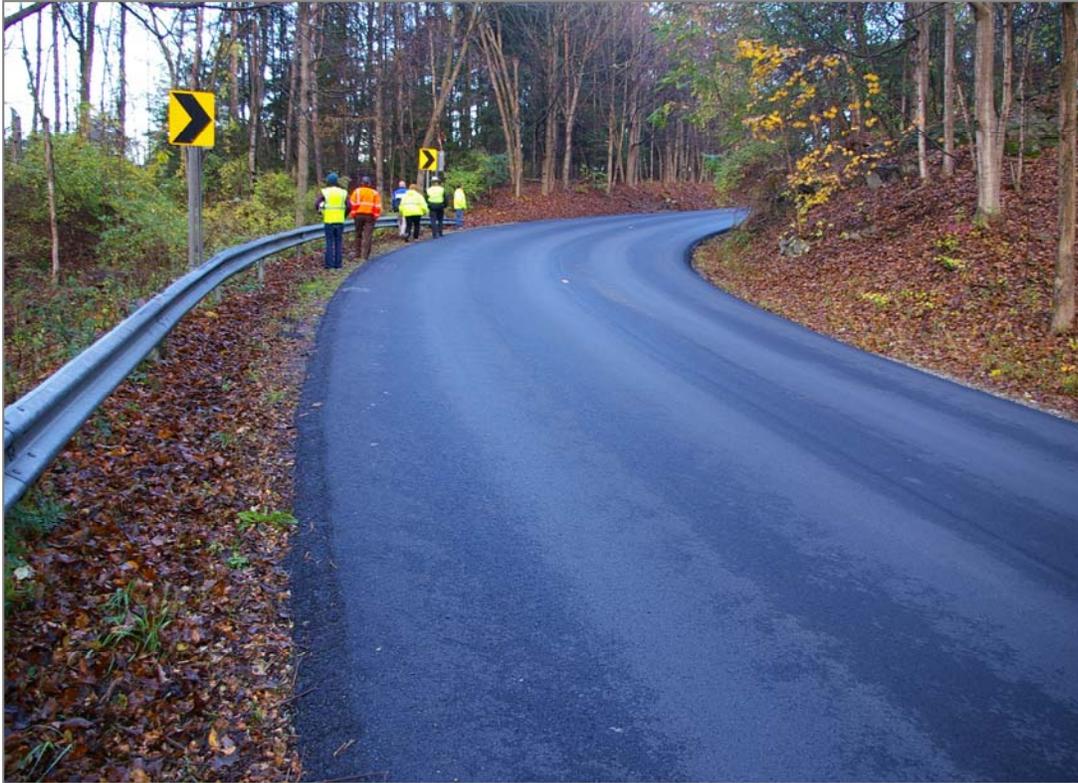
Observations: The horizontal and vertical geometry of Slate Quarry Rd changes throughout the eastern half of the study area. This challenging geometry is complicated by the presence of earthen embankments and vegetation that restrict visibility and reduce driver reaction time. This is especially noticeable at the curve on Slate Quarry Rd in the middle of the study area (91 Slate Quarry Rd), where the inside curve is framed by a rock embankment that includes trees and bushes. These obstructions prevent drivers from seeing down the road and recognizing potential hazards. The crash data does not indicate a safety issue related to poor visibility from driveways, but the road's geometry creates limited sight distances of east and westbound vehicles from driveways. See Figures 19-20.

Risk Analysis: Inadequate sight distance increases the risk of a crash by reducing the driver's ability to accurately judge upcoming roadway features and approaching vehicles. For vehicles turning from driveways, a lack of adequate sight distance increases the risk of a collision by affecting the driver's ability to accurately judge and accept gaps in approaching traffic. Operating speeds on Slate Quarry Rd increase the probability of a severe collision.

Figure 19. Looking west on Slate Quarry Rd, towards one of two major curves. The outcrop of trees and rocks to the right obscures oncoming vehicles.

2. Remove the rock embankment and trees located on the inside of the major curve located near 91 Slate Quarry Rd. DCDPW should investigate the ownership of this particular feature, since Dutchess County Parcel Access indicates that the rock embankment sits within the County's right-of-way and may not require taking property from local owners. It should be noted that the embankment is also bordered by a parcel that belongs to the mining operation at 410 White Schoolhouse Rd.

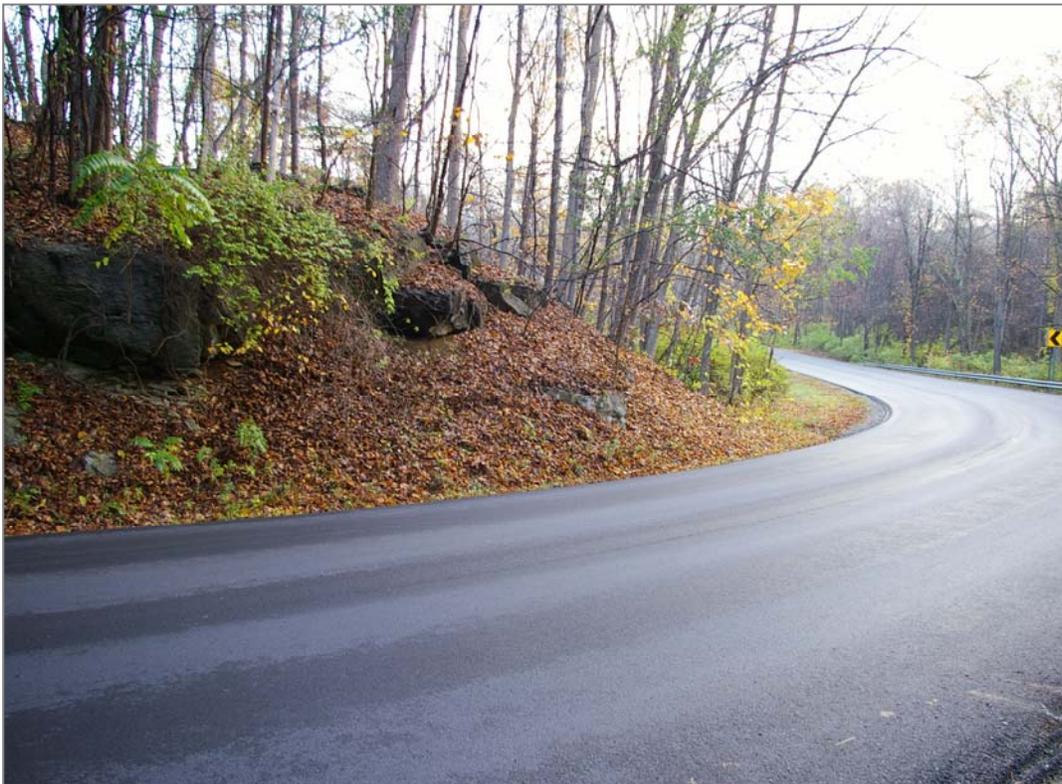
Figure 20. Looking east on Slate Quarry Rd towards the rock embankment located on the inside of the curve shown above.

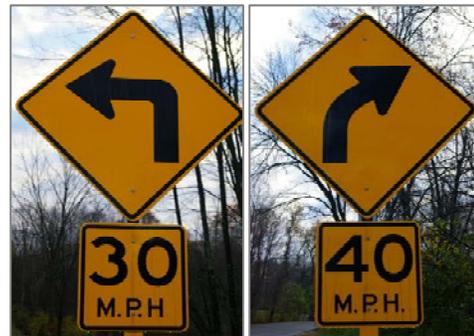
Observation: The SA Team noted that there are four different advisory speeds along Slate Quarry Rd, ranging from a high of 40 mph at gradual curves, 35 mph at moderate curves, and 30 and 25 mph at sharper curves. In light of the speed limit reduction to 45 mph, the 40 mph advisory speed seems possibly too high; the same holds true for the 30 mph advisory speed when compared to subsequent 25 mph advisory speeds along the road.

Figure 21. A variety of advisory speeds are used along Slate Quarry Rd.

Suggestion: Re-evaluate the posted advisory speeds and consider using only two advisory speeds (e.g. 25 and 35 mph) on Slate Quarry Rd.

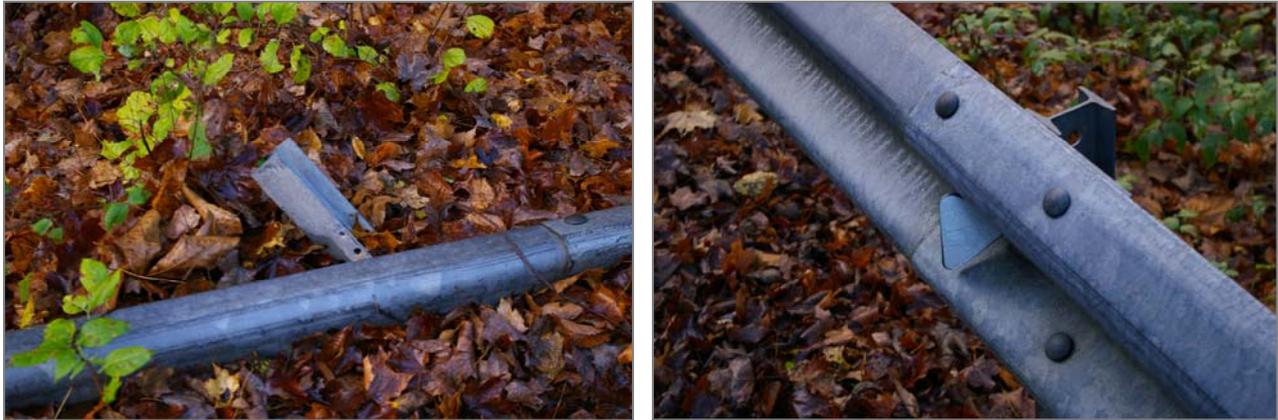
Safety Concern: Portions of existing guiderails are in poor condition and use the older “W-beam” style of rail, while some roadside areas with steep drop-offs and water features may warrant the installation of additional guiderails.

Observations: Recurring vehicle impacts and general wear and tear have damaged sections of guiderail, some of which are missing structural members and many of which are missing delineators. The guiderails use the older “W-beam” design that includes gradually tapered end features. These guiderail ends can sometimes act as a ramp for vehicles that depart the roadway, vaulting them over the guiderail if hit at high speeds. Instead, it is recommended that the box-beam design be used for existing and new guiderails. The SA

Figure 22. Some of the guidrails along Slate Quarry Rd are in need of repair (left), while delineators should be checked for retro-reflectivity (right).

1. Repair exiting guiderails.
2. Install metal reflectors and/or add a reflective strip along the side of the guiderails to increase visibility at night.

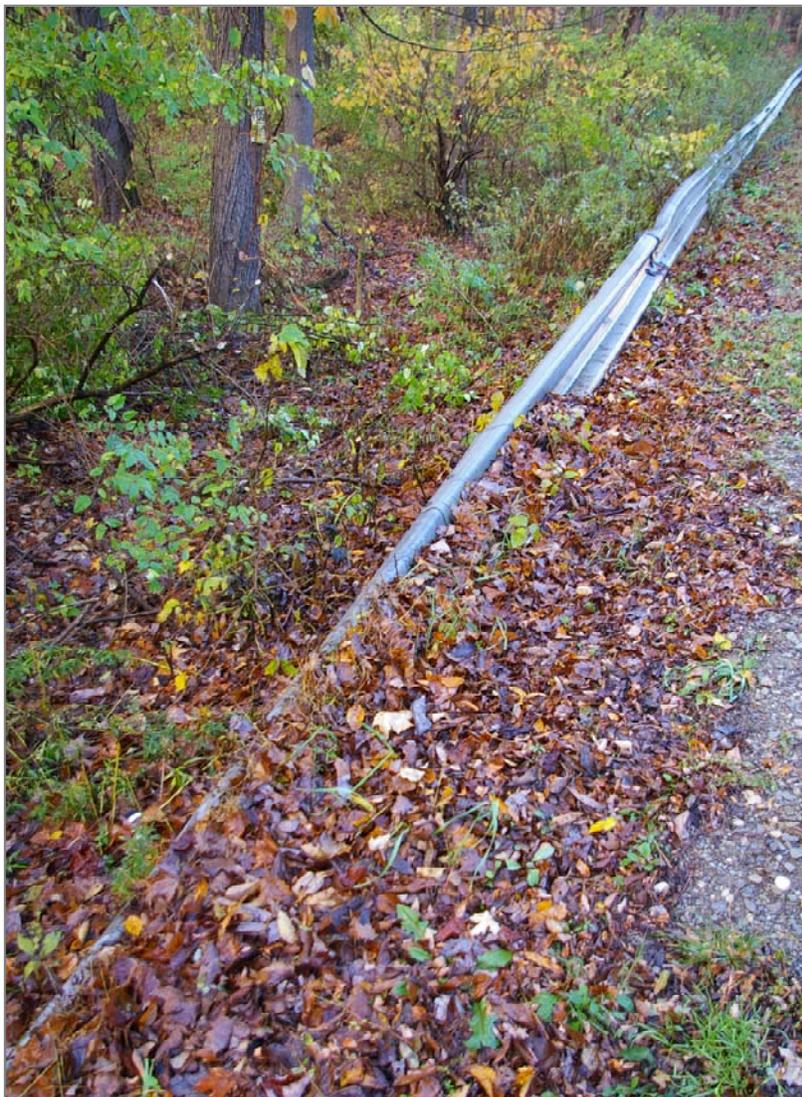
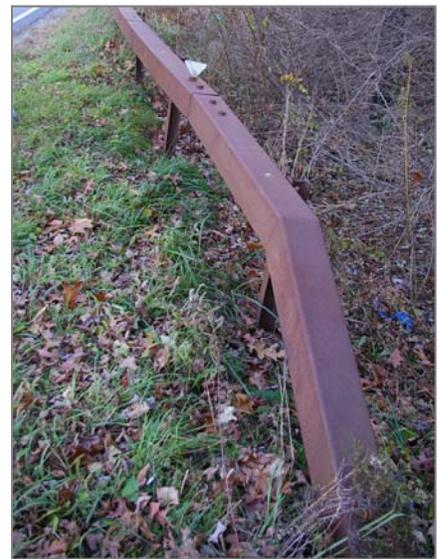
Figure 23. The guidrails along Slate Quarry Rd use the older “W-beam” design, which should be replaced with a “box-beam” design (as shown above on CR16). A significant issue with the “W-beam” design involves the end treatment, which can act as a ramp for vehicles that depart the road.

3. Replace existing guiderails with a box-beam design. The SA Team noted that the County standard for new installations is box beam guiderail and that DCDPW has a program to identify and replace deficient systems.

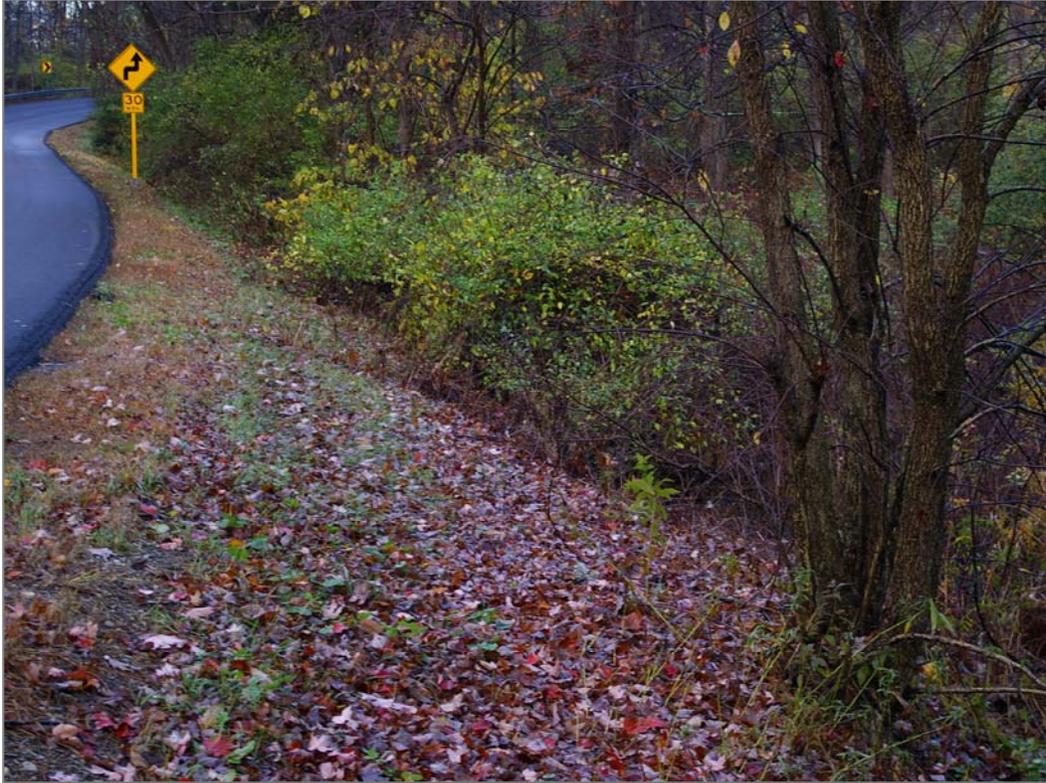
team also noted that new guiderails might be needed on both sides of Slate Quarry Rd between the major curves on the eastern half of the study area: several locations have steep drop-offs and/or standing water, which could magnify the impact of road departures. However, some SA Team members noted that additional guiderails could potentially redirect errant vehicles back into the roadway and the path of oncoming vehicles. See Figures 22-27.

Risk Analysis: Lack of adequate guiderails can result in an errant vehicle traversing down a steep, non-recoverable slope. This is of special concern if the area at the toe of the slope contains fixed objects or other hazards such as deep water. Askew guiderail systems and turned down end sections can also increase the risk of vehicle launching.

Figure 24. Sections of Slate Quarry Rd may warrant guiderails to prevent vehicles from travelling down steep embankments such as the one shown above.

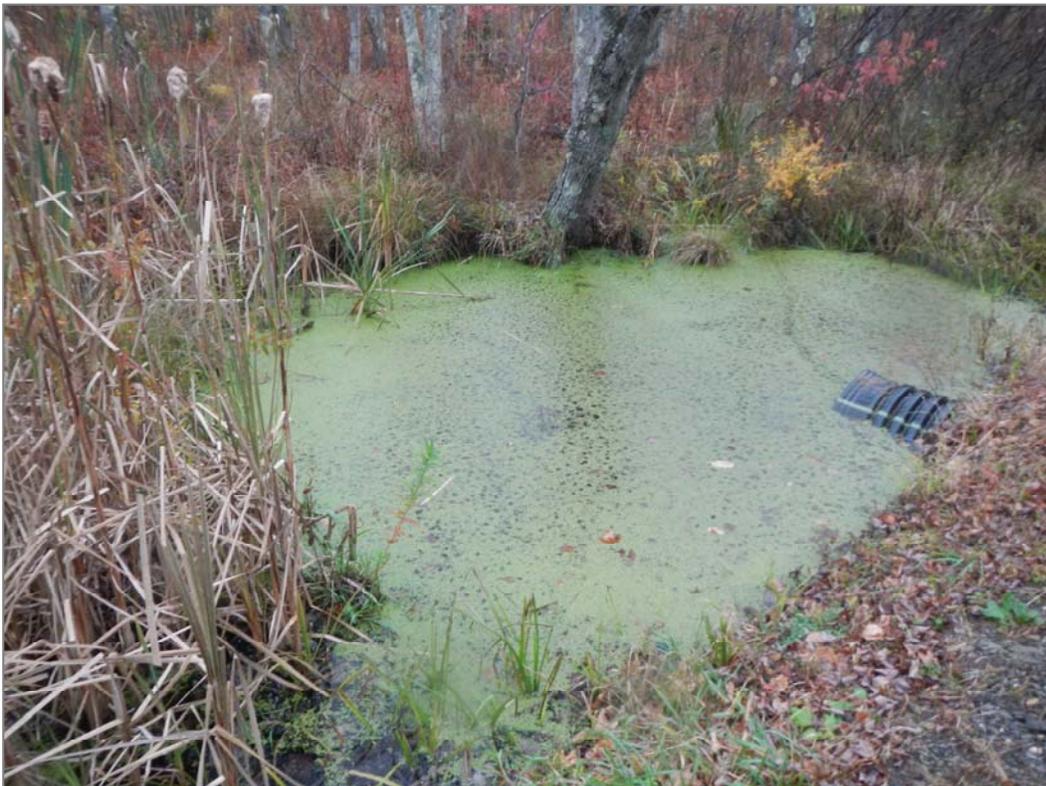
Figure 25. Some of the major culverts on Slate Quarry Rd remain unprotected by barriers, which could prevent vehicles from entering areas of standing water.

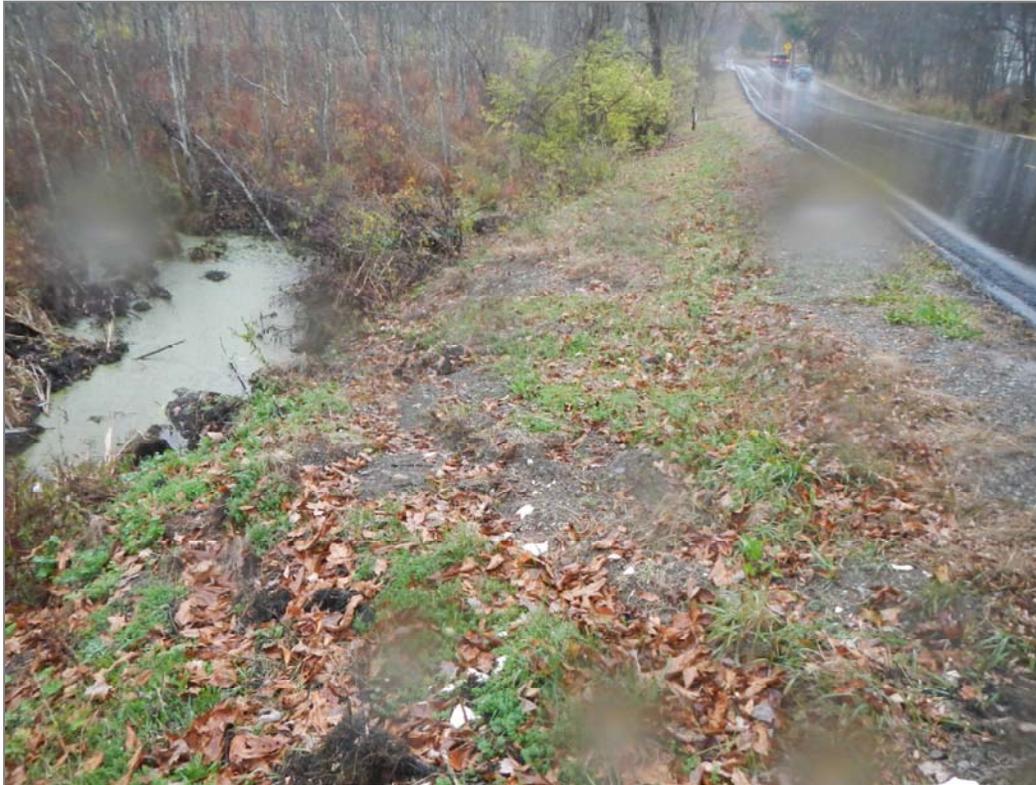
Figure 26. This area of Slate Quarry Rd may warrant guiderails to prevent vehicles from travelling into the adjacent swamp/marsh, as evidenced by the tire tracks in the shoulder.

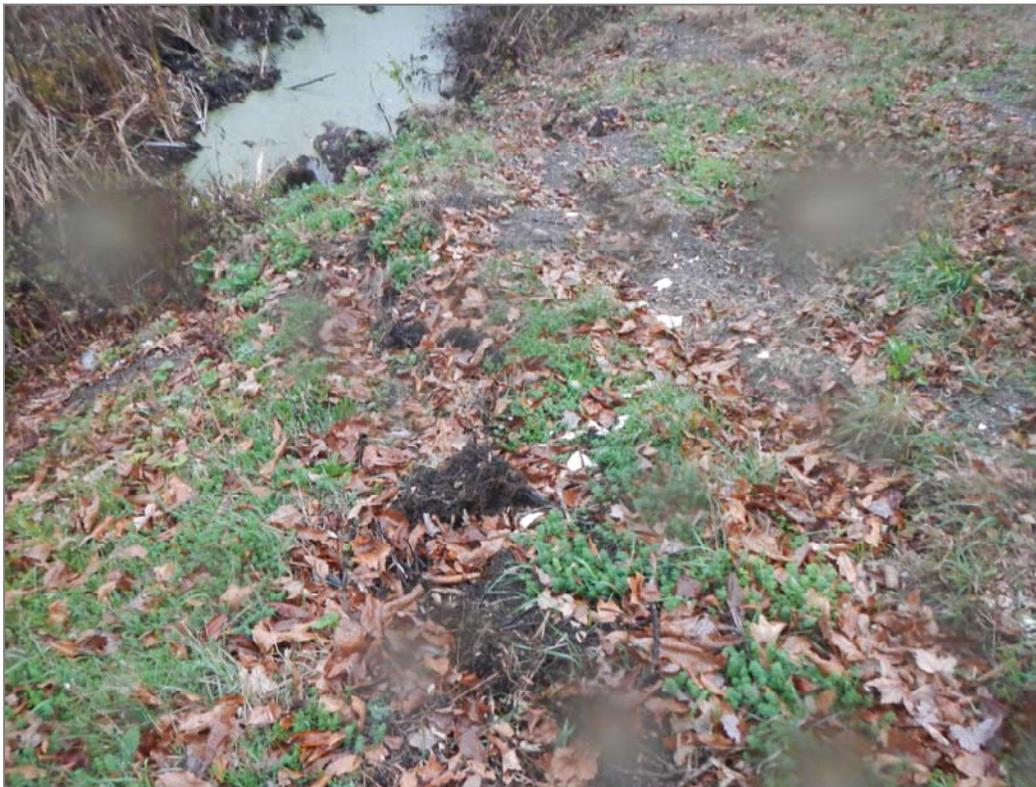
Figure 27. A close-up of the above photo, showing the tire tracks entering the swamp/marsh.

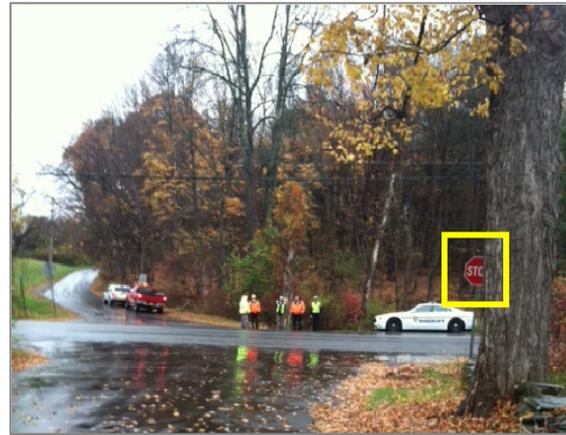
Risk Analysis: Inadequate STOP sign visibility can result in a high-speed, severe right-angle crash.

Figure 28. A large tree obscures the STOP sign on the southern approach of Wurtemberg Rd, as it intersects Slate Quarry Rd.
