**CR19 (Slate Quarry Rd) Safety Assessment**

**NYS Route 9G-White Schoolhouse Rd, Town of Rhinebeck**

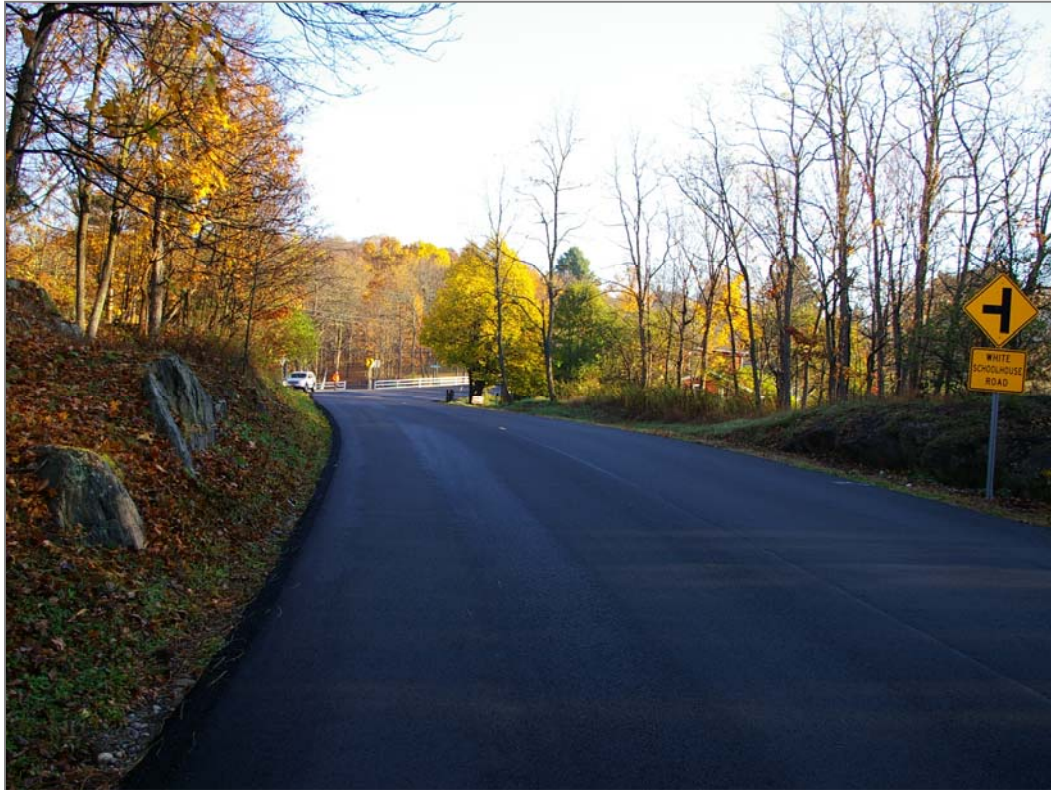
**Observations:** Drivers on Slate Quarry Rd have difficulty seeing vehicles approaching from the opposite direction as they reach White Schoolhouse Rd. Though the intersection itself is visible from Slate Quarry Rd, approaching vehicles in the opposite lane are masked by an outcrop of trees and bushes on the south side of Slate Quarry Rd, directly opposite White Schoolhouse Rd. These trees may prevent drivers from recognizing vehicles that intend to turn onto White Schoolhouse Rd, and in turn, make them lose valuable reaction time. In particular, the SA Team noted that the sight line for Slate Quarry Rd could be improved by removing the large tree located on the inside of the curve. DCDPW previously discussed removal of this tree with the landowner (220 Slate Quarry Rd), but no changes have been made. The SA Team reported that residents at 209 Slate Quarry Rd had also complained of poor visibility from their driveway, particularly looking east. Sight lines from White

**Risk Analysis:** The lack of adequate sight distance decreases driver reaction time, increasing the risk of a collision. Operating speeds on Slate Quarry Rd increase the probability of a severe collision, especially as westbound vehicles descend the hill on Slate Quarry Rd towards White Schoolhouse Rd.

*Figure 17. Looking towards White Schoolhouse Rd from eastbound Slate Quarry Rd. Note the change in horizontal geometry towards the curve.*

1. Trim and/or Remove Existing Vegetation. Pursue trimming or removal of the bushes and trees on the south side of Slate Quarry Rd across from and east of White Schoolhouse Rd.
2. Lower Vertical and Straighten Horizontal Curves on Slate Quarry Rd. This would improve sight distance for both eastbound Slate Quarry Rd drivers and those stopped at the intersection. The SA Team realized that this would require significant funding, so identified this as a low priority.
3. Trim the trees at the northeast corner of the Slate Quarry Rd/White Schoolhouse Rd intersection (on the north side of Slate Quarry Rd).
4. Remove rock and brush on both sides of the driveway to 209 Slate Quarry Rd, and consider installing a DRIVEWAY warning sign.

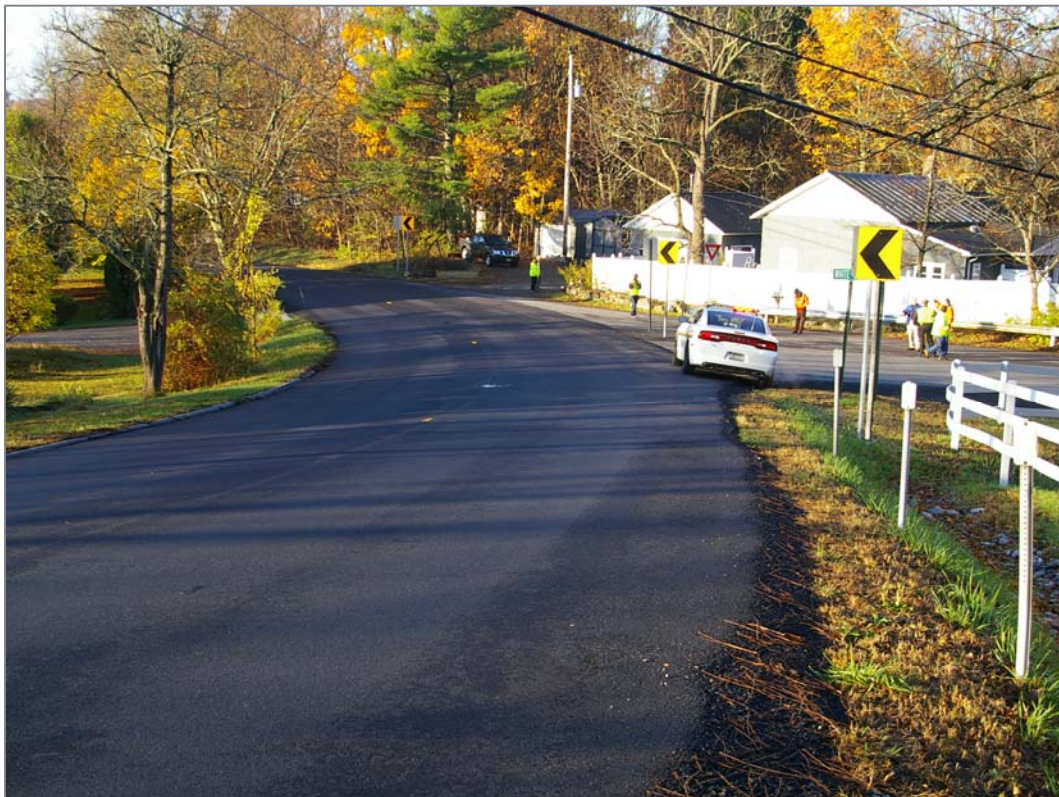
*Figure 18. Looking towards White Schoolhouse Rd from westbound Slate Quarry Rd. The trees located to the left, inside the curve, obscure approaching vehicles.*

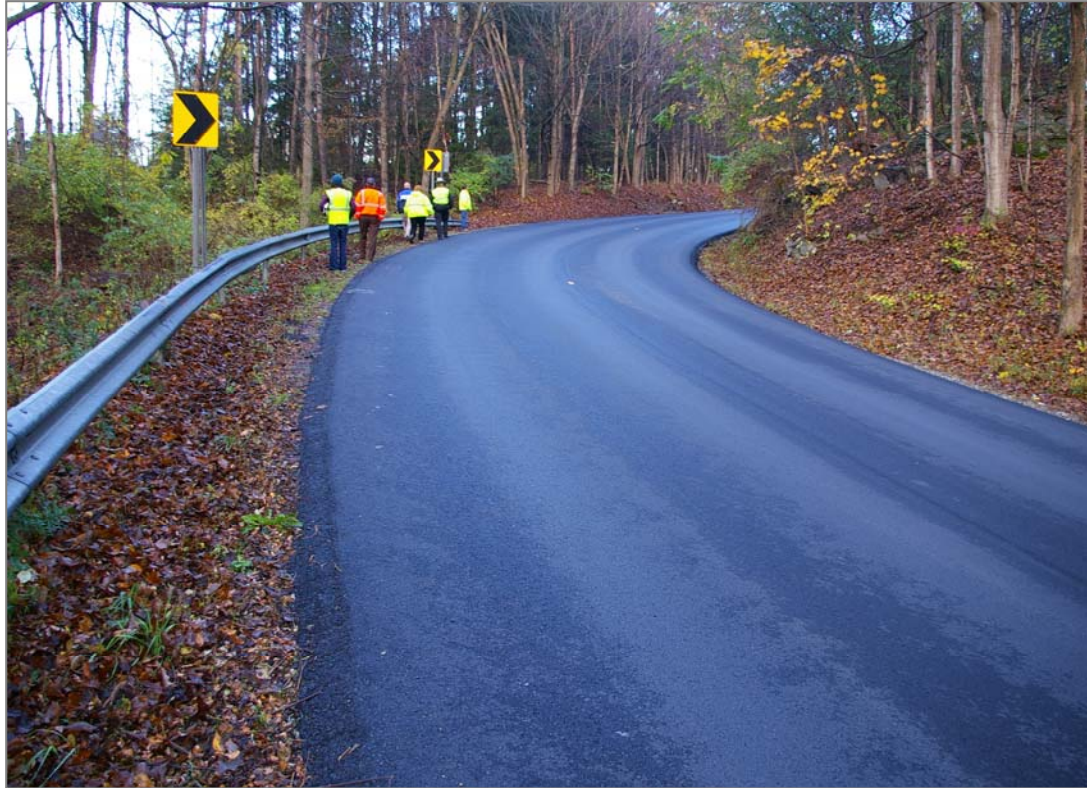
**Observations:** The horizontal and vertical geometry of Slate Quarry Rd changes throughout the eastern half of the study area. This challenging geometry is complicated by the presence of earthen embankments and vegetation that restrict visibility and reduce driver reaction time. This is especially noticeable at the curve on Slate Quarry Rd in the middle of the study area (91 Slate Quarry Rd), where the inside curve is framed by a rock embankment that includes trees and bushes. These obstructions prevent drivers from seeing down the road and recognizing potential hazards. The crash data does not indicate a safety issue related to poor visibility from driveways, but the road's geometry creates limited sight distances of east and westbound vehicles from driveways. See Figures 19-20.

**Risk Analysis:** Inadequate sight distance increases the risk of a crash by reducing the driver's ability to accurately judge upcoming roadway features and approaching vehicles. For vehicles turning from driveways, a lack of adequate sight distance increases the risk of a collision by affecting the driver's ability to accurately judge and accept gaps in approaching traffic. Operating speeds on Slate Quarry Rd increase the probability of a severe collision.

Figure 19. Looking west on Slate Quarry Rd, towards one of two major curves. The outcrop of trees and rocks to the right obscures oncoming vehicles.

1. As part of normal tree maintenance, DCDPW should ensure that the County right-of-way is free and clear of obstructions and that the clear zone is sufficient for this type of facility. If vegetation is located on private property and is determined to compromise safety, DCDPW should notify the applicable property owner of the situation and suggest that they remove the obstruction(s).

2. Remove the rock embankment and trees located on the inside of the major curve located near 91 Slate Quarry Rd. DCDPW should investigate the ownership of this particular feature, since Dutchess County Parcel Access indicates that the rock embankment sits within the County's right-of-way and may not require taking property from local owners. It should be noted that the embankment is also bordered by a parcel that belongs to the mining operation at 410 White Schoolhouse Rd.

3. Reduce the horizontal and vertical curves at the two major curve sections on Slate Quarry Rd. This would improve sight distance for drivers exiting driveways along the road, while allowing drivers on Slate Quarry Rd to recognize oncoming vehicles earlier, increasing reaction times. Due to the cost and time needed for such improvements, the SA team identified this as a long-range suggestion.

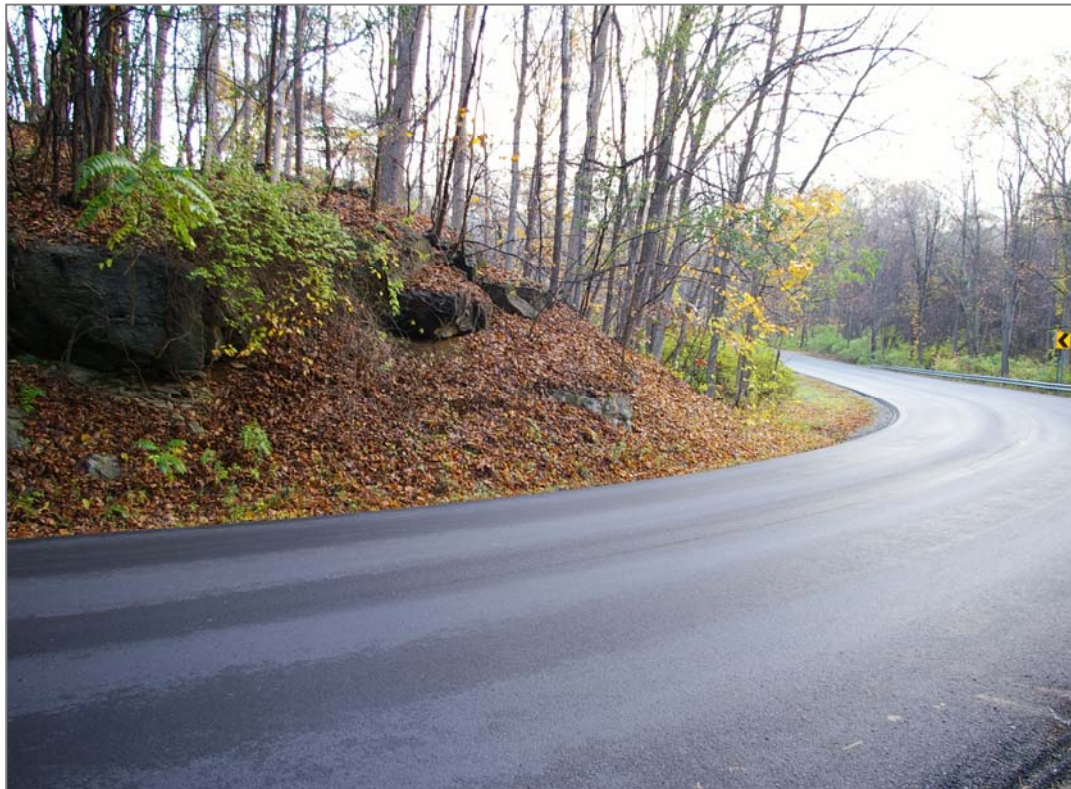
Figure 20. Looking east on Slate Quarry Rd towards the rock embankment located on the inside of the curve shown above.

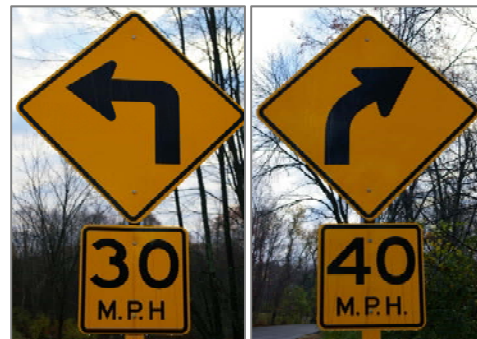
**Observation:** The SA Team noted that there are four different advisory speeds along Slate Quarry Rd, ranging from a high of 40 mph at gradual curves, 35 mph at moderate curves, and 30 and 25 mph at sharper curves. In light of the speed limit reduction to 45 mph, the 40 mph advisory speed seems possibly too high; the same holds true for the 30 mph advisory speed when compared to subsequent 25 mph advisory speeds along the road.

**Risk Analysis:** Drivers may become confused by the inconsistent advisory speeds and ignore them, increasing the likelihood of a collision or road departure.

*Figure 21. A variety of advisory speeds are used along Slate Quarry Rd.*

**Suggestion:** Re-evaluate the posted advisory speeds and consider using only two advisory speeds (e.g. 25 and 35 mph) on Slate Quarry Rd.

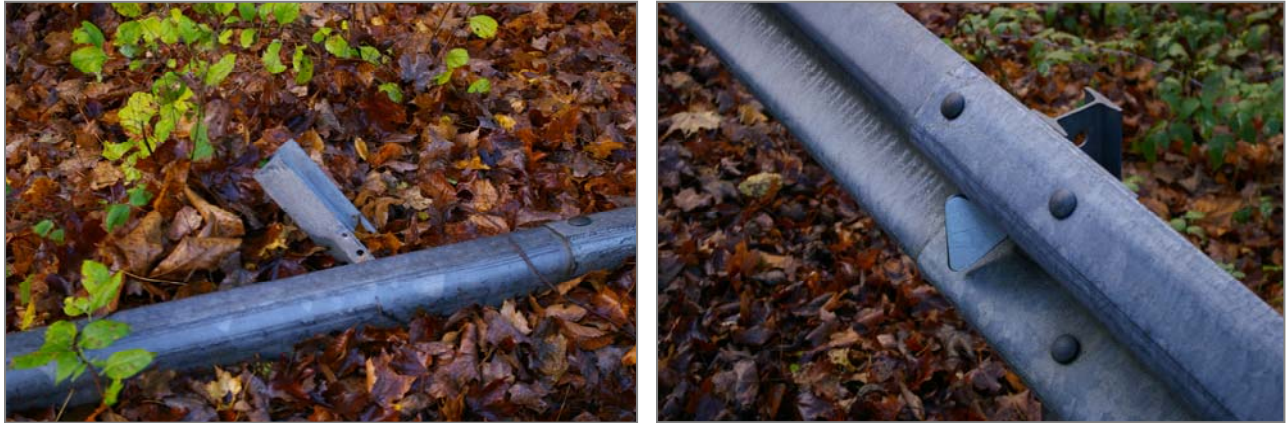
**Observations:** Recurring vehicle impacts and general wear and tear have damaged sections of guiderail, some of which are missing structural members and many of which are missing delineators. The guiderails use the older “W-beam” design that includes gradually tapered end features. These guiderail ends can sometimes act as a ramp for vehicles that depart the roadway, vaulting them over the guiderail if hit at high speeds. Instead, it is recommended that the box-beam design be used for existing and new guiderails. The SA

Figure 22. Some of the guidrails along Slate Quarry Rd are in need of repair (left), while delineators should be checked for retro-reflectivity (right).

1. Repair exiting guiderails.
2. Install metal reflectors and/or add a reflective strip along the side of the guiderails to increase visibility at night.

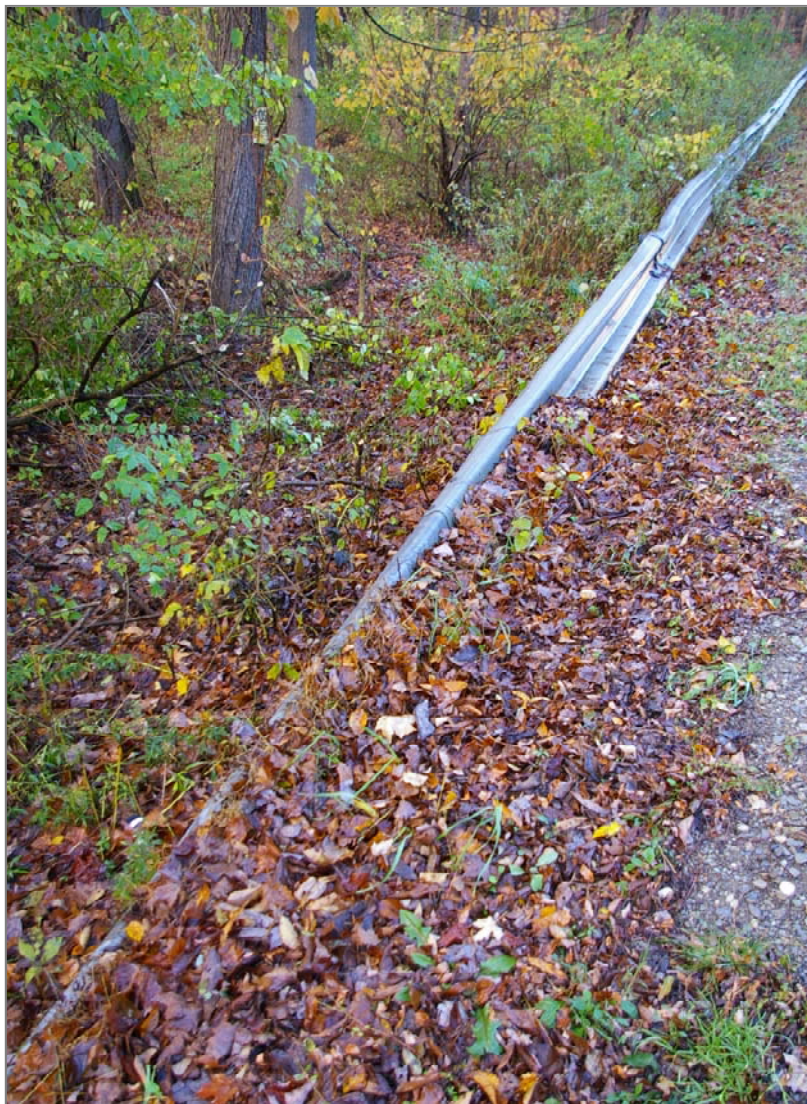
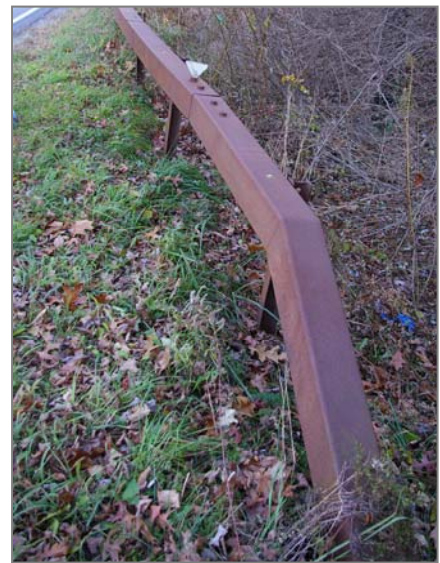
**Risk Analysis:** Lack of adequate guiderails can result in an errant vehicle traversing down a steep, non-recoverable slope. This is of special concern if the area at the toe of the slope contains fixed objects or other hazards such as deep water. Askew guiderail systems and turned down end sections can also increase the risk of vehicle launching.

Figure 23. The guidrails along Slate Quarry Rd use the older “W-beam” design, which should be replaced with a “box-beam” design (as shown above on CR16 ). A significant issue with the “W-beam” design involves the end treatment, which can act as a ramp for vehicles that depart the road.

3. Replace existing guiderails with a box-beam design. The SA Team noted that the County standard for new installations is box beam guiderail and that DCDPW has a program to identify and replace deficient systems.

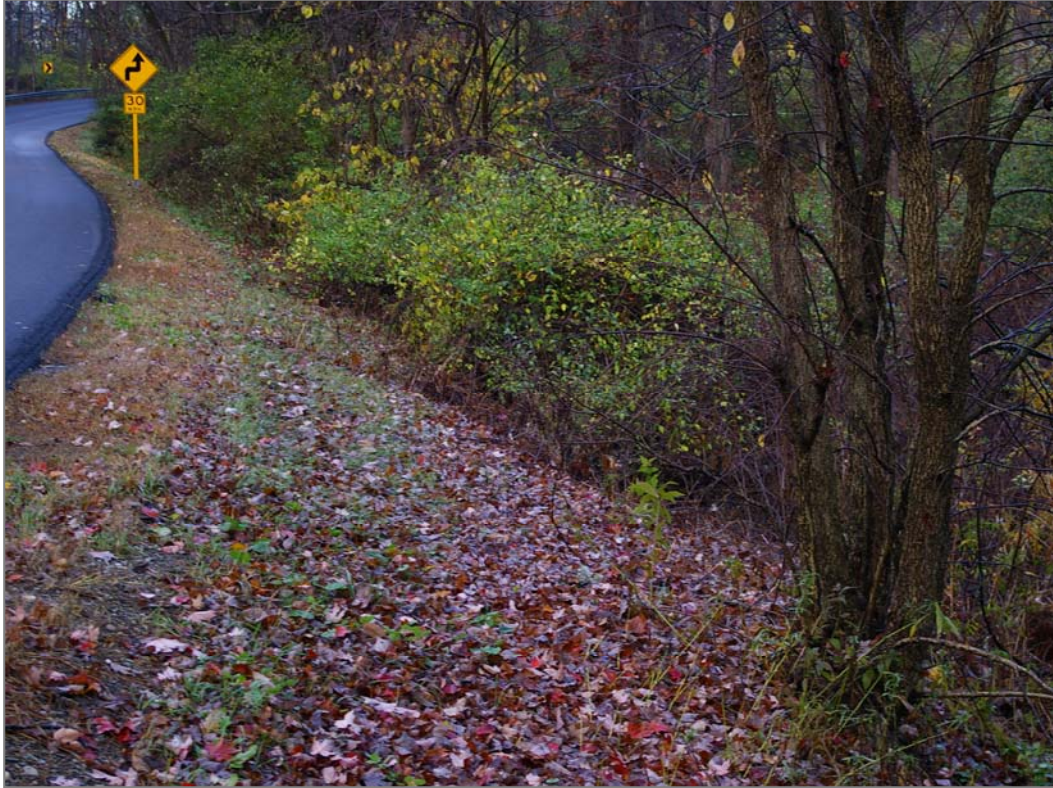
team also noted that new guiderails might be needed on both sides of Slate Quarry Rd between the major curves on the eastern half of the study area: several locations have steep drop-offs and/or standing water, which could magnify the impact of road departures. However, some SA Team members noted that additional guiderails could potentially redirect errant vehicles back into the roadway and the path of oncoming vehicles. See Figures 22-27.

*Figure 24. Sections of Slate Quarry Rd may warrant guiderails to prevent vehicles from travelling down steep embankments such as the one shown above.*

4. Evaluate the need for installation of one more new guiderails along Slate Quarry Rd, especially in the section between the two major curves in the eastern half of the study area. DCDPW should weigh the benefit of a new guiderail with the potential of increasing possible head-on crashes if errant vehicles bounce back into traffic. As an alternative and where appropriate, DCDPW could consider raising shoulder and clear zone elevations to reduce drop-off distances.

5. As an interim measure, consider object markers at significant drop-off areas until guiderail can be installed.

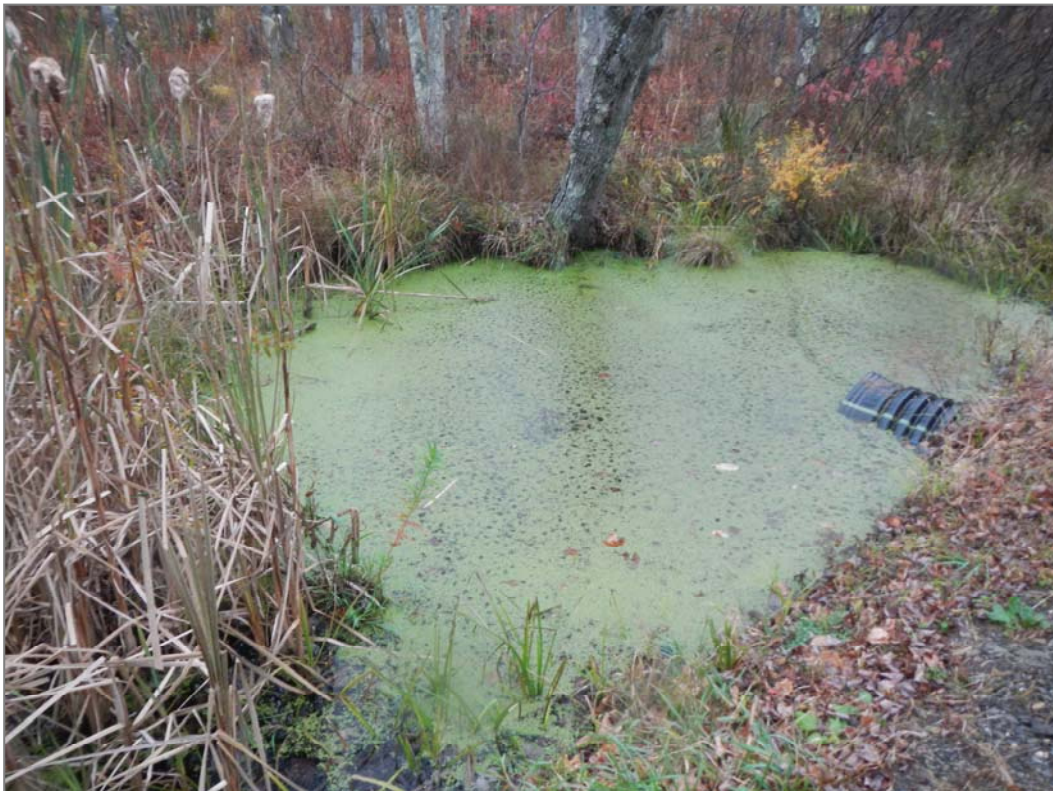
*Figure 25. Some of the major culverts on Slate Quarry Rd remain unprotected by barriers, which could prevent vehicles from entering areas of standing water.*

**Observations:** A number of culverts along Slate Quarry Rd do not have barriers to prevent vehicles from entering nearby water and possibly becoming submerged. See Figure 25.

**Risk Analysis:** A vehicle that departs the road at or near a culvert could become submerged in standing water, thus increasing the risk of injury or death.

**Suggestion:** Conduct an engineering evaluation of existing culverts to determine if they warrant barriers.

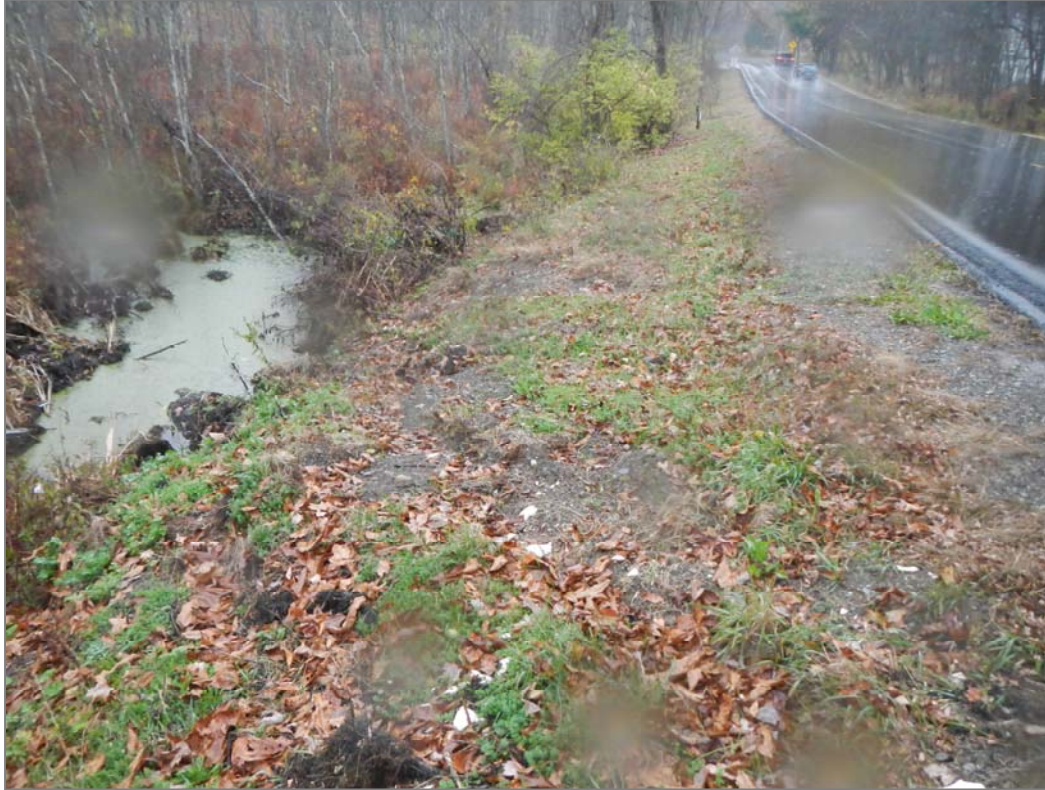
*Figure 26. This area of Slate Quarry Rd may warrant guiderails to prevent vehicles from travelling into the adjacent swamp/marsh, as evidenced by the tire tracks in the shoulder.*

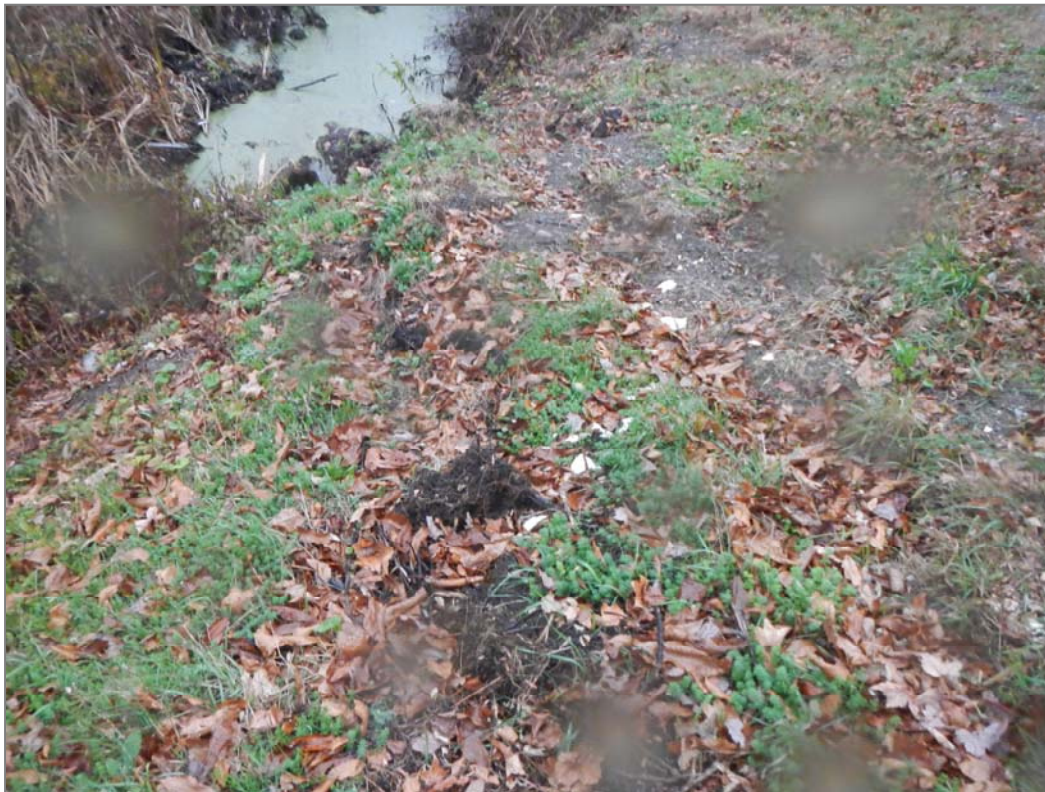
*Figure 27. A close-up of the above photo, showing the tire tracks entering the swamp/marsh.*

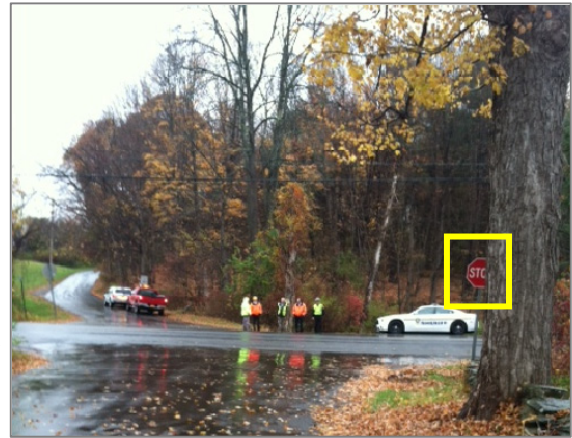
**Observations:** A large tree partially obscures the STOP sign on northbound Wurtemberg Rd as it approaches Slate Quarry Rd. The SA Team also noted that the stop lines on both approaches to Slate Quarry Rd were faded. Stop lines help motorists recognize the need to stop and designate proper positioning for optimal sight distance prior to entering the intersection. See Figure 28.

**Risk Analysis:** Inadequate STOP sign visibility can result in a high-speed, severe right-angle crash.

*Figure 28. A large tree obscures the STOP sign on the southern approach of Wurtemberg Rd, as it intersects Slate Quarry Rd.*

1. Move the STOP (R1-1) sign post away from the large tree at the southeast corner of the intersection.
2. Consider the use of a vertical retro-reflective strip on the STOP (R1-1) sign support to enhance visibility.
3. Install a new pictorial STOP AHEAD warning sign (W3-1) on Wurtemberg Rd to warn drivers of the upcoming STOP sign. [Note: this was subsequently installed].
4. Consider restriping the stop lines on both Wurtemberg Rd approaches to Slate Quarry Rd, using the NYSDOT recommended standard width of 18 inches or the wider 24 inches, which would provide an additional cue to drivers.
