**Dutchess County
Public Works**

Nelson House Annex

Building Conditions Assessment

28 Market Street
Poughkeepsie, NY 12601

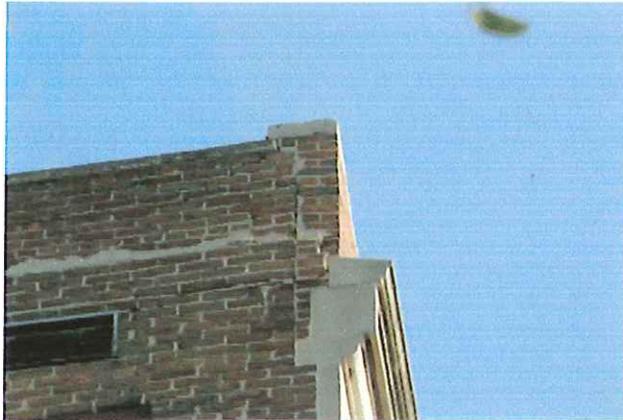
The parapets and copings protecting the top of the parapet walls are displaced, cracked, and spalled in some locations. Continued exposure to weather will, eventually, cause the parapets to fail. (See Photos 04 through 06.)

Photo 04: Prior repairs and displacement of parapet at the southeast corner of Nelson House Annex.

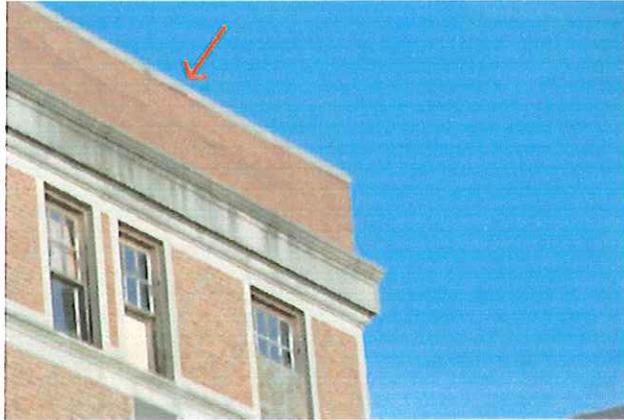
Photo 05: Displaced and spalled coping stone (arrow) at the north end of parapet at east façade of Nelson House Annex.

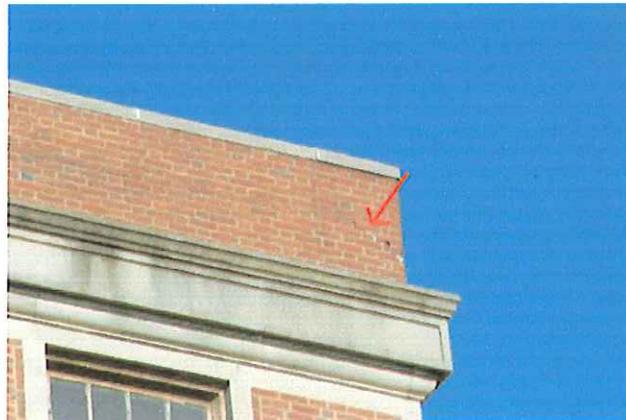
Photo 06: Crack in the parapet (arrow) at the north end of the parapet at the east elevation of the Nelson House Annex.

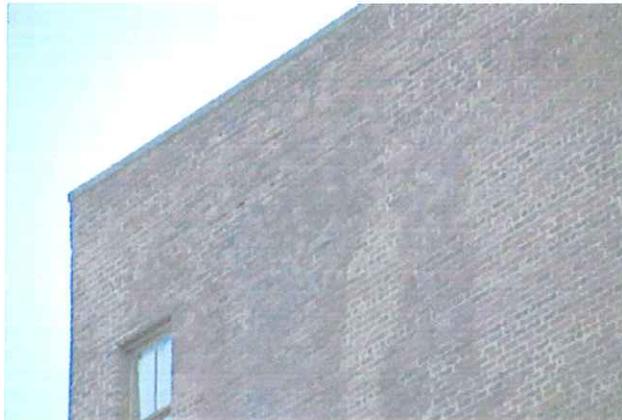
Broken drain lines and/or clogged roof drains in conjunction with the loss of the roof membrane in the southwest corner of the Nelson House Annex have resulted in saturation of a portion of the south wall of the building. At other locations around the exterior cracks have developed in the masonry as the result of corrosion of the steel lintels spanning windows. This condition, which can be dangerous, hasn't become endemic, but will the longer the building remains unoccupied. (See Photos 07 through 11.)

Photo 07: Wet areas of brick (darker vertical streaks) on the south wall of the Nelson House Addition are the result of a failed roofing membrane and broken and/or plugged internal roof drains.

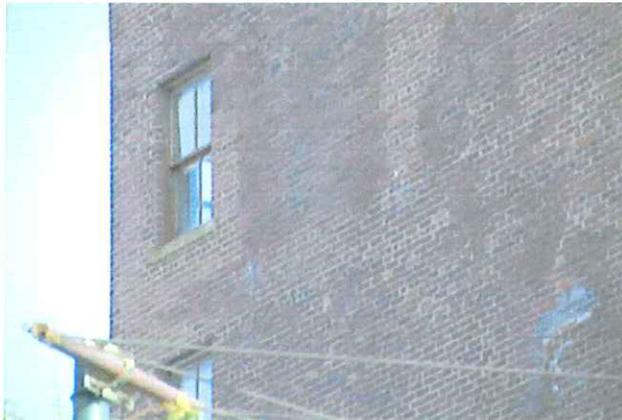
Photo 08: The damp brick areas extend down the west end of the south wall several stories.

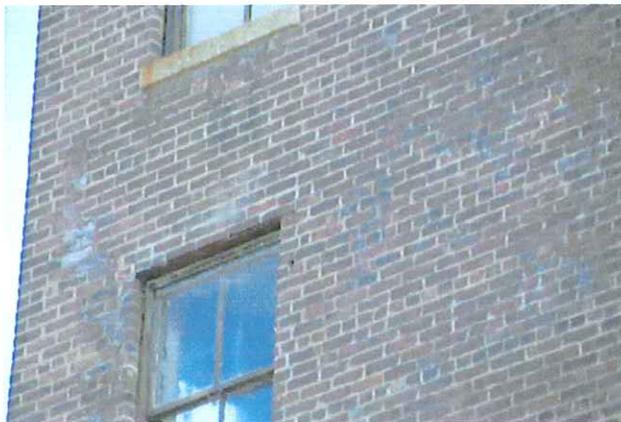
Photo 09: Efflorescence, salt crystalizing on the surface of the masonry is evident at the periphery of the damp areas of brick. Corrosion of the steel lintel of the window opening is also evident.

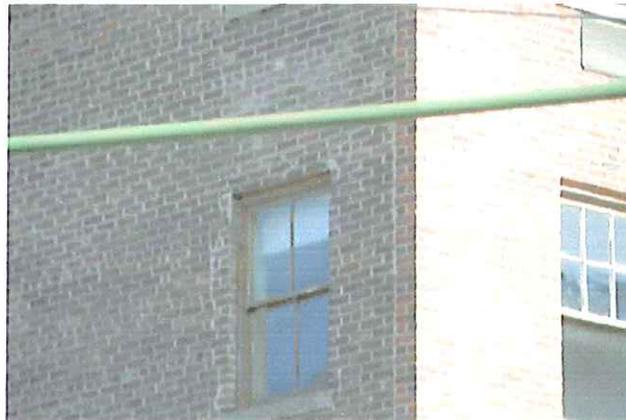
Photo 10: Cracks at the jambs of this window at the east end of the south wall of the Nelson House Addition are likely caused by corrosion of the steel lintel spanning the window opening. This condition, which can be dangerous, hasn't become endemic, but will the longer the building remains unoccupied.

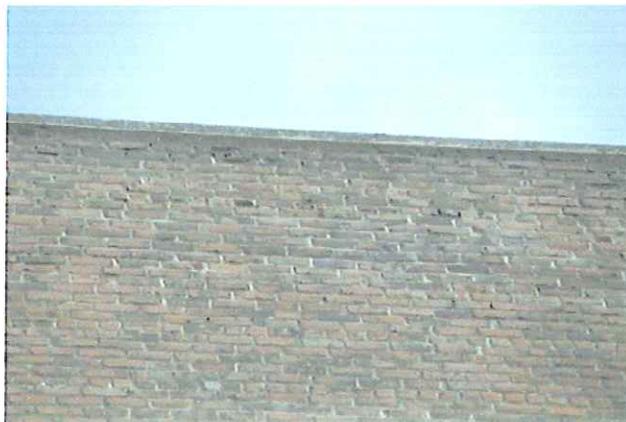
Spalling and erosion of the brick was observed along the parapet at the west elevation of the Nelson House Annex. Spalling is typically evidence of freeze-thaw cycling or efflorescence – both resulting from chronic or periodic wetting of the brick. Over time, freeze-thaw cycling and efflorescence can reduce the section of the masonry wall assembly to the point where it becomes unstable. (See Photos 12 through 14).

Photo 11: Spalling and erosion of the brick along the parapet at the west elevation of the Nelson House Annex. Spalling is typically evidence of freeze-thaw cycling or efflorescence – both resulting from chronic or periodic wetting of the brick. Over time, freeze-thaw cycling and efflorescence can reduce the section of the masonry wall assembly to the point where it becomes unstable.

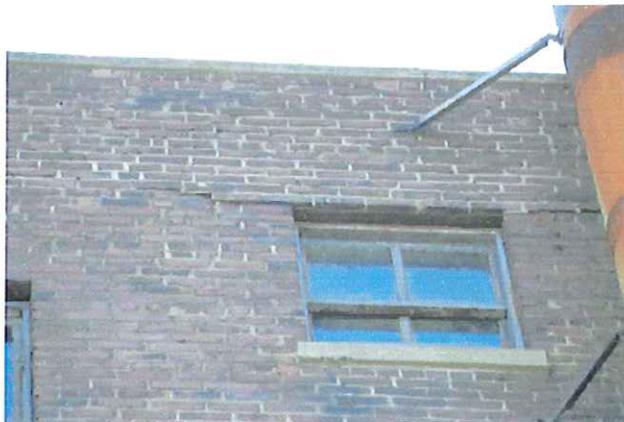
Photo 12: Displaced masonry and corroded lintel at the parapet of the west elevation of the Nelson House Annex.

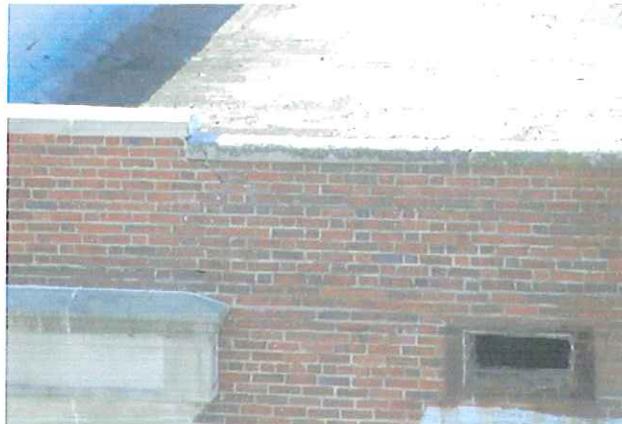
Photo 13: Upper portion of a crack that may be associated with deterioration of spandrel beams or lintels at the top floor of the Nelson House Annex. This view is of the east end of the north wall.

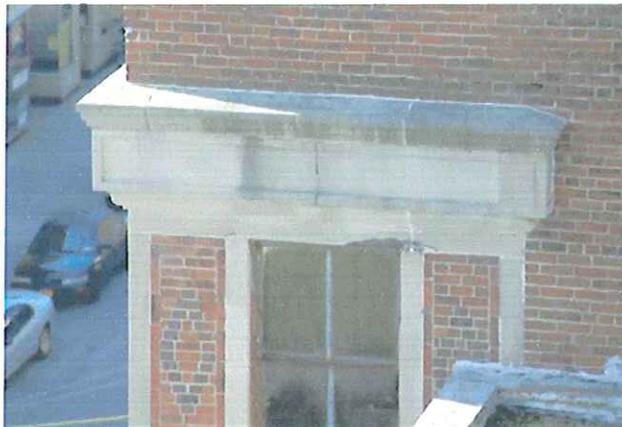
Photo 14: A large spall at the limestone cornice / watertable at the north wall of the Nelson House Annex. See Photo 13 for additional information.

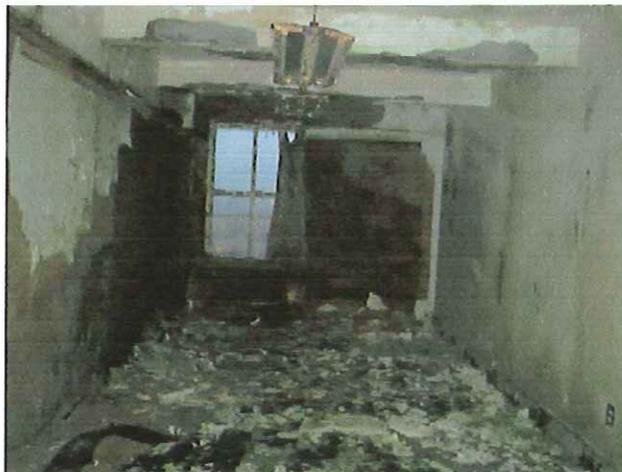
The finishes and concrete slab at the southwest corner of the building are saturated at the upper floors. The areas of saturation are smaller on lower floors, but are generally still present. Continued exposure to water will, ultimately, lead to corrosion of the steel reinforcing in the concrete, corrosion of the steel frame, and a reduction in the capacity of the structure to carry load. Freeze-thaw damage may also occur as the building is unoccupied and unheated. (See Photo 15.)

Photo 15: The finishes and concrete slab at the southwest corner of the building are saturated at the upper floors. The areas of saturation are smaller on lower floors, but are generally still present. Continued exposure to water will, ultimately, lead to corrosion of the steel reinforcing in the concrete, corrosion of the steel frame, and a reduction in the capacity of the structure to carry load. Freeze-thaw damage may also occur as the building is unoccupied and unheated.

While there are no apparent imminent risks of structural failure at the steel and concrete-framed floor slabs at the Nelson House Annex, portions of the floors are saturated and will continue to deteriorate unless the building envelope (roof, walls, and windows) is made more weather-resistant. The scope of deferred repairs to the existing steel and concrete-framed floors at the Nelson House, which is presently un-quantified, will increase if the roof remains in its current state.

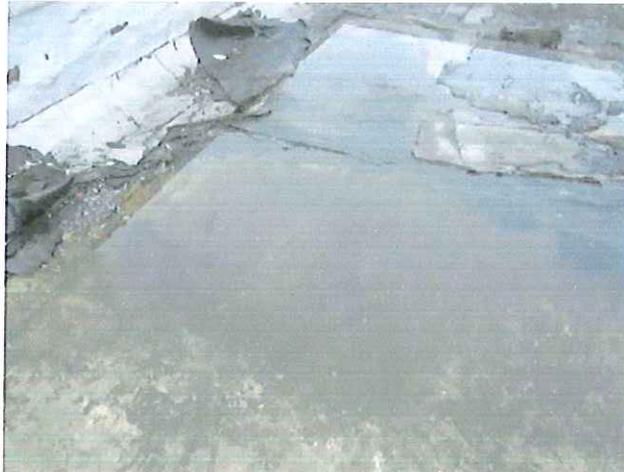
The roof membrane is missing and the roof drain is plugged at the southwest corner of the roof at the Nelson House Annex (see above). This condition will lead to deterioration of the concrete and steel frame. In the near term, the plugged drain may lead to accumulation of water and/or snow on the roof that will exceed the capacity of the concrete or steel structure, leading to a local collapse of the roof. (See Photo 16.)

Photo 16: The roof membrane is missing and the roof drain is plugged at the southwest corner of the roof at the Nelson House Annex. This condition will lead to deterioration of the concrete and steel frame (see caption for Photo 15). In the near term, the plugged drain may lead to accumulation of water and/or snow on the roof that will exceed the capacity of the concrete or steel structure, leading to a local collapse of the roof.

Immediate Structural Stabilization – To minimize risk of structural collapse at the roof of the Nelson House Annex, which is in poor condition, we recommend that a temporary membrane be installed and the roof drains be repaired. This work should be done to create a safe working environment regardless of which Option (see the Sen Architects report) is ultimately pursued.

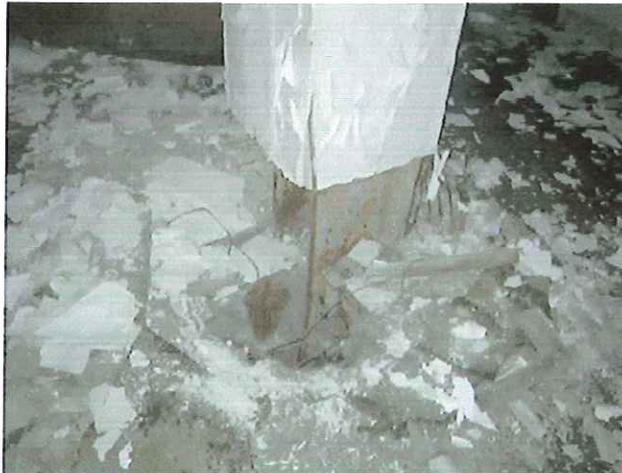
Photo 17: View of the concrete and steel structure at the Nelson House Annex. This probe was probably opened as part of a prior study of the building.

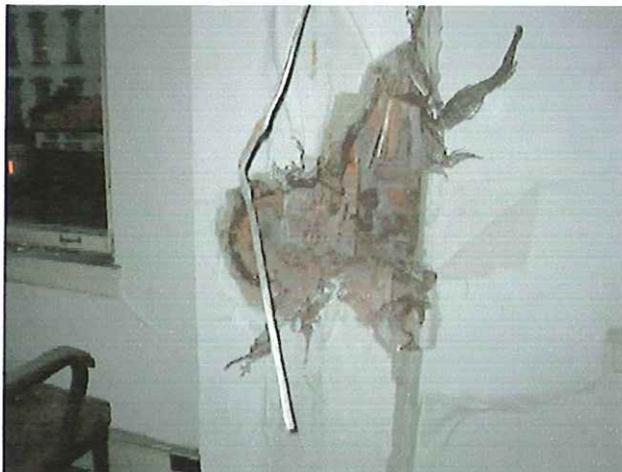
Photo 18: A second probe in the east wall of the building shows a steel column and the masonry enclosure wall. This probe was also probably opened as part of a prior study of the building.

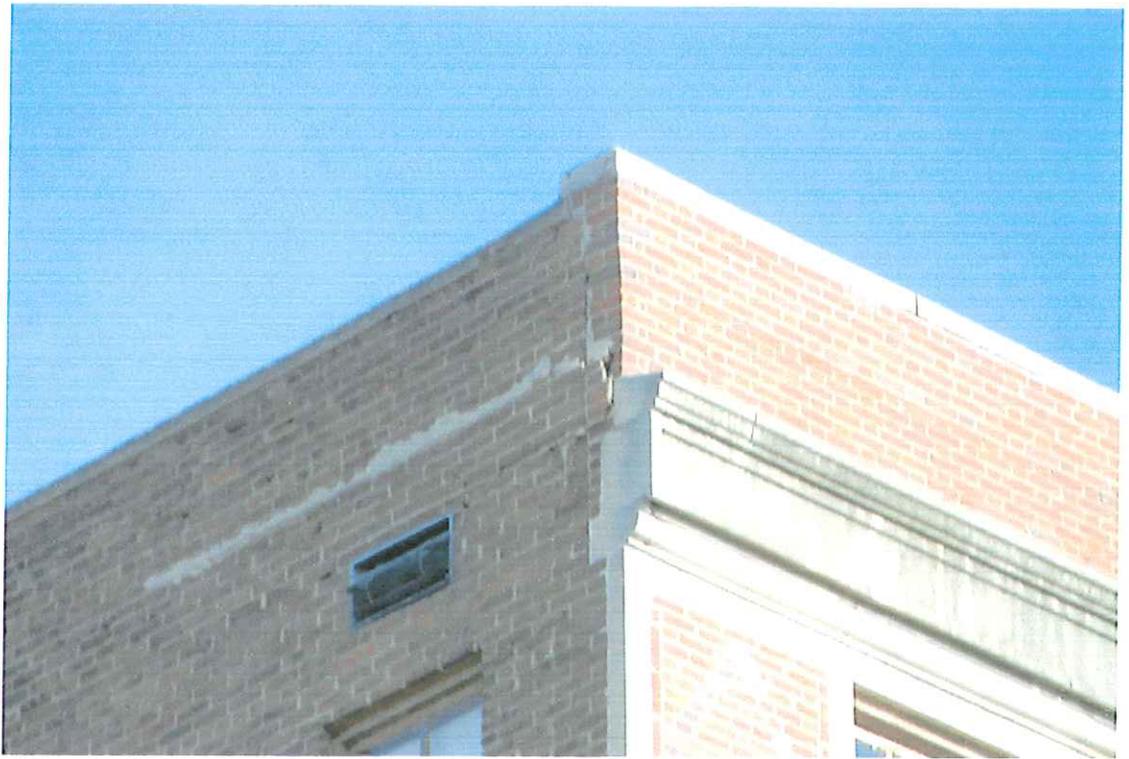
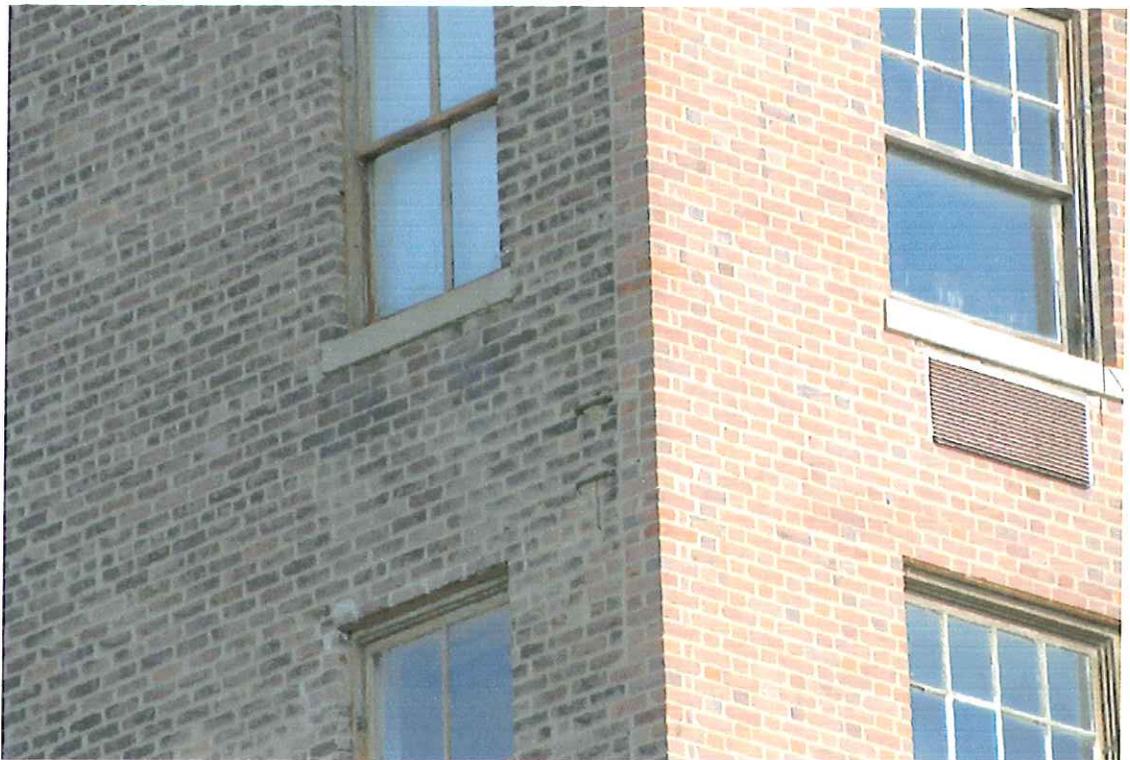
MASONRY CRACKS AT PARAPET AND WINDOW HEADS

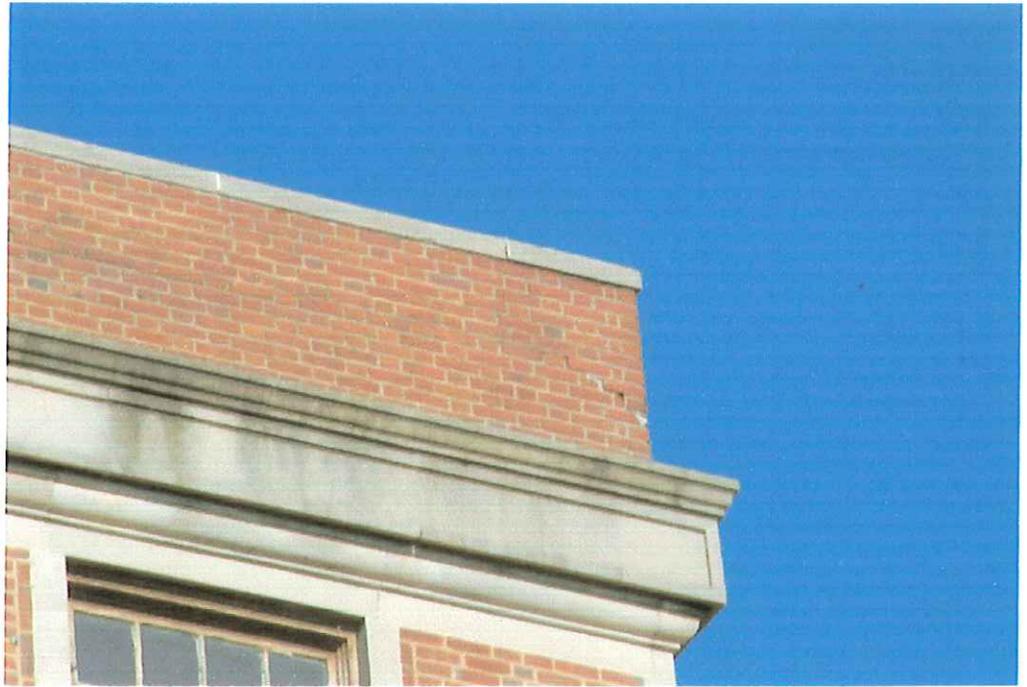
MASONRY CRACKS AT PARAPET

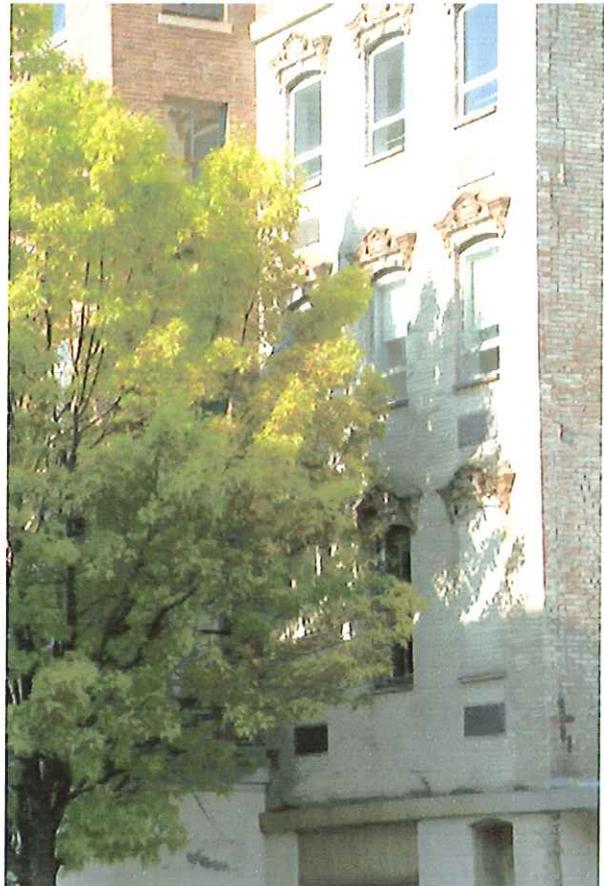
MASONRY CRACKS AT BUILDING CORNERS

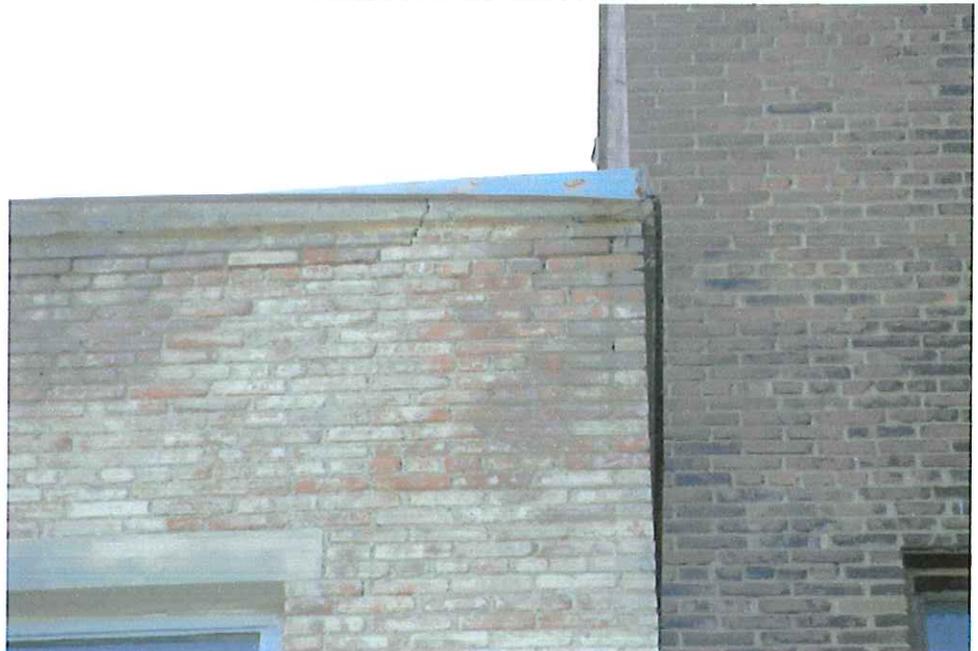
MASONRY CRACKS AT PARAPET

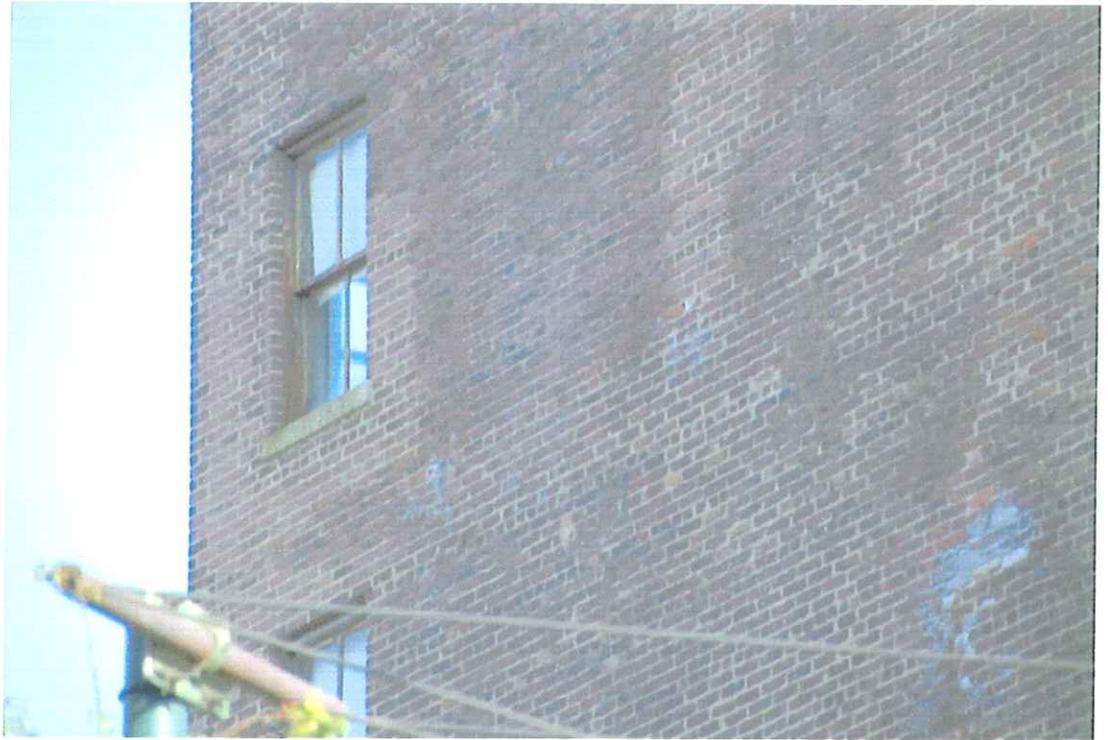
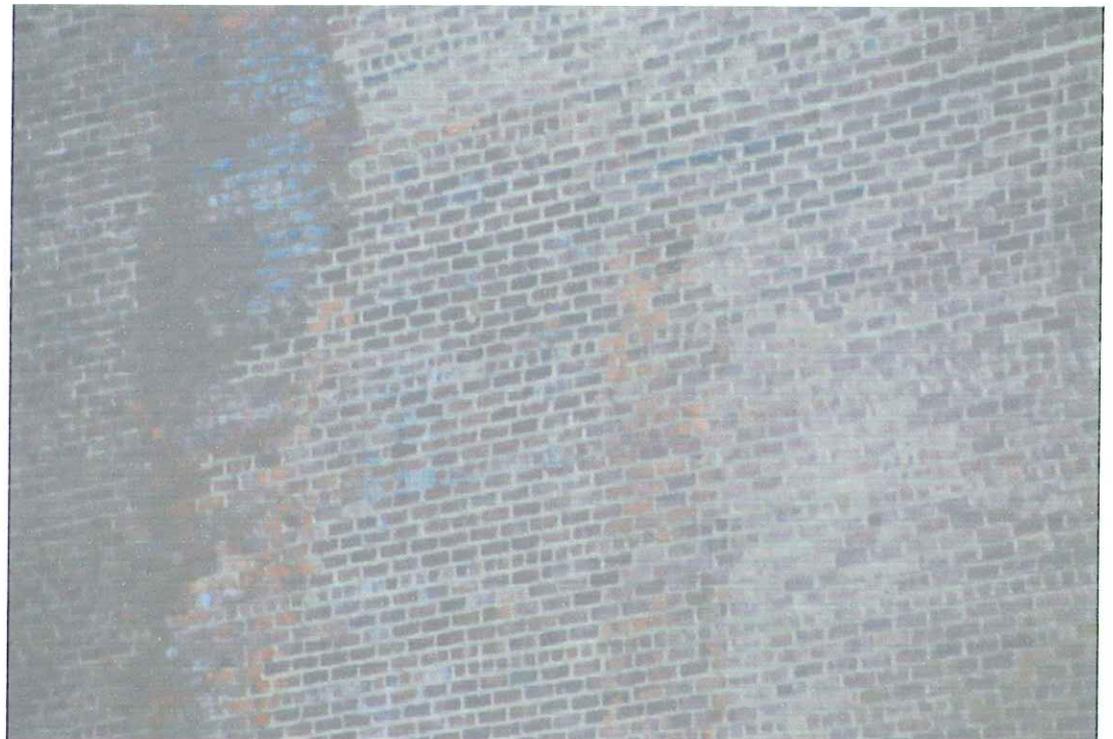
The South facade is the worst effected. A large section of the masonry wall appears to be saturated, visible by its overall deep color tone. This could be due to several reasons - parapet wall leakage, roof leakage, thru slab internal waterfall damage leading to water running into the

wall from inside. There is a serious risk, due to freeze/thaw cycles that the masonry may dislodge and fall off.

VIEWS OF SATURATED EXT MASONRY WALL AT SOUTH FACADE

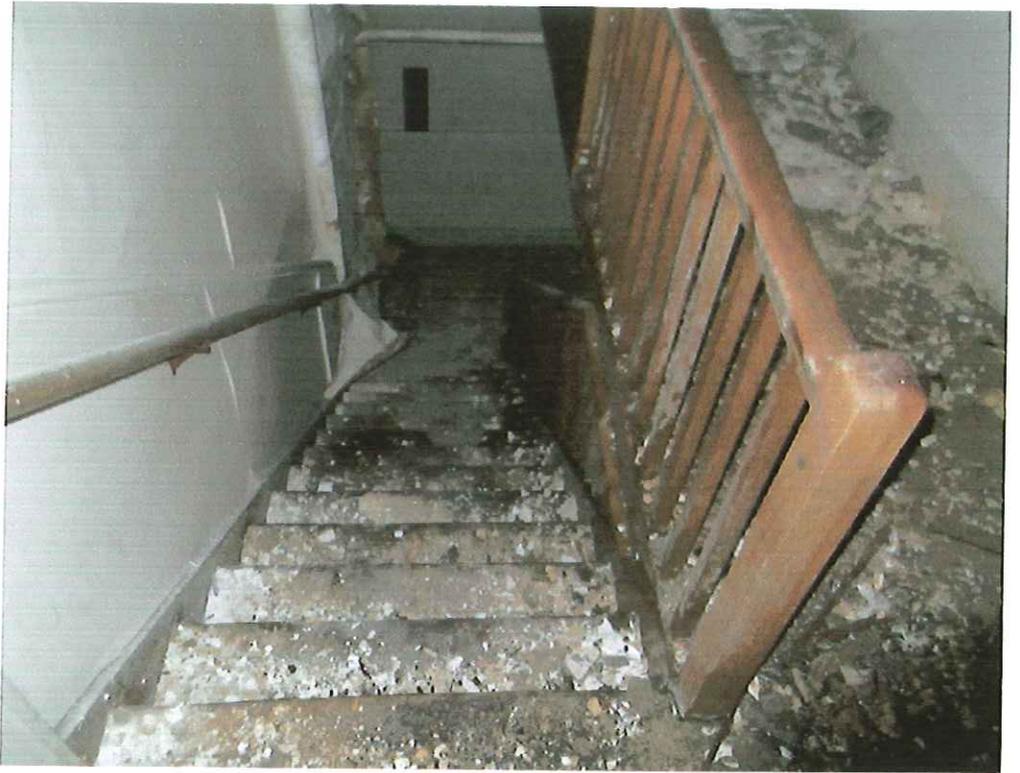
INTERIOR WOOD STAIR AT 1876 STRUCTURE

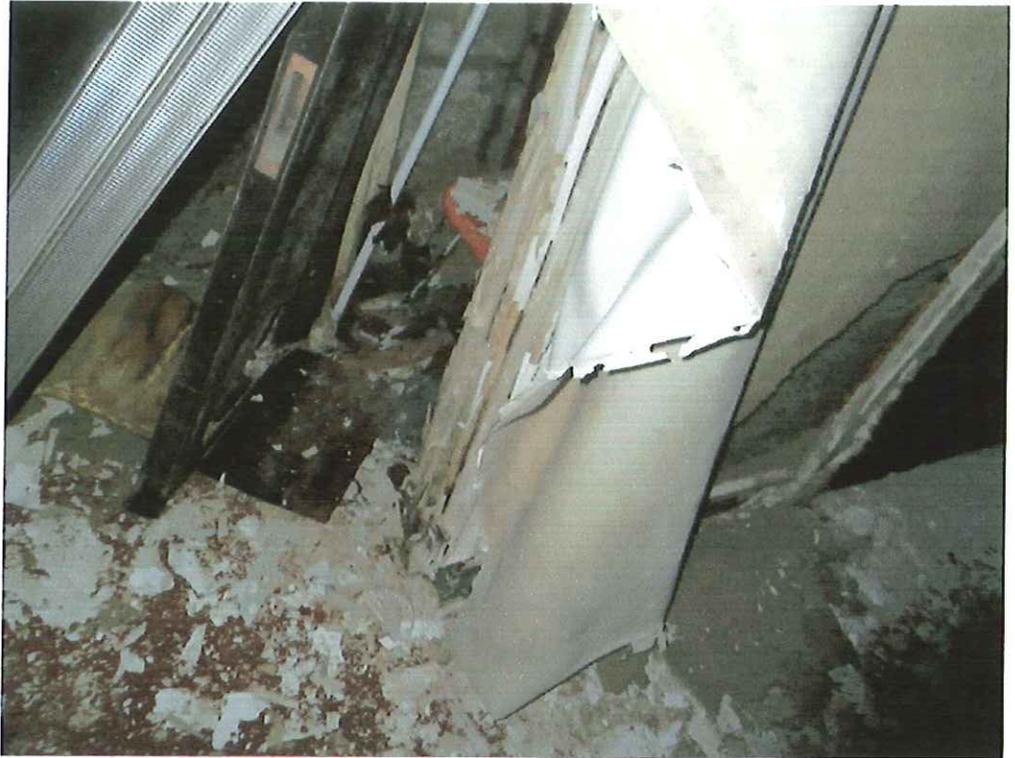
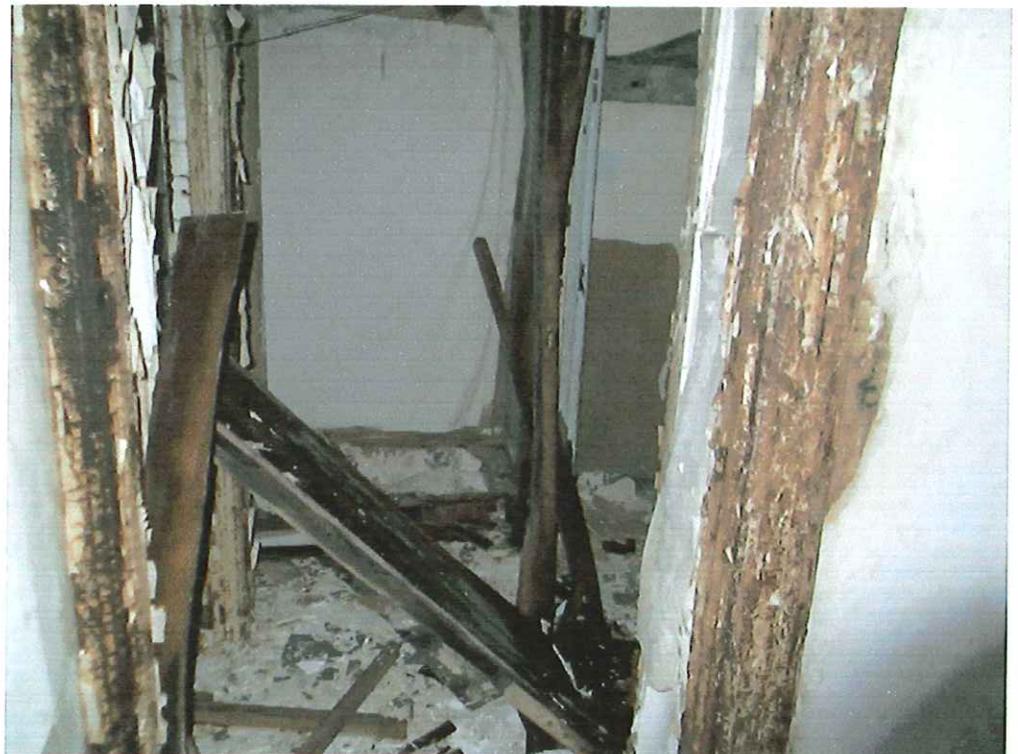
INTERIOR VIEWS INDICATING TYPICAL POOR CONDITION

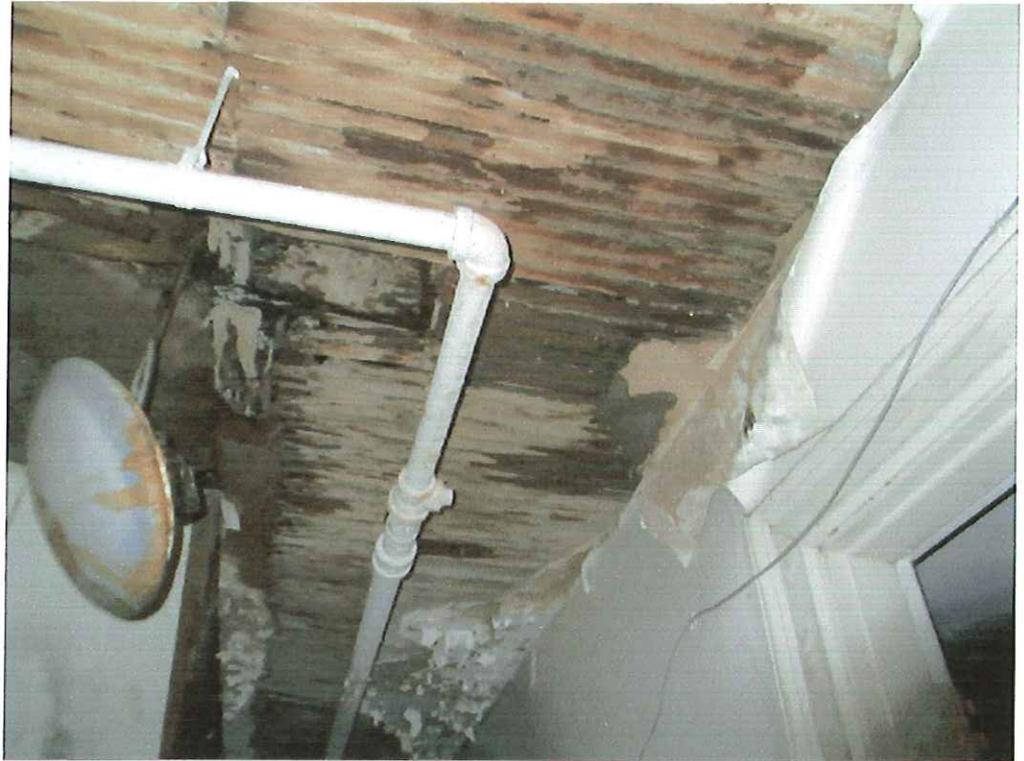
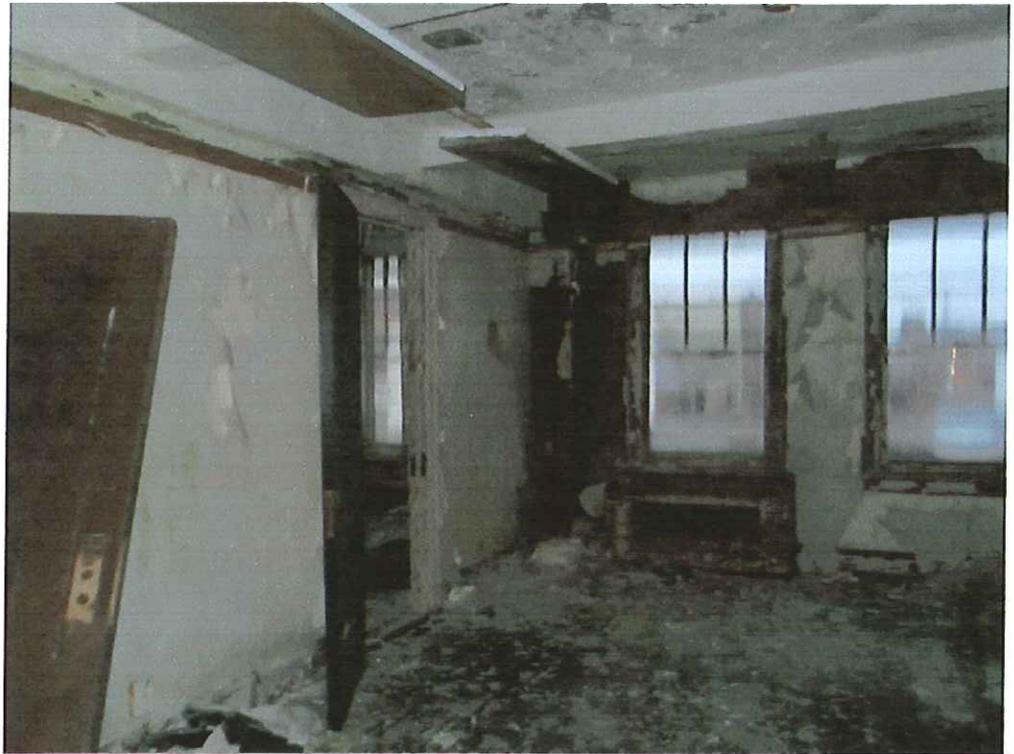
INTERIOR VIEWS INDICATING TYPICAL POOR CONDITION

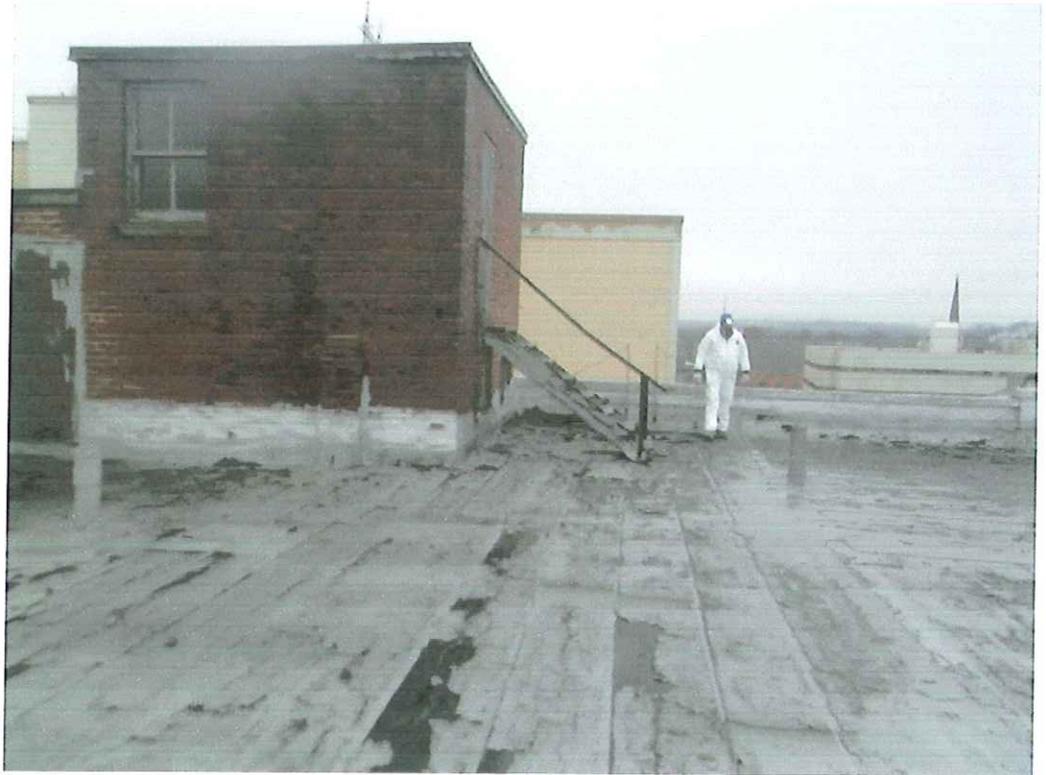
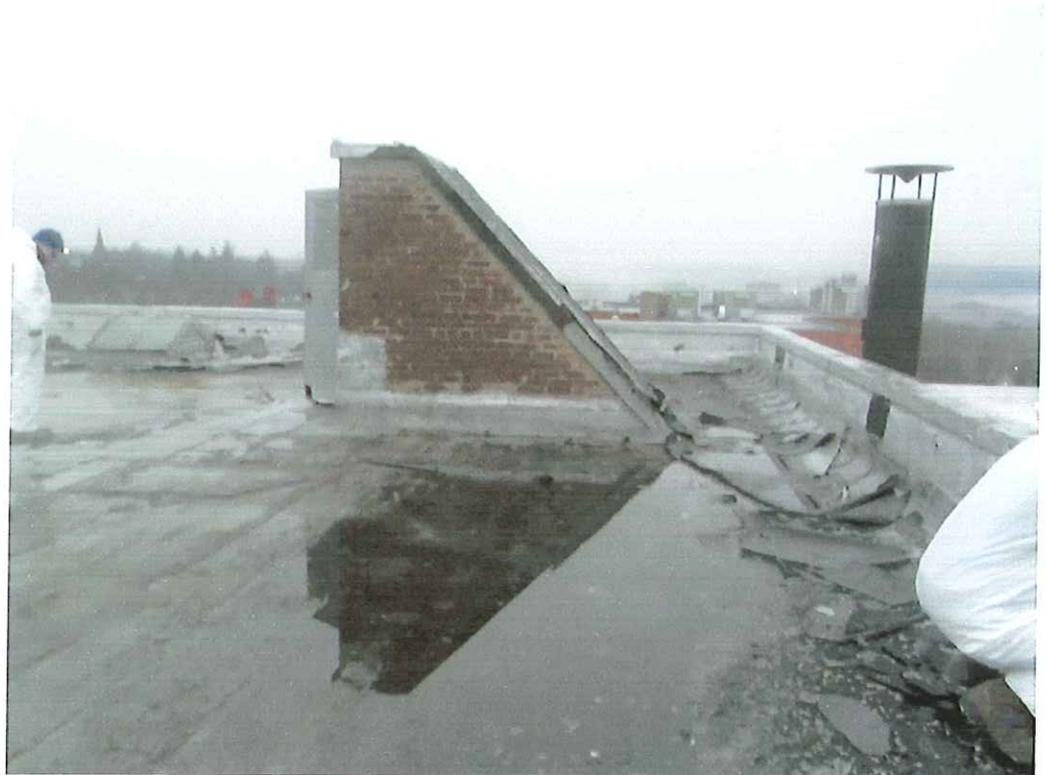
The roof of this structure is in total disrepair. The plys of the roofing are peeling off, the drains are non-existent (covered up and not visible), severe water ponding at various locations, base flashing at parapet walls are peeling, and cap flashing at parapet walls are missing.

WATER PONDING AND DELAMINATING LAYERS AT EXISTING ROOF
