CR 14 (Hollow Rd) Safety Assessment

S Creek Rd – W Cookingham Rd, Town of Clinton

December 2021

Dutchess County Transportation Council

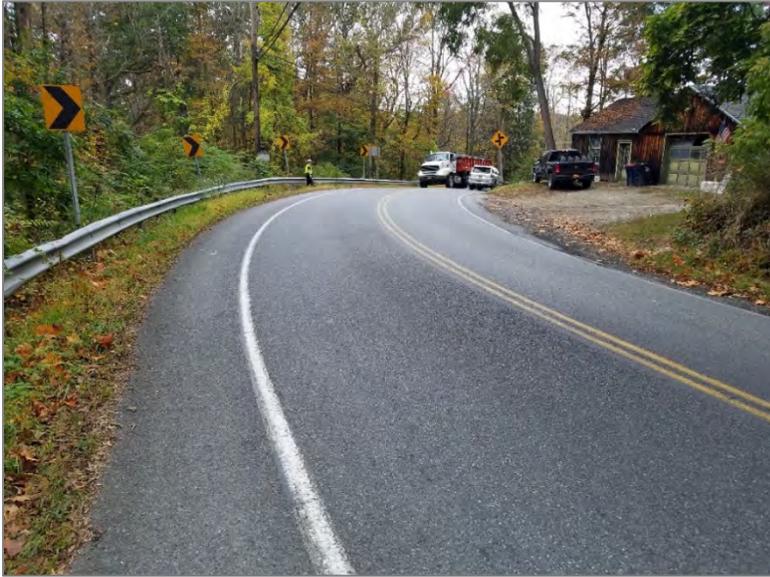
Figure 4: Middle section of curve facing west. Note shoulders and guiderail on eastbound (left) and minimal shoulder on westbound (right) side of CR 14.

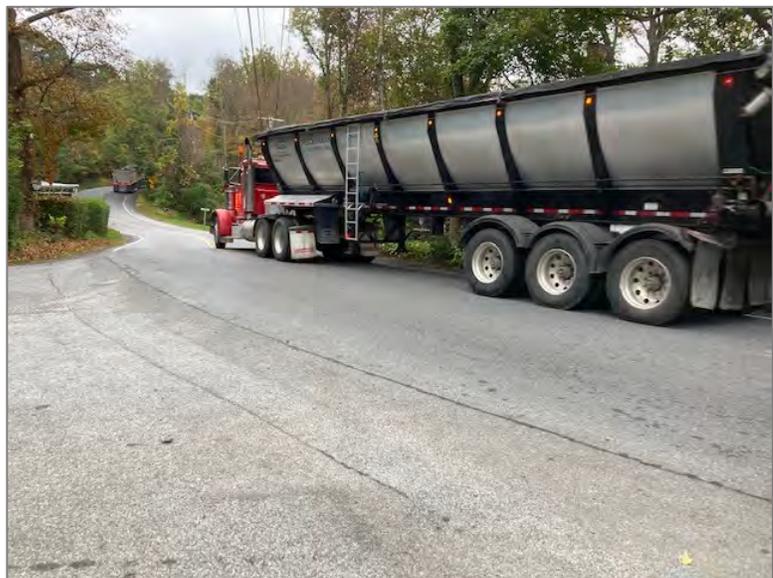
Figure 5: View from N Creek Rd as eastbound truck enters curve on CR 14. Note a second truck further ahead.

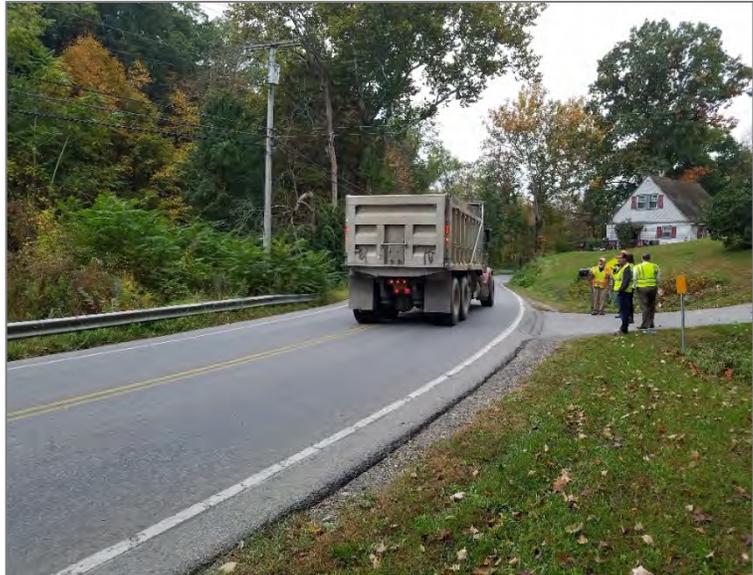
The SA team also noted that westbound vehicles approach the curve at high speeds, sometimes causing drivers to cross over the centerline to negotiate the curve. Many examples of this were witnessed during the field assessment. Speed data collected near W Cookingham Rd, east of the curve in 2018 showed an 85th percentile speed of 45 mph westbound and 43 mph eastbound – that is, 10 mph over the posted speed limit for this road, and 20+ mph over the advisory speed for the curve. Speed data collected on the west side of the curve, near Route 9G, showed eastbound and westbound 85th percentile speeds of approximately 35 mph.

Figure 6: A large westbound truck crosses over the center line as it approaches the curve. Though this observation may be due to the presence of the SA Team, members commented that this is a common occurrence, nonetheless.

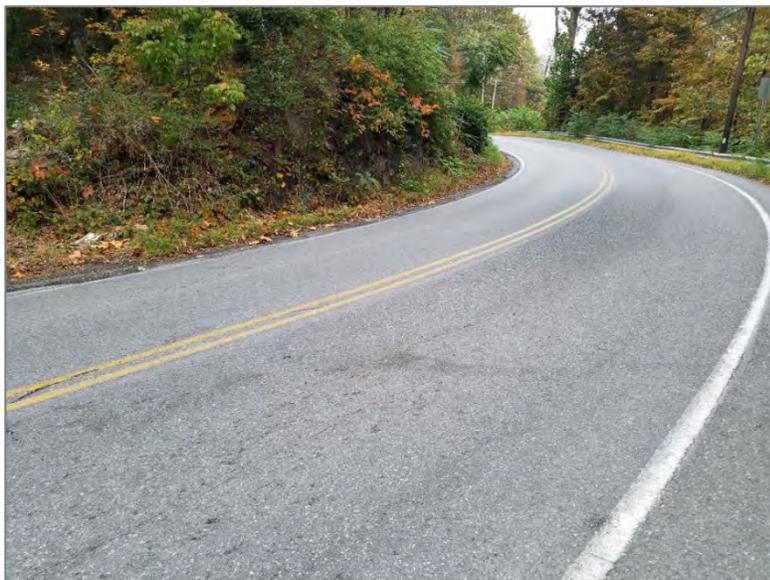
Figure 7: Minimal shoulders in middle section of curve.

The lack of substantial shoulders on the westbound side of the road and limited sight distance combined with high operating speeds discourage walking and bicycling in this area, though it was noted by some team members that bicyclists have been seen on the road, specifically during organized rides that occur from time to time.

1. Widen shoulders where feasible, especially on the westbound edge of the curve.
2. Reconstruct or repave shoulders where needed (for example, near Creek Rd on both sides).
3. Reduce shoulder drop-offs by backfilling along shoulders, especially on the westbound

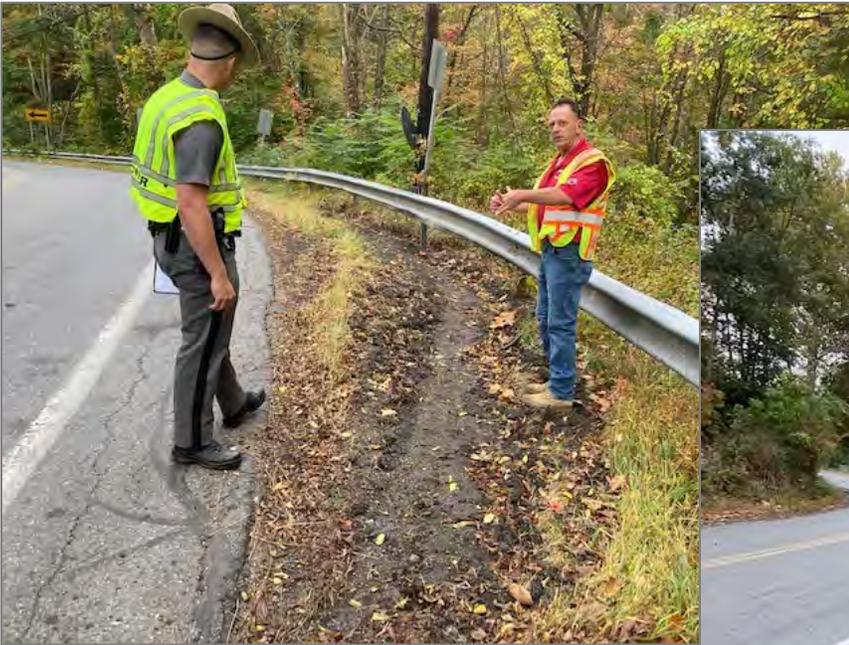
Figure 10: SA team members discuss evidence of a recent roadway departure by a large truck that reportedly swerved off the road to avoid an oncoming vehicle.

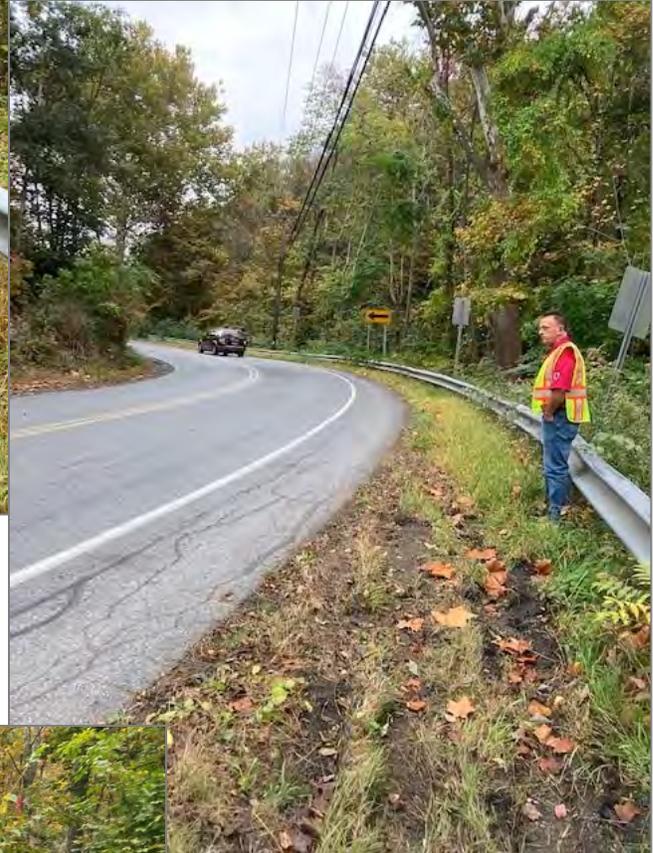
Figure 11: A view of tire tracks just off the shoulder on the eastbound curve.

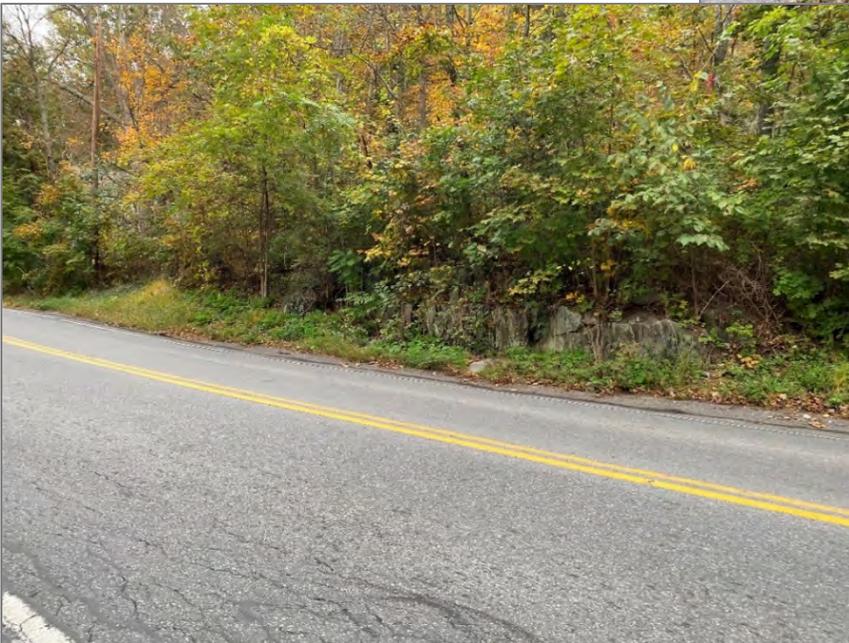
Figure 12: A rock outcrop along the narrow shoulder of the westbound curve.

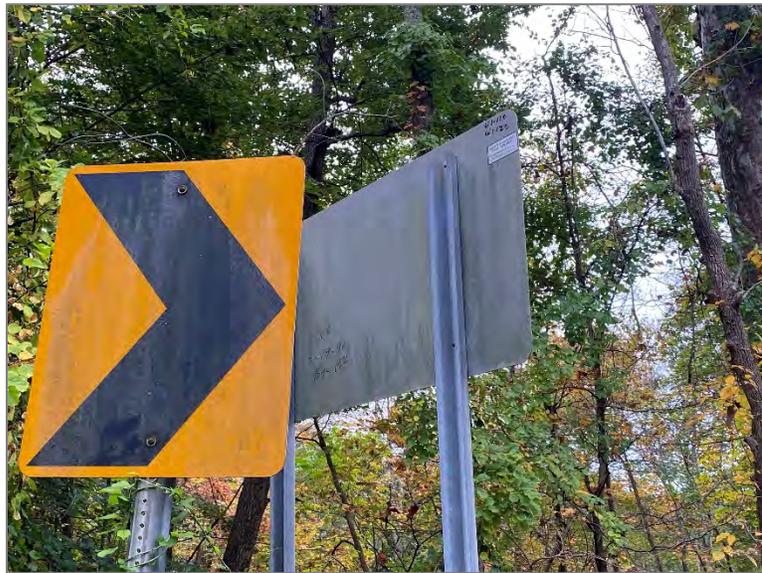
Other sign issues included that the bus stop warning sign near 55 Hollow Rd was not needed; the 20-mph advisory speed sign approaching the curve eastbound was partially obscured by vegetation; and several signs were 20-25 years old and may have lost their retro-reflectivity and/or be outdated.

Figure 13: Older signs may have limited retroreflectivity.

1. Evaluate all signs within the study area for their location, spacing, necessity, retro-reflectivity, and visibility.

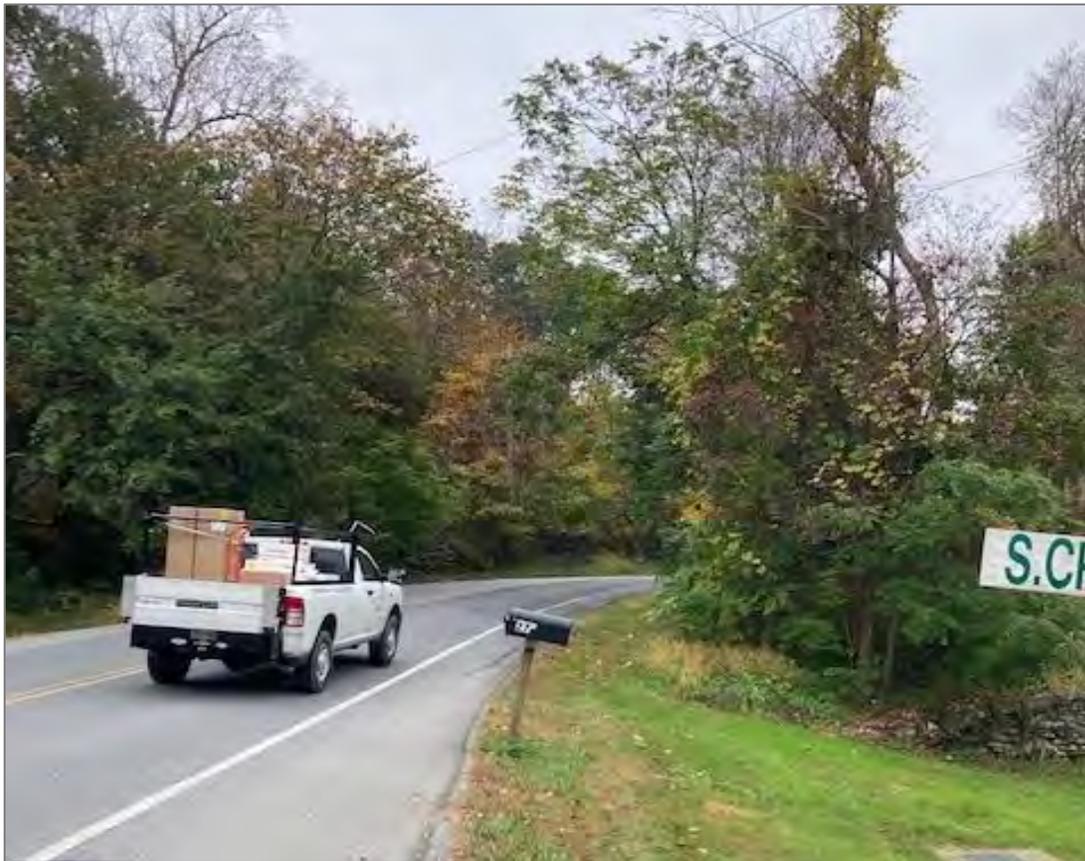
Figure 14: Curve warning sign and 25-mph advisory speed limit obscured by brush on eastbound approach to the curve.

2. Upgrade, relocate, remove, or consolidate signs based on DCDPW's sign evaluation. Trim vegetation around signs where needed. In particular:
 - a. Remove the school bus stop sign (School District confirmed it is not needed).
 - b. Replace the chevron signs with double-backed chevrons.
 - c. Consider a sign with flashing lights if other changes are not effective.
 - d. Trim vegetation to increase visibility of the 20-mph advisory speed sign approaching the curve eastbound.
3. Consider adding vertical signpost reflectors to warning signs.

1. Trim vegetation (tree limbs and brush) throughout the corridor, particularly near the guiderail, along both approaches to the curve, and near the eastbound advisory speed sign.

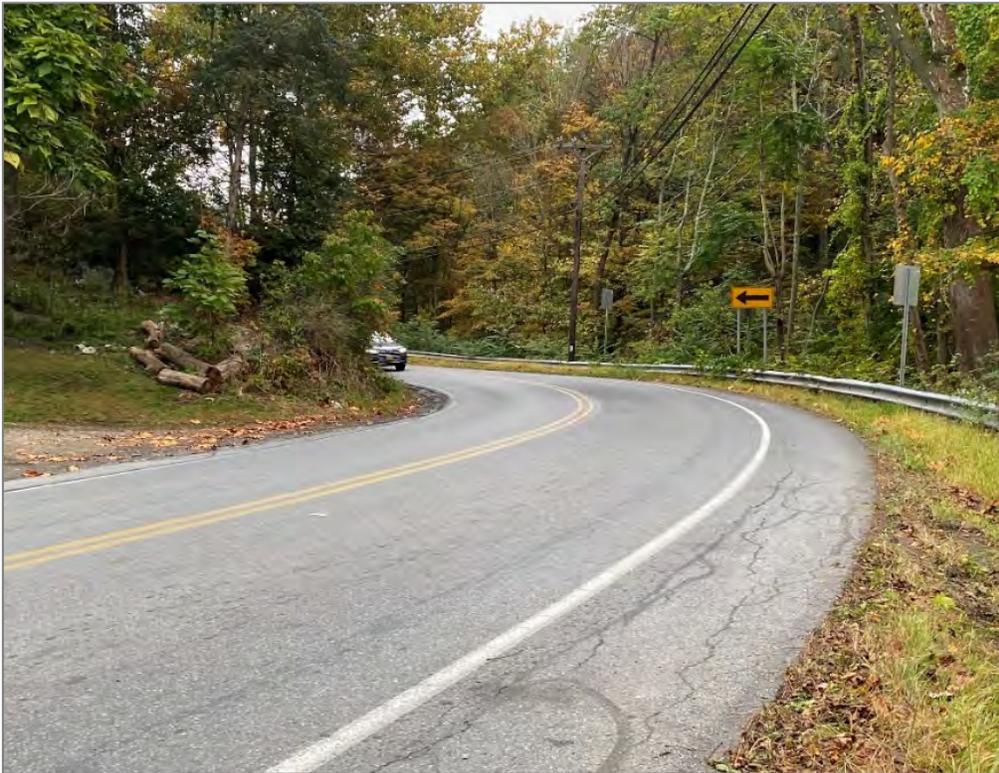
Figure 15: Arrow warning sign on eastbound exterior of curve. Note the back of the chevron warning signs.

The SA team discussed changing the chevrons (W1-8) on the curve to be double-backed, supplemented by the existing arrow signs (W1-6). The SA team also discussed new signs, including a potential warning sign with flashing lights for westbound vehicles entering the curve, if initial improvements are deemed ineffective.

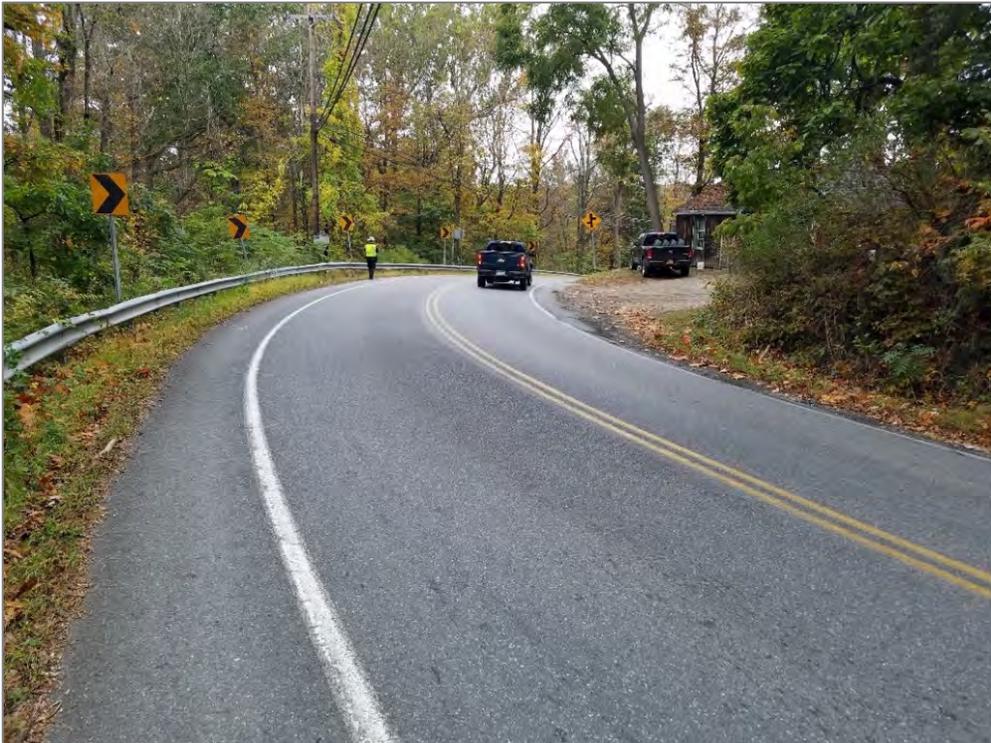
Figure 16: Chevron signs on westbound exterior of curve.

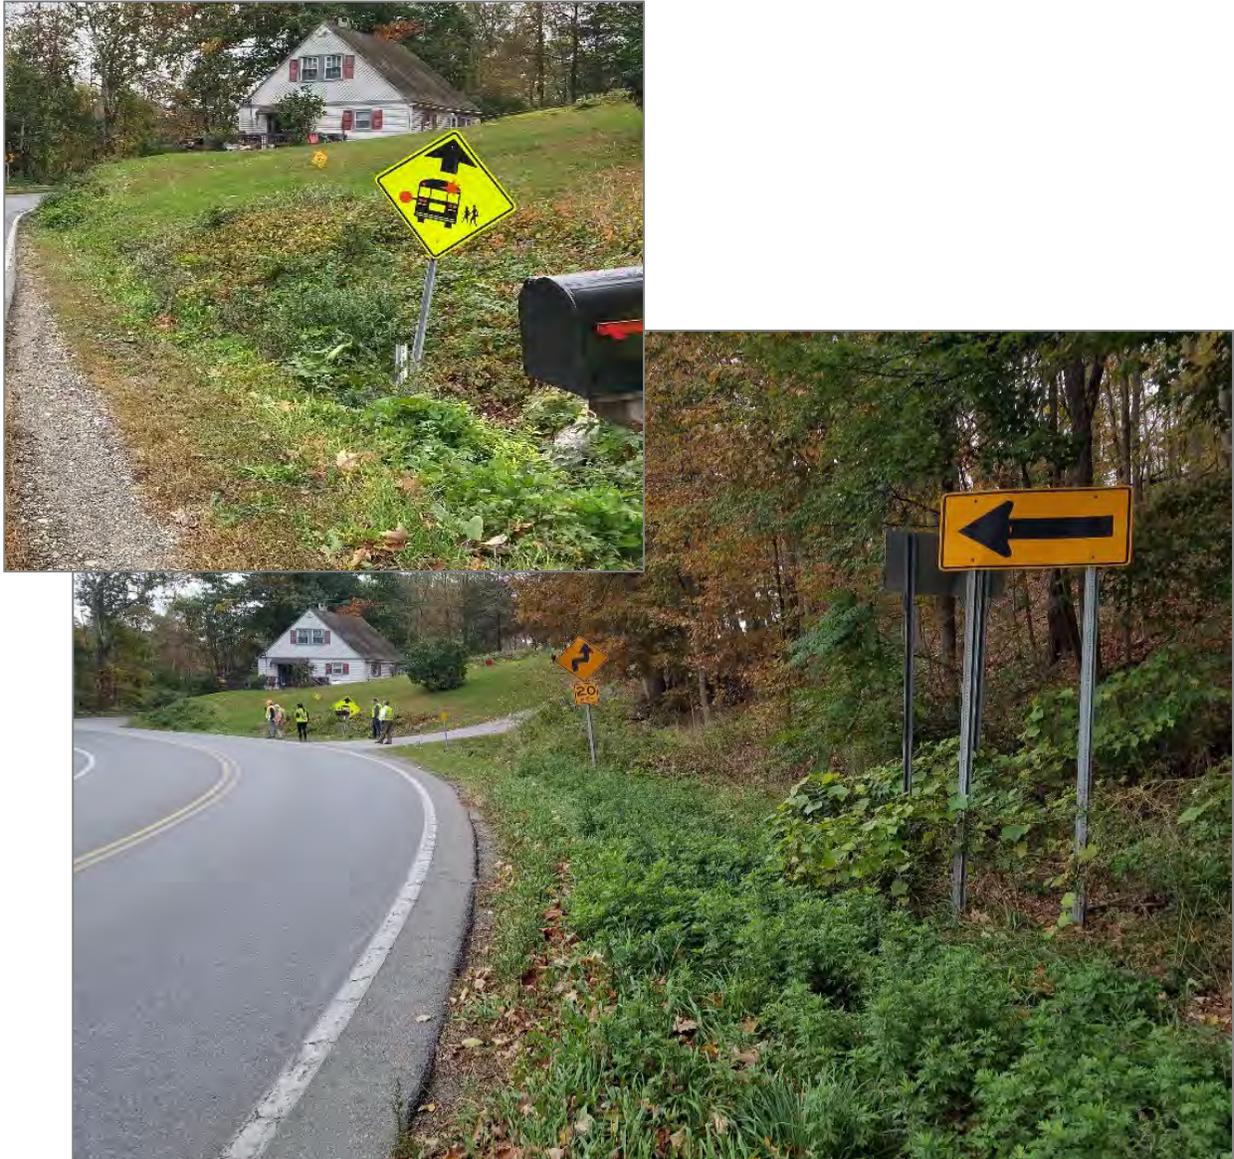
Figure 17: Warning signs on westbound approach to the curve; see unnecessary school bus stop sign in background and inset.

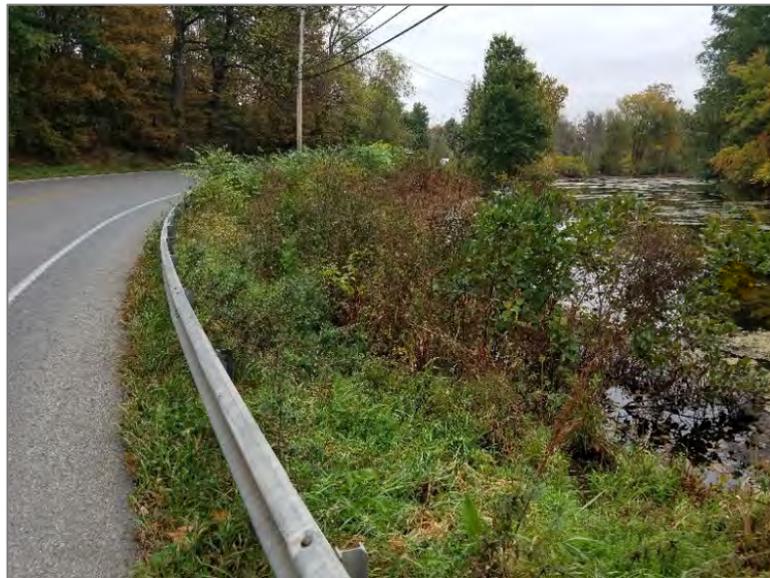
Figure 18: W-style guiderail.

The team also noted that the guiderail near the dam (eastbound lane, just east of the curve) appeared to be shorter than recommended, and all guiderail along the corridor was the older W style, rather than the current box beam design (see Figure 18).

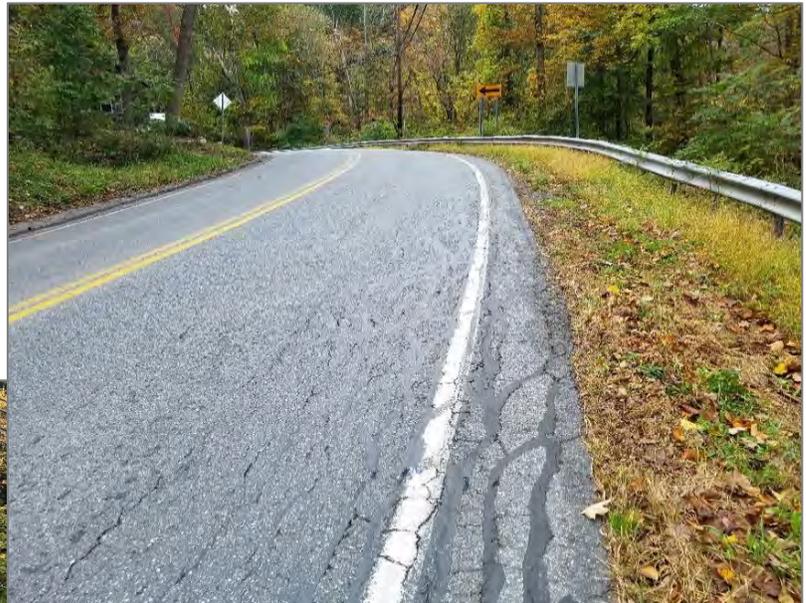
Observations: The SA team noted that shoulders were narrow and in poor condition in some areas, especially on the westbound edge of the curve. There were also significant shoulder drop-offs in some locations on the westbound lane. Shoulder markings were visible but appeared to have lost their reflectivity, which is especially important in dark conditions. On the westbound lane, at the apex of the curve, narrow shoulders abut a rock outcrop. Combined with high operating speeds, these conditions are unforgiving to errant vehicles, as there is limited space and ability to recover. On the eastbound lane, tire tracks off the shoulder along the guiderail pointed to evidence of a recent road departure.

Figure 19: Shoulders on eastbound lane.

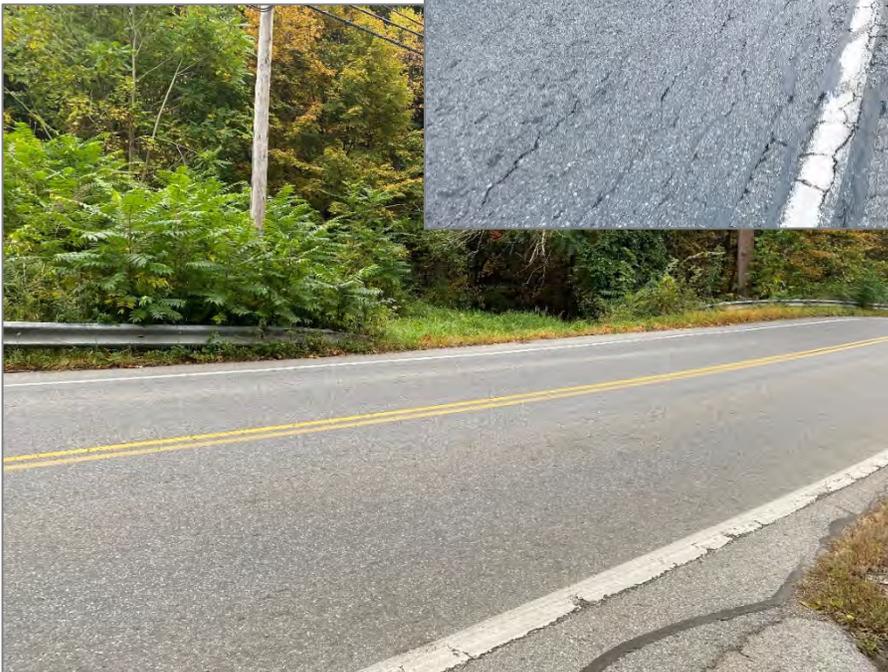
Figure 20: W-style guiderail near the dam is lower than the standard height.

4. Consider adding a [Safety Edge](#), which allows drivers who drift off the road to return to the road safely. Instead of a vertical drop-off, the Safety Edge shapes the edge of the pavement to 30 degrees. FHWA-supported research has shown that this is the optimal angle for drivers to re-enter the roadway safely. This could be done as part of a future repaving project.
5. Repaint shoulder lines with reflective material.
6. Upgrade guiderail to box beam style and ensure it is the recommended height (particularly near the dam).

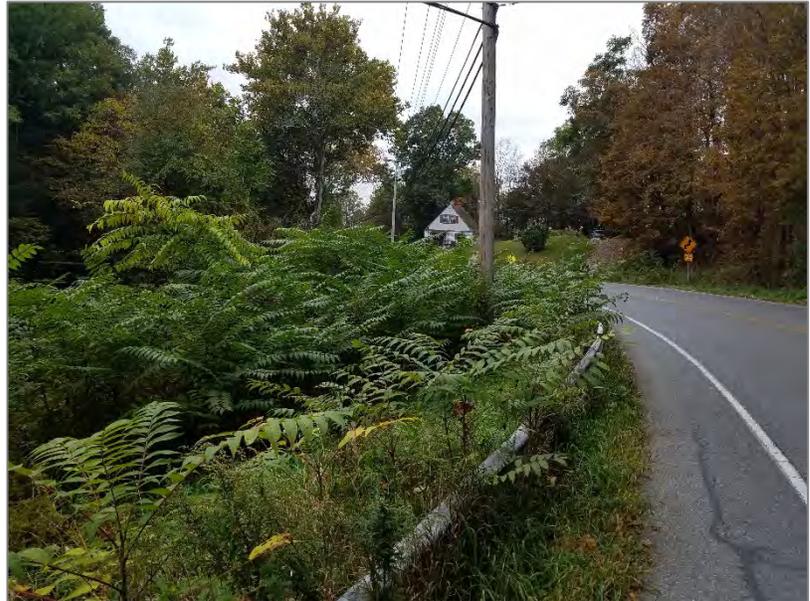
Observations: Sight lines on the westbound approach to the curve are limited by overgrown vegetation by the guiderail along the dam pond. The SA team observed westbound vehicles approach this blind spot at high speeds, with subsequent heavy braking as the curve ahead came into sight. At the apex of the curve, there is overgrown brush that reduces visibility for both westbound and eastbound traffic. DPW noted that brush clearing in this area is on a regular maintenance schedule, but that it grows back quickly.

Figure 21: Overgrown vegetation by the guiderail along the dam pond.

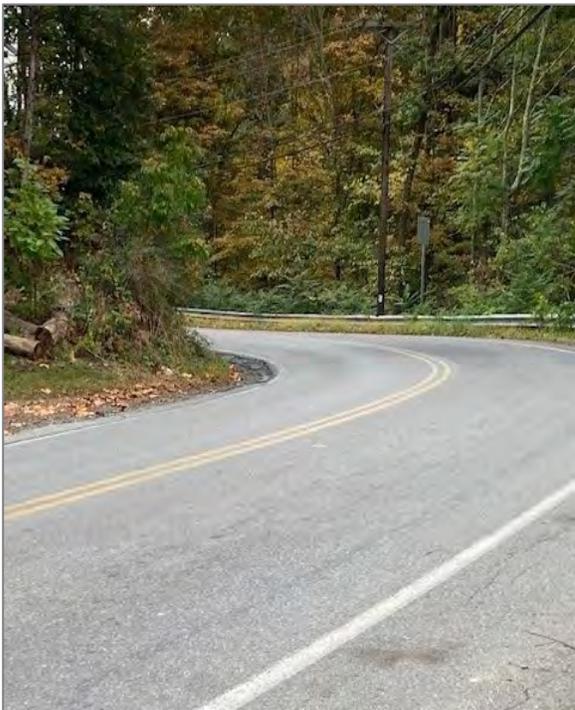
Figure 22: Vegetation on interior of curve.

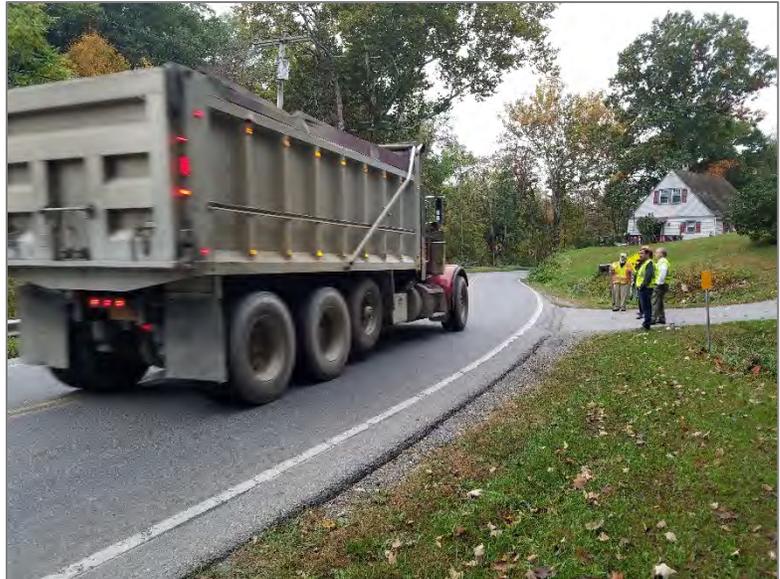
Observations: Based on traffic data and field observations, heavy truck use on this road is relatively high and could increase. It is difficult for heavy trucks to navigate the tightest part of the curve; large westbound trucks were observed with their back wheels on the edge of or falling off the shoulder. Evidence of a large truck departing the road was also observed on the eastbound lane. According to SA team members, this was an attempt by the driver to avoid a collision with a westbound vehicle.

Figure 23: Heavy truck approaching the curve eastbound.

1. Continue to monitor heavy vehicle usage.
