CR 9 (Beekman Rd) Safety Assessment

CR 29 (Carpenter/Clove Branch Rd)-Taconic State Parkway, Town of East Fishkill

January 2019

Dutchess County Transportation Council

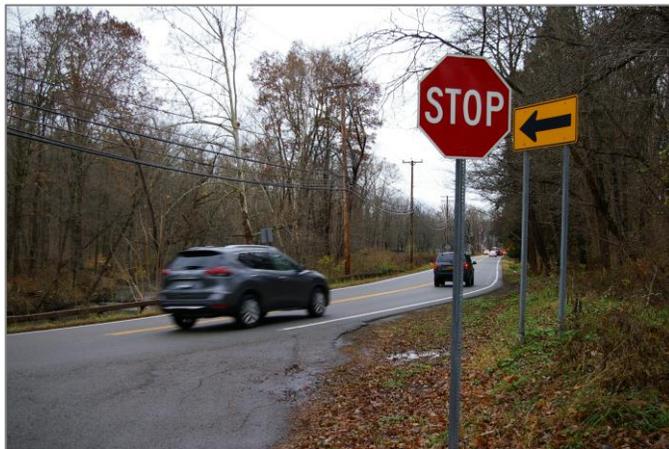
Safety Concern: Vehicle operating speeds appear too high in some locations or during poor road conditions.

Observations: The regulatory speed limit of 45 mph appears to be a generally acceptable speed limit for this corridor under most road conditions. However, operating speeds appear slightly higher than desired in some locations, especially for vehicles descending from some of the higher elevations along the road (e.g. westbound traffic near both Augusta Dr intersections). As noted in the speed data, westbound vehicles operate at a slightly higher 85th percentile speed than eastbound vehicles (50.4 mph and 48.7 mph respectively). These high operating speeds pose a safety issue for vehicles negotiating the more challenging horizontal and vertical alignments on Beekman Rd, even more so during wet or snowy road conditions. This is particularly true for vehicles travelling westbound near the curve west of Augusta Dr (West), as evidenced by the 25 mph advisory speed plaque on the curve warning sign.

Risk Analysis: Elevated operating speeds increase the probability of a severe crash. The vertical geometry near the Augusta Dr (East) intersection may contribute to higher than desired speeds, which may substantially increase the risk of a collision.

Fig. 6. The SA team noted that operating speeds on Beekman Rd seemed higher than the posted speed limit of 45 mph, which was supported by speed data collected by the DCTC in 2018.

2. Though speed enforcement is typically a useful tool to change driver behavior, it appears difficult to set up enforcement on this corridor. However, the County Sheriff could employ its speed awareness trailer/Variable Messaging Sign (VMS) to alert drivers to their operating speeds. The SA team noted that this would be a temporary measure but could still influence behavior; if feasible, a permanent speed warning sign could also be used.

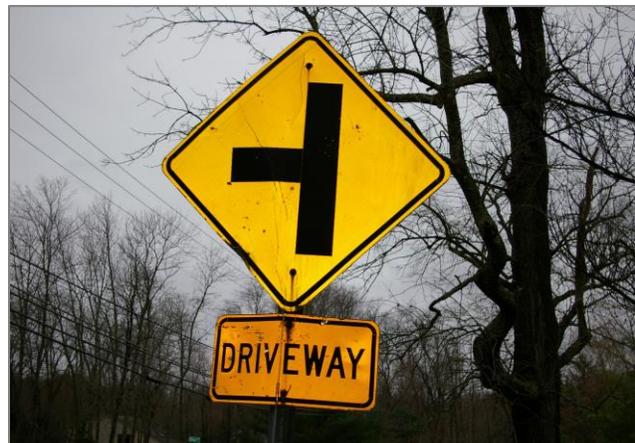
Safety Concern: Some warning signs on Beekman Rd. have lost their retro-reflectivity, are damaged or obscured, or may not be optimally located to adequately warn drivers of imminent road hazards.

damaged and/or had lost some of their retro-reflectivity. For example, the driveway/intersection warning sign (W2-2L) east of Willow Dr is damaged and appears to have lost retro-reflectivity; it may also be too close to the intersection, reducing its effectiveness. Also, the curve warning arrows (W1-6R/L) just west and east of Augusta Dr (West) have slightly diminished retro-reflectivity; given the high number of crashes at this location, they may warrant replacement (these may also be replaced as part of an expanded safety improvement project at the intersection/curve, noted later in this SA). Some warning signs were obscured by tree branches/vegetation, notably the 25 mph advisory speed plaque mounted on the curve warning sign (W1-2L) east of Willow Dr. The SA team also observed that the warning signs on Beekman Rd did not have vertical sign post reflectors, as DCDPW has used on other County highways (including the chevron warning signs (W1-8) on CR 19-Slate Quarry Rd). Lastly, the SA Team noted that some signs may no longer be necessary, such as those on Carpenter Rd referencing the TSP median closures.

Risk Analysis: Less-effective warning signs, whether due to poor retro-reflectivity, placement, or condition, reduce driver reaction times, increasing the risk of a crash.

Fig. 7. DCDPW should consider replacing this damaged driveway warning sign east of Willow Dr.

2. Develop a county-wide sign reflectivity monitoring program to enforce retro-reflectivity standards.
3. Replace the driveway/intersection warning sign (W2-2L) east of Willow Dr to improve retro-reflectivity and driver awareness; also consider relocating this sign further east to provide drivers with more reaction time. See Fig. 7.

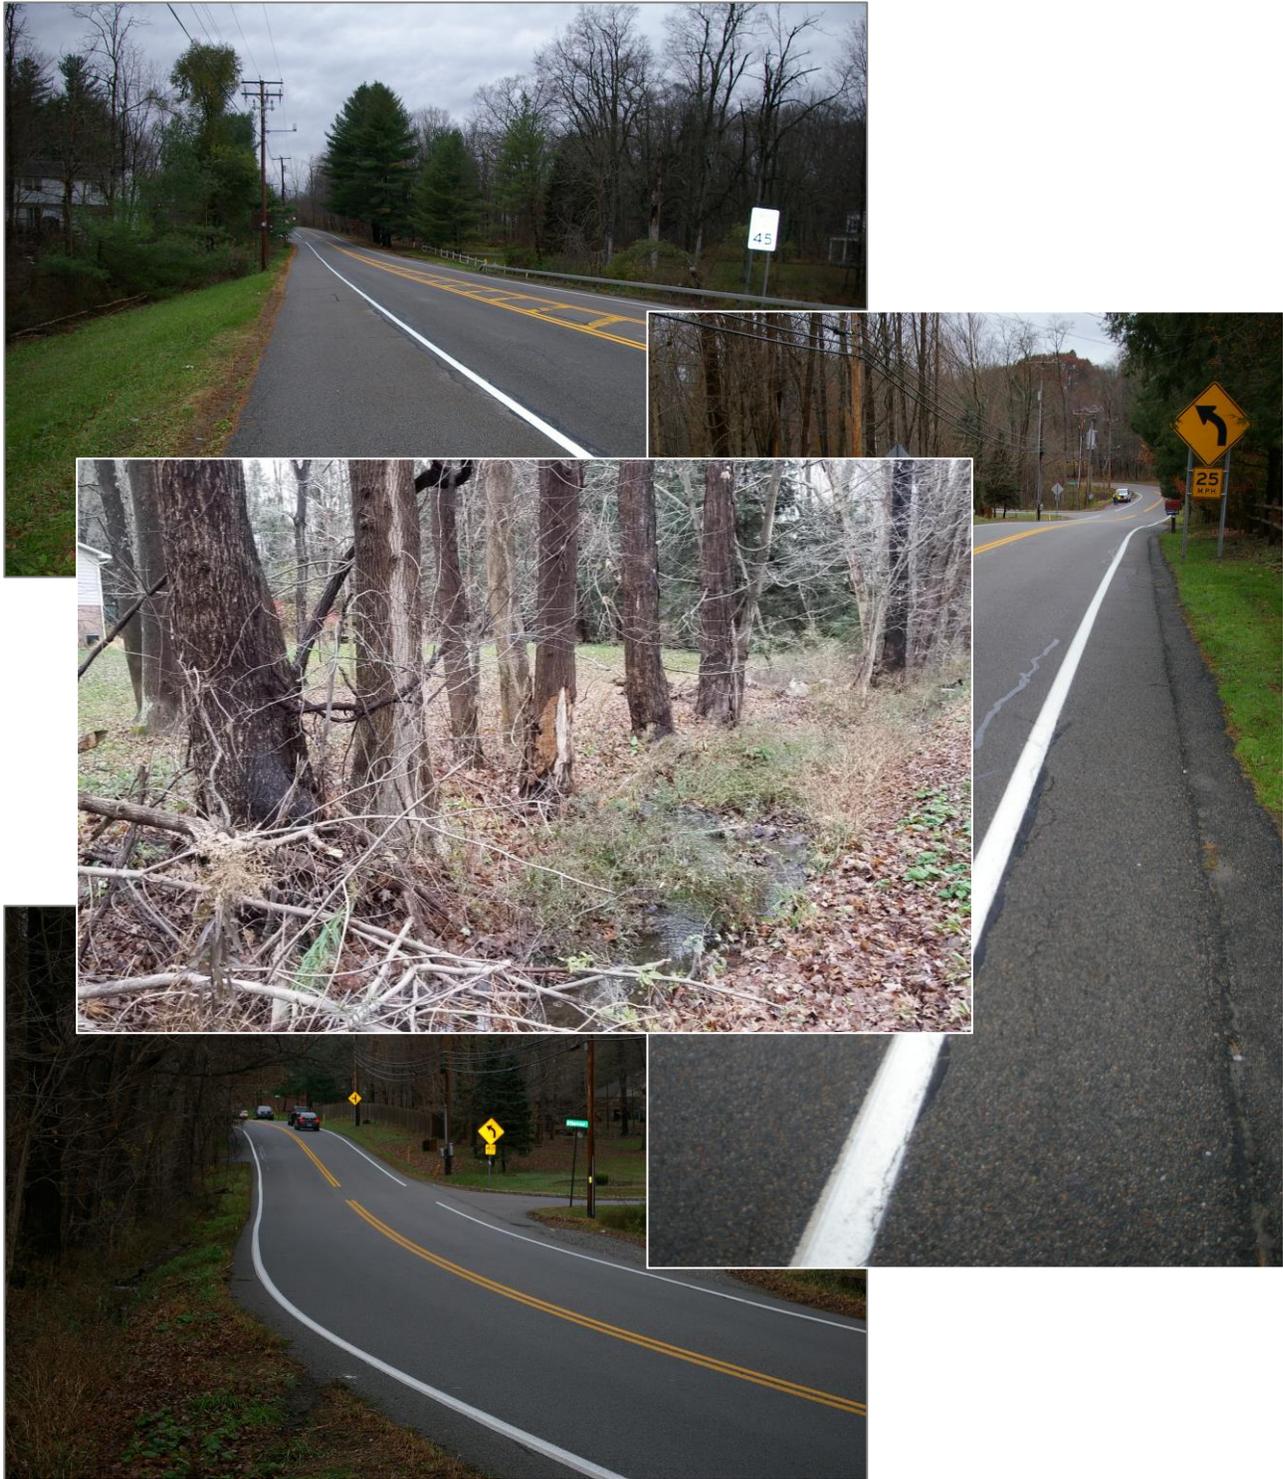
Risk Analysis: Poor shoulder conditions can increase the possibility of a driver losing control of their vehicle as they drift towards the shoulder. If a driver attempts a sudden correction to regain control, the vehicle can become destabilized resulting in a crash. The lack of adequate clear areas and high operating speeds along Beekman Rd increase the chances of a severe crash.

Fig. 8. The shoulders on CR 9 (Beekman Rd) are generally three to four feet in width (middle). However, the shoulders tend to widen near the TSP (top), while locations near steep slopes and other terrain features tend to have narrower shoulders (bottom).

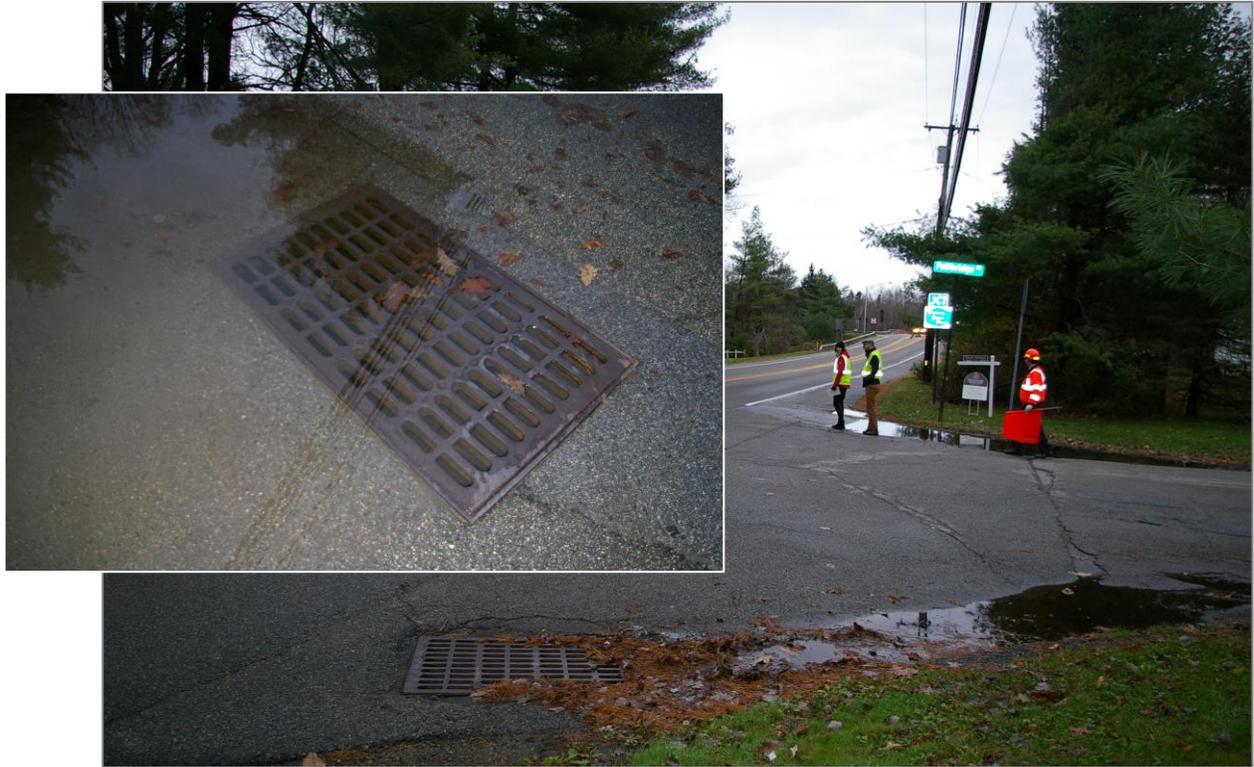
Fig. 9. Water ponding and a stopped-up basin were evident at the Pellbridge Dr intersection. During winter, these areas can freeze and create unsafe conditions.

Observation: The SA team noted that the catch basin located at the southeast corner of the Pellbridge Dr intersection was overflowing, likely due to above average rainfall and leaves. This could limit its capacity to discharge water runoff during extreme weather events or prolonged wet periods. The resulting standing water could freeze during winter and create slippery conditions for vehicles entering Beekman Rd from Pellbridge Dr.

Risk Analysis: Road ponding during severe weather events could create a hazard to drivers and contribute to slippery pavement conditions.

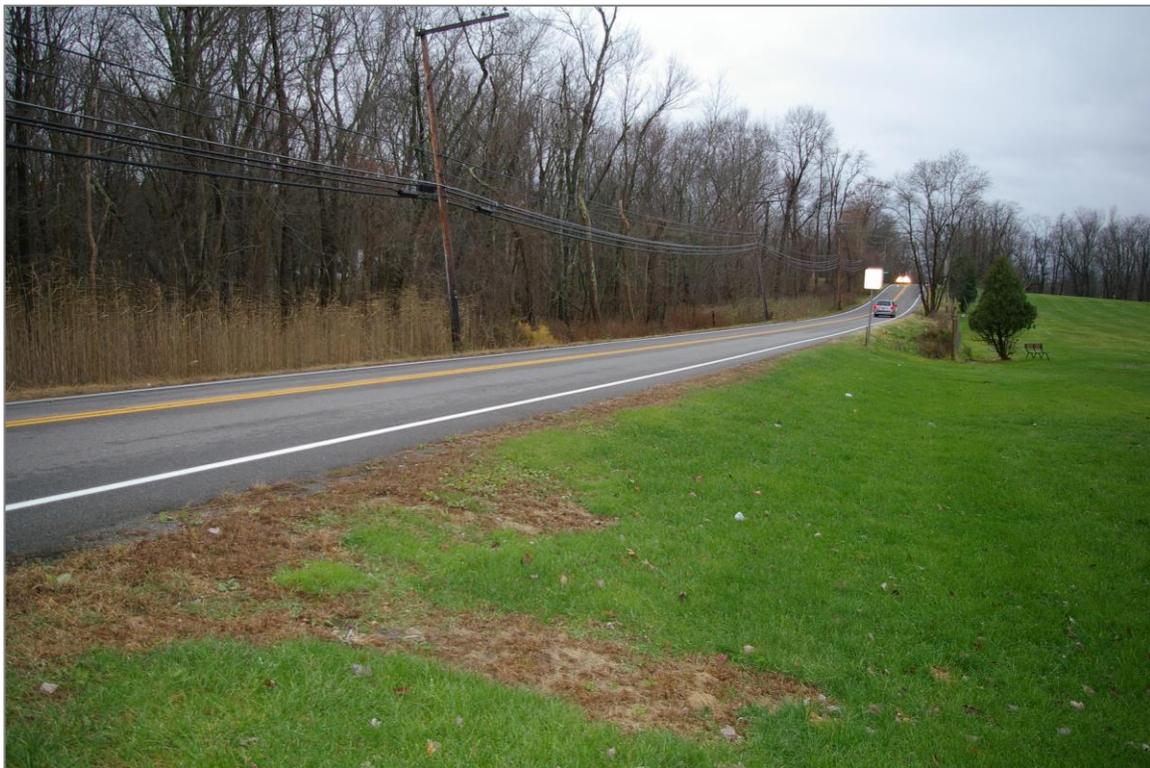
Fig. 10. This stretch of CR 9 (Beekman Rd), adjacent to the Beekman Country Club, experienced the highest number of deer/animal strikes along the study corridor.

Safety Concern: The SA team noted that almost all of the deer/animal strikes recorded on this section of Beekman Rd occurred on the straight section between Stormville Rd and Pellbridge Dr. See Fig. 10.

Observations: During the field visit, SA team members noted that deer were likely travelling through the Beekman Country Club property and crossing Beekman Rd, increasing the risk of a vehicle/animal strike. The SA team also noted that there was an existing fence along part of the golf course's property along Beekman Rd, though it did not run along the entire length of its border, nor was it completely deer-proof. The SA team also noted that most of the deer/animal crashes occurred during dark conditions.

Risk Analysis: The presence of deer and other animals in the area increases the risk of a crash, especially during dark conditions.

5-1	Consider installing deer warning signs near the golf course (W11-3).	Moderate
5-2	Encourage the golf course to install deer-proof fencing.	Low
CR 9 (Beekman Rd)/CR 29 (Clove Branch/Carpenter Rd) Intersection		
1-1	Consider installing a guiderail on the southern edge of Beekman Rd.	High
1-2	Add reflective delineators to new guiderail above.	Moderate
2-1	Replace the existing “W” style guiderail with a box beam guiderail.	Moderate
2-2	Add reflective delineators along guiderails.	Moderate
CR 9 (Beekman Rd)/Augusta Dr (West) Intersection		
1-1	Remove trees within the County right-of-away, west of intersection.	High
1-2	Create a clear zone at the apex of the curve.	High
1-3	Consider installing Slippery When Wet signs (W8-5).	Moderate
1-4	Consider a high-friction pavement overlay to improve skid resistance.	High
1-5	Assess super-elevation to ensure it meets current design standards.	High
2-1	Install warning chevrons (W1-8) for both directions at the curve.	High

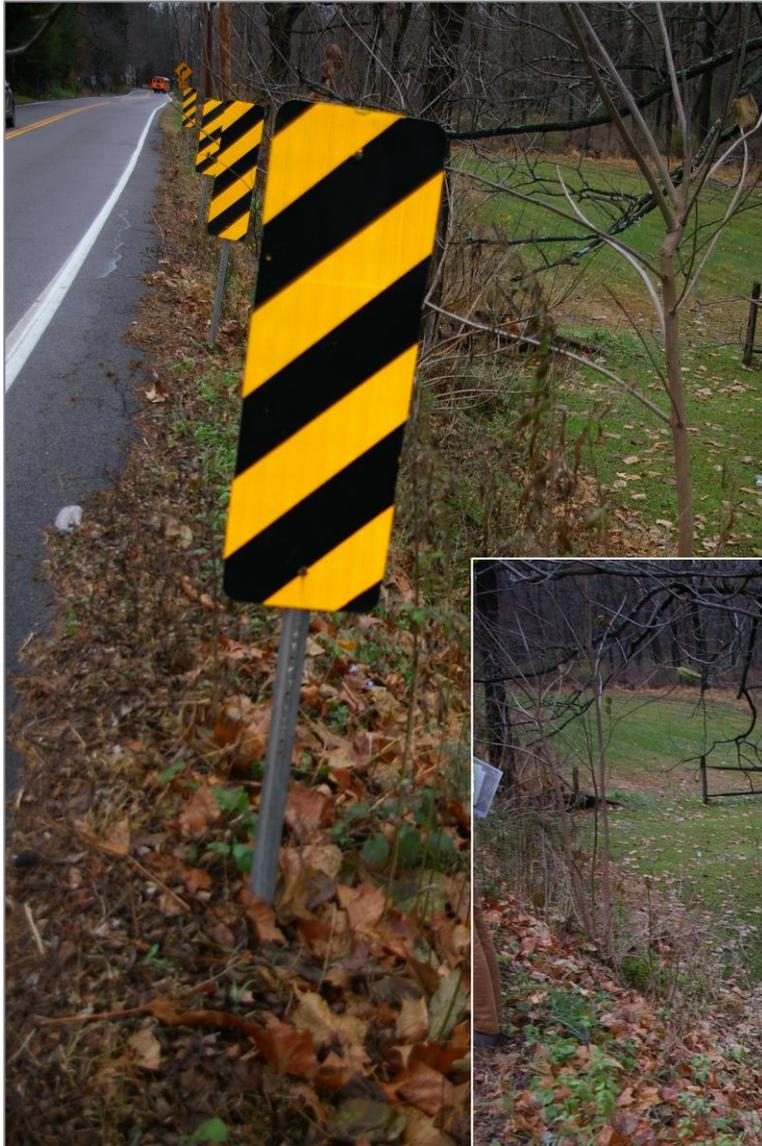
Observations: The SA Team noted that there was a steep drop-off from the southern edge of Beekman Rd, approximately 150 feet east of the Carpenter Rd intersection, down to a low lying area near the Fishkill Creek. This drop-off is marked by a series of object markers (OM3-R) that denote the roadside hazard. However, the SA Team noted that a guiderail might be warranted at this location to prevent errant vehicles from travelling down the embankment and possibly over-turning. The Team noted that there may not be space for a guiderail at the location, but should be evaluated. See Fig. 14.

Risk Analysis: Lack of adequate guiderails can result in an errant vehicle travelling down a steep, non-recoverable embankment. This is of special concern if the area at the toe of the slope contains fixed objects or other hazards such as water (in this case, the Fishkill Creek).

Fig. 14. The southern edge of CR 9 (Beekman Rd), just east of the CR 29 (Carpenter/Clove Branch Rd) intersection, abuts a steep slope that is marked by a series of object markers. Due to the significant grade change from the road, DCDPW might consider installing a guiderail at this location to prevent errant vehicles from travelling down the embankment towards Fishkill Creek.

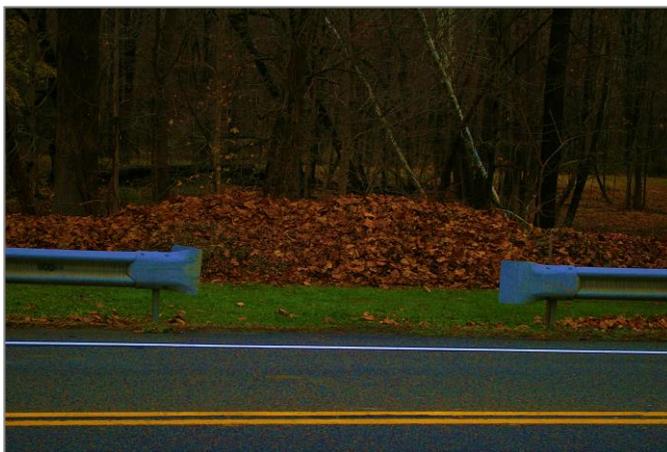
Observations: The existing guiderail on the southern edge of Beekman Rd west of the Carpenter Rd intersection is the older “W” style. The guiderail also has a gap between sections to allow walking access from the Church across the street to the area near Fishkill Creek. The SA team noted that the “W” style guiderail uses end treatments that may not absorb a vehicle crash as well as a modern box beam guiderail. See Fig. 15.

Fig. 15. DCDPW should consider replacing this “W” style guiderail with a more modern box beam design, while also investigating the possibility of closing the gap between guiderails since an errant vehicle could impact one of the end knuckles.

1. Replace the eastbound guiderail with a box beam style and consider closing the gap. The SA team noted that the County standard for new installations is box beam guiderail and that DCDPW has a program to identify and replace deficient systems.
2. Add reflective delineators along the side of the guiderail.

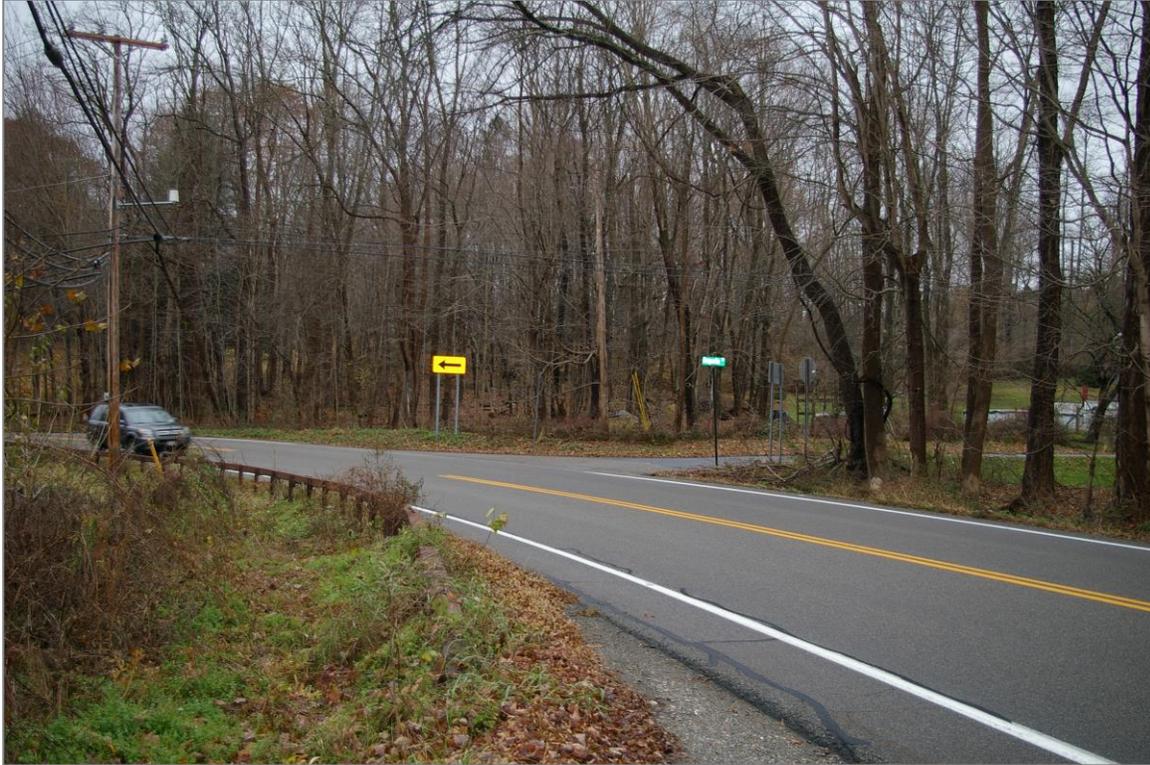
Fig. 16. A view of the Augusta Dr (West) intersection, looking west from CR 9 (Beekman Rd). This area experienced the highest number of crashes along the corridor, many occurring during wet road conditions.

The segment of Beekman Rd near Augusta Dr (West) had the highest number of crashes in the study area. Unsafe speeds during wet weather, coupled with the road's geometry, have resulted in numerous road departures and multiple-vehicle crashes. Beyond short-term improvements such as better signage and pavement treatments, DCDPW might consider creating a larger clear zone on the northern edge of the curve just west of the intersection. See Fig. 16 and 17.

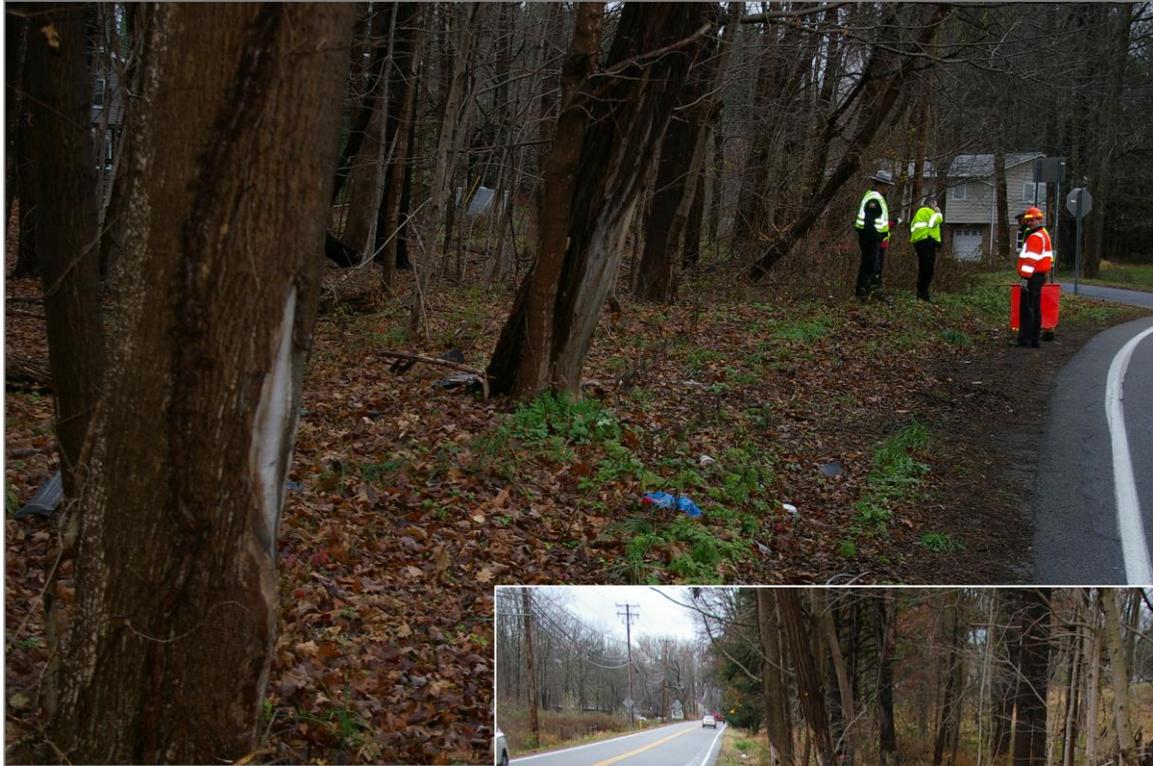
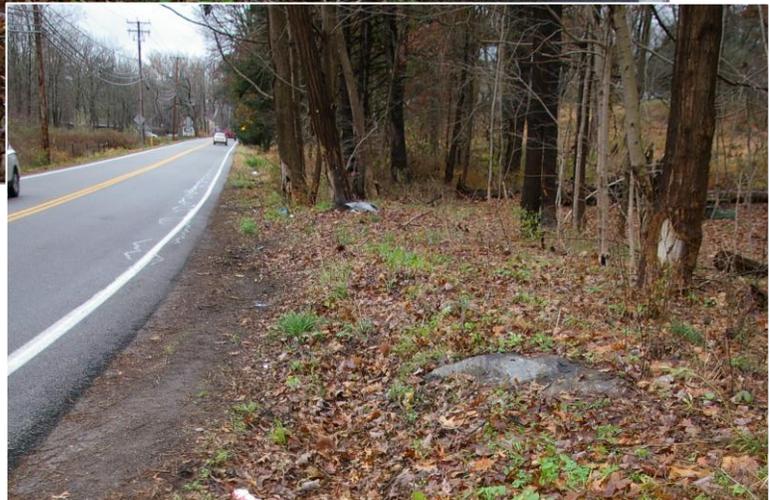
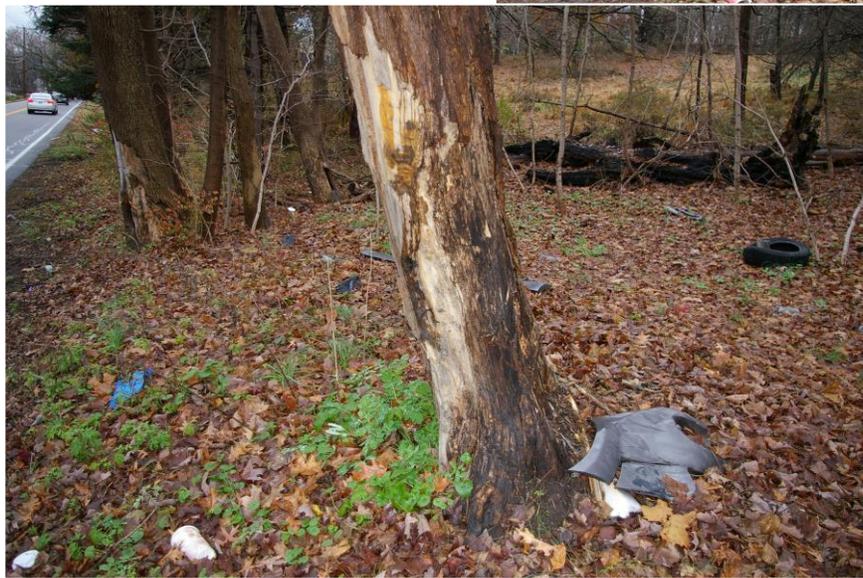
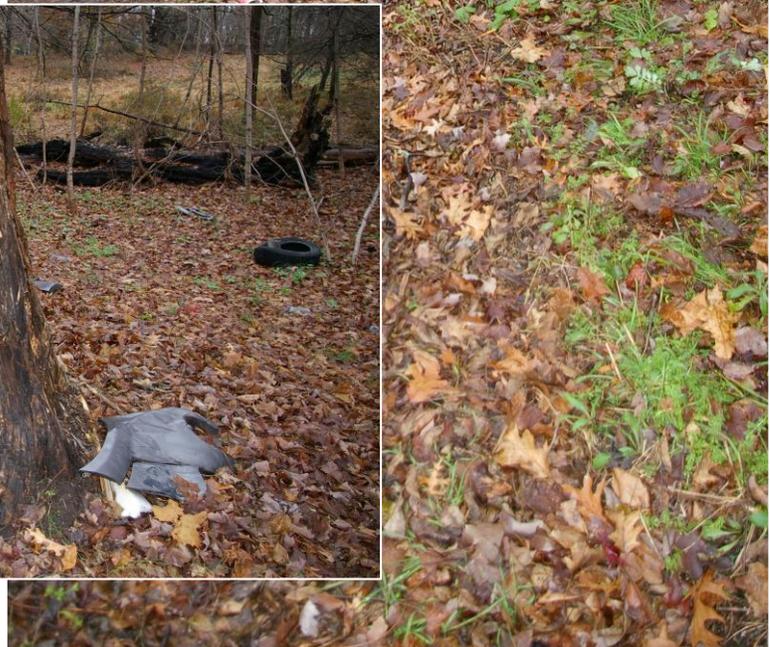
Observations: Crash data indicated that wet or snowy road conditions were present at 19 of the 25 crashes at this location (76 percent). Evidence of previous crashes was present during the site visit, especially at the apex of the curve, where a number of trees showed signs of repeated vehicle impacts. The area also appeared to have poor drainage that could diminish the capacity of drivers to recover from a road departure. Once off the pavement, there is a high probability of a collision with a fixed object such as a tree. The SA team noted that westbound vehicles tended to gain speed as they approached the curve, partly due to the elevation of Beekman Rd. The SA team also observed that the crash area off of Beekman Rd was moderately wooded and potentially unforgiving to errant vehicles (several vehicle parts were visible in the area, including a tire). The SA team also wondered if the super-elevation of the road might contribute to vehicles departing the road at the curve. See Fig. 18 and 19.

Fig. 18. This area west of the curve near Augusta Dr (West) has witnessed numerous road departure crashes, as evidenced by the vehicle debris field and tree damage.

of the road departure. Clear zones are free of rigid fixed objects such as trees and utility poles. For this location, this would entail removing a majority of trees located within the County right-of-way on the northern edge of Beekman Rd, just west of Augusta Dr (West). The amount of clear zone created should follow AASHTO's Roadside Design Guide and account for the road's design speed and the radius of the curve.

3. Consider installing Slippery When Wet signs (W8-5) to warn drivers approaching the curve. This would respond to the number of incidents occurring under wet pavement conditions. While the SA Team agreed that these signs are applicable, the group also felt adding more signs at or before the curves could detract from the primary message about the geometry. If installed, the placement of these signs should be carefully considered as part of the overall signage package for Beekman Rd.

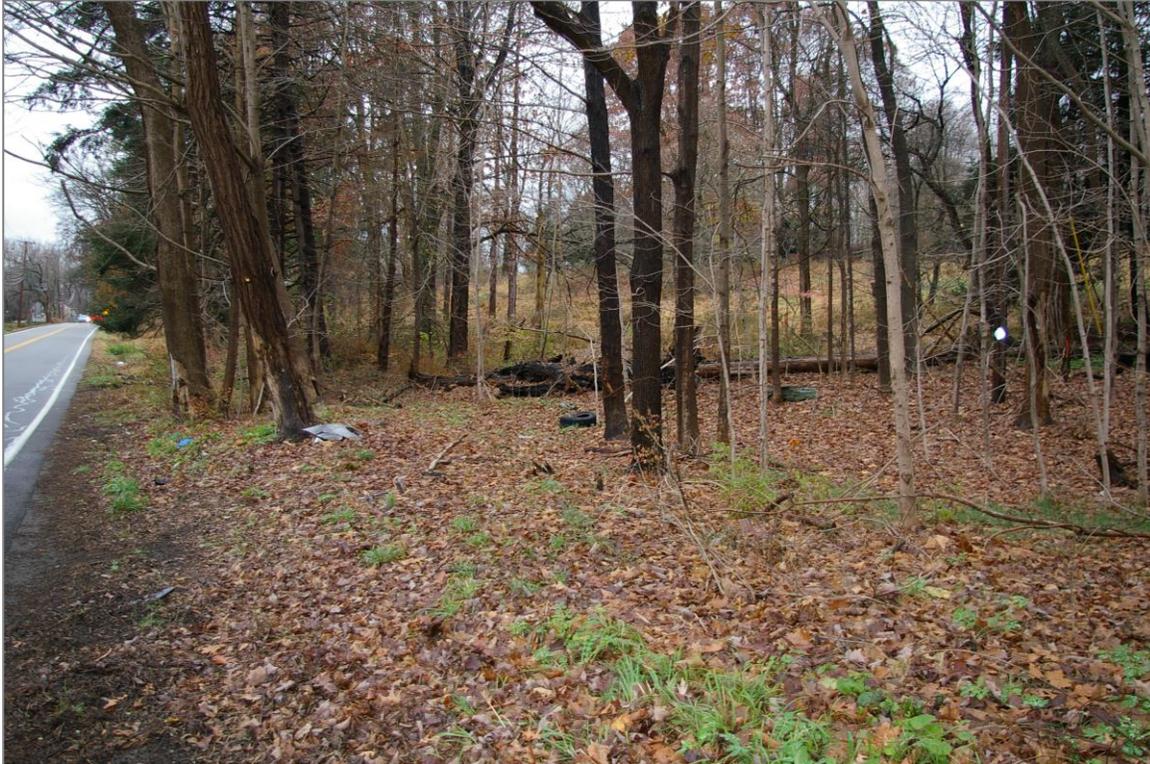
Fig. 19. Another view of the impact area near the Augusta Dr (West) curve. The SA report recommends that this area be cleared of fixed objects.

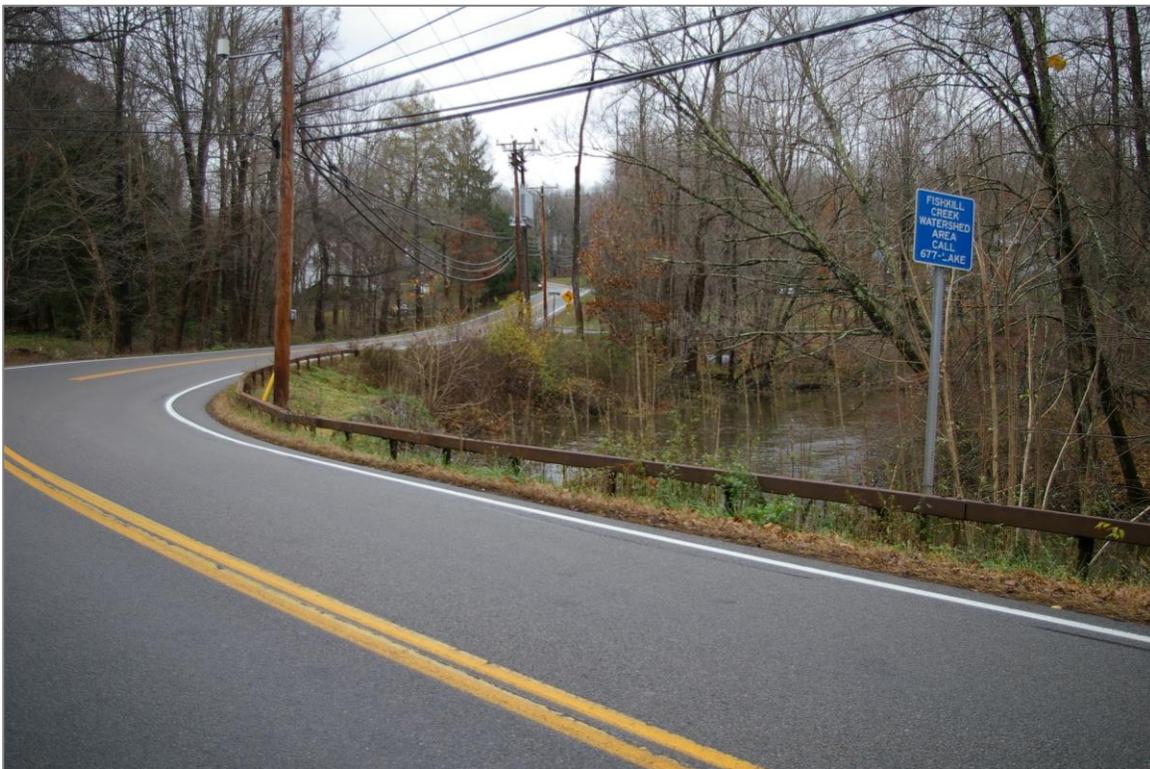
Fig. 23. This guiderail, located on the inside curve across from Augusta Dr (West), prevents errant vehicles from entering Fishkill Creek.

Observations: A segment of the guiderail above the Fishkill Creek is in poor condition and leaning out and away from Beekman Rd, indicating that it has been struck by vehicles and may lack suitable back-up support. The steep slope and soil erosion may have also compromised the guiderail, making its height too low to be effective. These conditions reduce the effectiveness of the guiderail, increasing the possibility of an errant vehicle falling down the embankment and into Fishkill Creek. See Fig. 23 and 24.

Risk Analysis: Lack of adequate guiderails can result in an errant vehicle traversing down a steep, non-recoverable embankment. This is of special concern if the area at the toe of the slope contains fixed objects or other hazards such as water. A steep slope also increases the chance of a vehicle overturning, and if water is present, the possibility of drowning trapped vehicle occupants.

1. Repair or replace the damaged box beam guiderail located on the southern edge of Beekman Rd above the Fishkill Creek.
2. Add reflective delineators along the side of the guiderail.

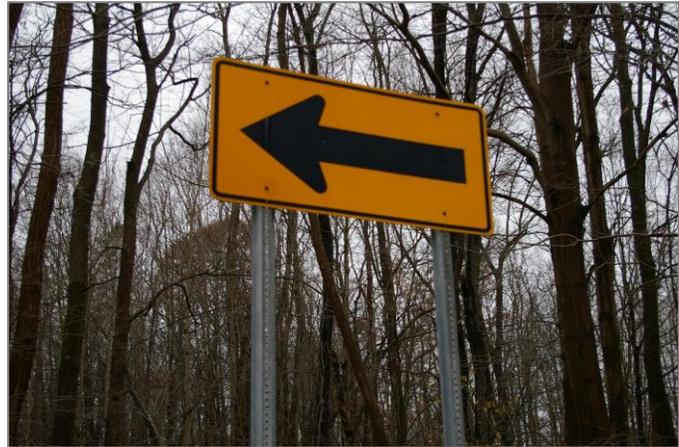
Safety Concern: The curve warning signs on both approaches to the intersection on Beekman Rd may not be located correctly based on current standards and may not effectively inform oncoming drivers of the approaching hazard.

Observation: Based on SA team member input, the two arrow warning signs (W1-6L/R) at the curve may not adequately capture the attention of drivers. At a minimum, the SA team felt that these signs should be replaced to improve their retro-reflectivity. The SA team also thought that the curve might be a suitable location for a series of two to three chevrons (W1-8L/R) on each approach. These should follow MUTCD guidance, which recommends not using chevrons as a single visual target on a long tangent, but more as a series of signs to inform drivers.

Risk Analysis: Insufficient warning signs, whether due to condition, frequency, or location, elevate the chance that a driver might not adjust their behavior in time to successfully negotiate a road hazard. Placing a sign too far from the target feature increases the chance that the sign might be missed or forgotten by the time a driver reaches the curve.

Fig. 20. This warning arrow (W1-6) at Augusta Dr (West) may not fully communicate the need for drivers to exercise caution when approaching the curve on CR 9 (Beekman Rd), just west of the intersection.

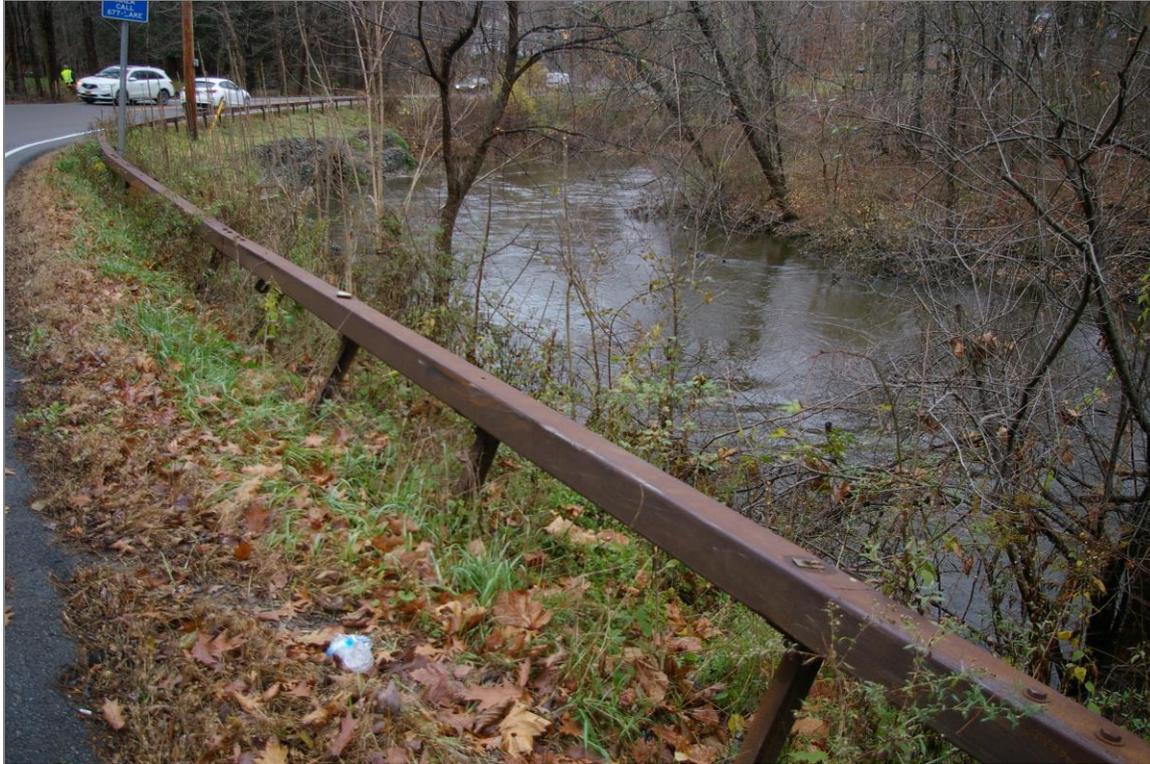
Fig. 24. A closer view of the guiderail from Fig. 23. Notice that it leans away from the road, likely due to repeated vehicle impacts and soil erosion.

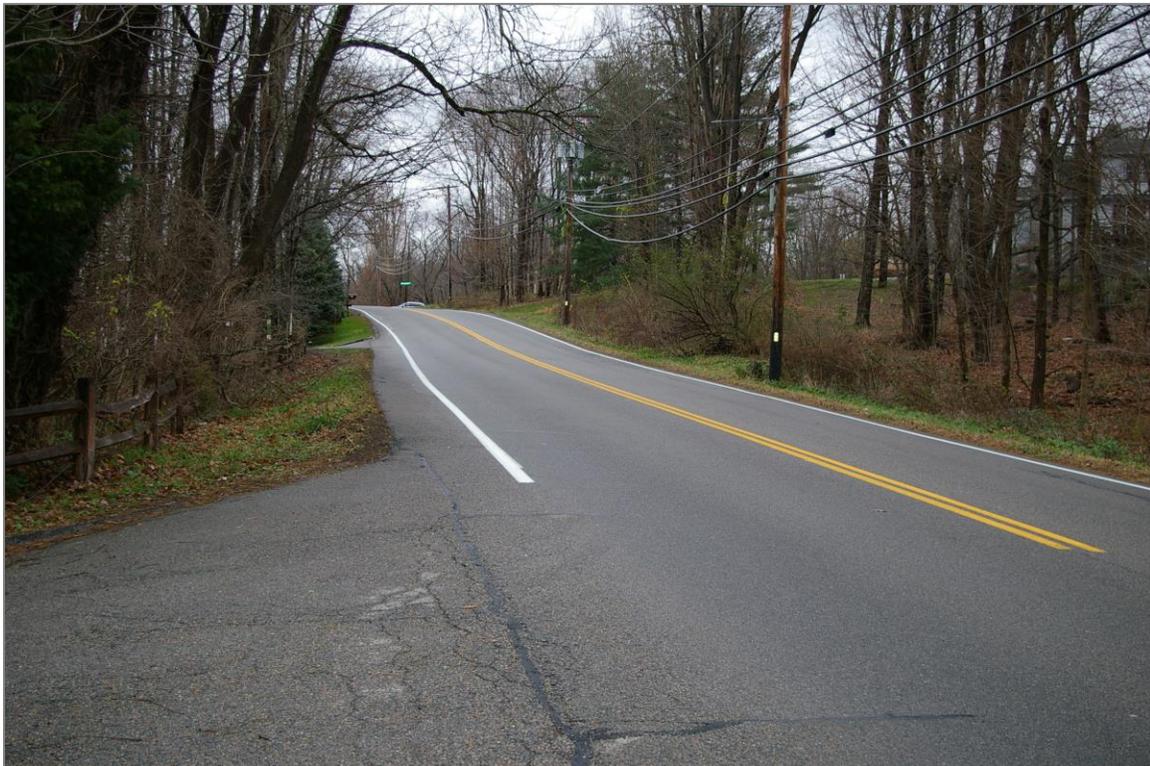
Fig. 25. The view from Augusta Dr (East), looking east towards Beekman Rd. The vertical crest and nearby trees limit a driver's ability to see oncoming vehicles.

Observations: The vertical geometry on Beekman Rd near the Augusta Dr (East) intersection creates limited sight distances for westbound vehicles on Beekman Rd and also for vehicles exiting Augusta Dr (East) onto Beekman Rd. This caused drivers to creep past the stop sign to see traffic on Beekman Rd. The SA team interviewed drivers exiting

Augusta Dr (East), who confirmed the difficulty they had seeing westbound vehicles coming from their left. They also noted that westbound vehicles tended to gain speed as they travelled down the hill towards Augusta Dr (East) and Willow Dr. The SA team also noted that large trees on the northeast corner of the intersection restricted the visibility of drivers looking east from Augusta Dr. Some SA team members discussed the possibility of creating a one-way in and out travel pattern on Augusta Dr (e.g. enter at the eastern leg and exit at the western leg); the team determined that this would be unpopular with local residents, so it was removed from consideration. Lastly, the Team noted that a street light, co-located on an existing utility pole, might be beneficial to drivers. See Fig. 25.
