Main Street/Innis Avenue/Worrall Avenue Safety Assessment
City of Poughkeepsie

FINAL REPORT

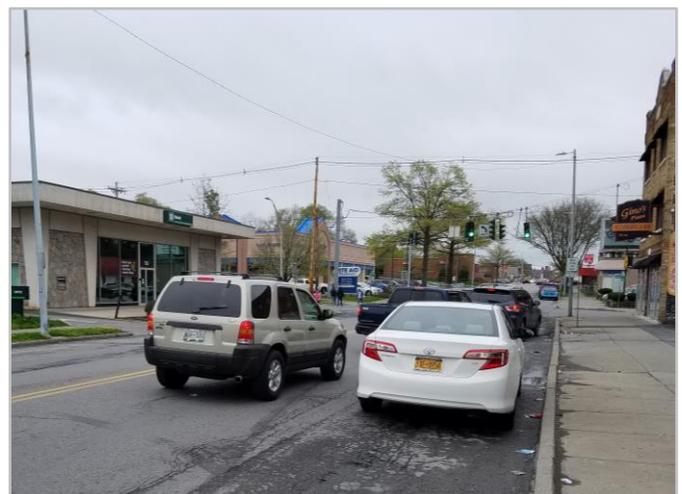
Observations: The team observed that eastbound through drivers often maneuver into the left turn lane to avoid parked cars, stopped buses, and loading trucks near the intersection, then back towards the curb as they approach the intersection, and then back towards the centerline on the far side of the intersection, to avoid parked cars. When traffic is heavy, this creates a fair amount of weaving in and out. The eastbound through lane jogs towards the curb to

Eastbound vehicles maneuver around a parked car and back towards the curb to enter the through lane.

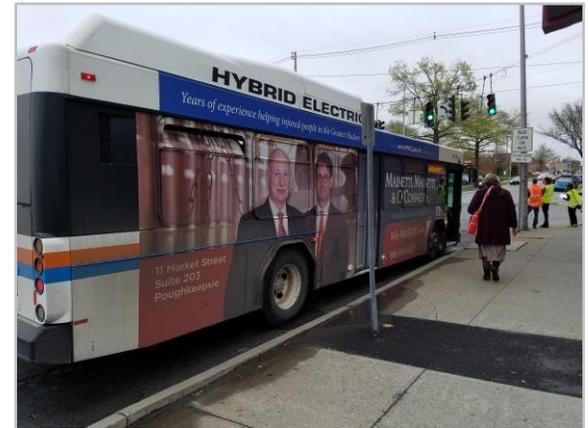
Eastbound buses stop on the south side of Main St just before the intersection.

As part of the relocation, restrict parking on the south side of Main St between the intersection and the street light pole to the east.

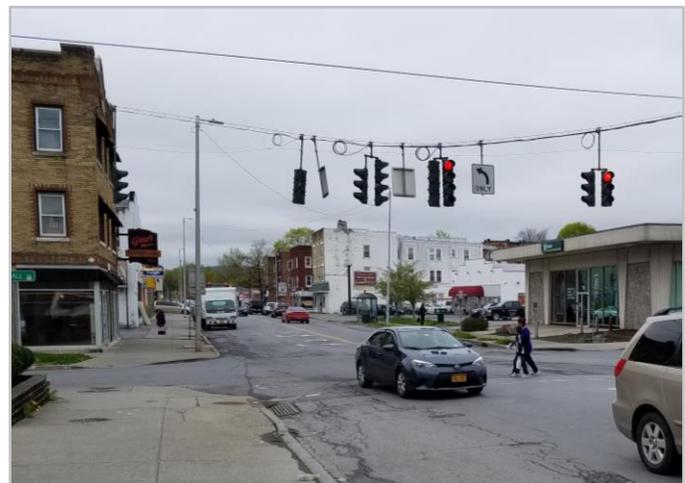
A mother and child cross the east leg of the intersection, as a driver turns right in front of them.

1. Install pedestrian signals with countdown timers for each crossing.
2. Incorporate pedestrian signal timing in the recommended signal timing evaluation and optimization (see Issue #1 under Traffic Signals).
3. Consider automatic pedestrian signals, which activate every signal cycle without the

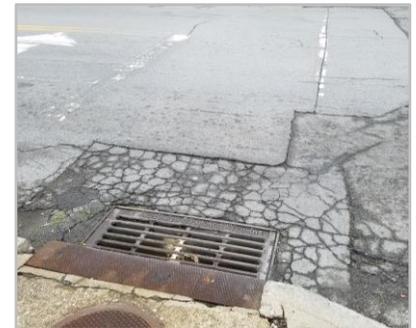
Observations: The team observed that the drainage grate on the westbound Main St approach (near the intersection) had relatively long openings. The other grates appeared more 'bicycle safe'.

This drainage grate should be replaced with one with smaller openings.

1. Replace the drainage grate on the westbound Main St approach with a bicycle-safe (reticuline or other) grate, in coordination with repaving.

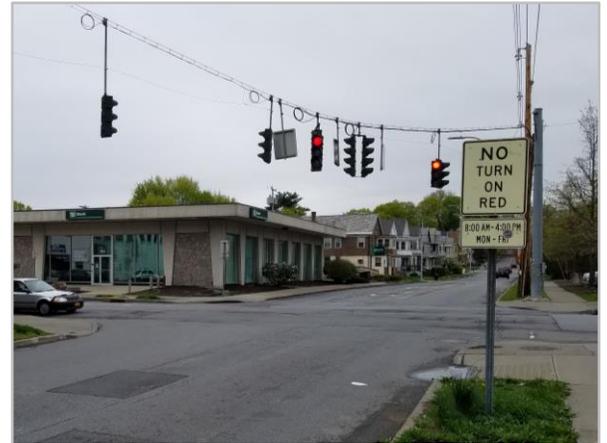
Because there are two sets of traffic signals at the northbound approach to the intersection (as required by the federal MUTCD) and no lane markings, some drivers may believe there are two northbound lanes rather than one. The team discussed the pros and cons of a centerline. It would increase costs for striping/maintenance, but may clarify the intended layout and improve operations on the Worrall Ave approach. Worrall Ave has the lowest volume of the four approaches to the intersection, but does back up, particularly in the morning and afternoon with school and bus traffic.

Northbound Worrall Ave has two traffic signal heads and no lane markings.

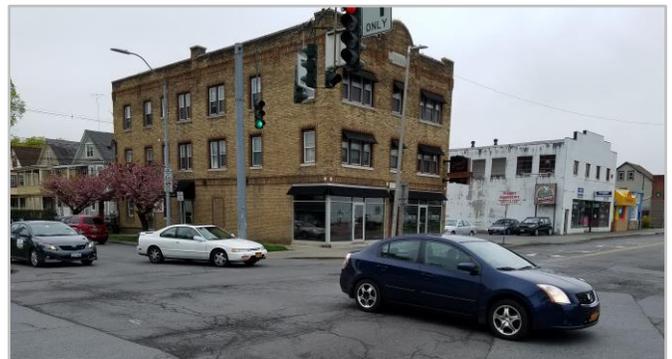
The team also discussed the possibility of creating a left turn pocket. The team observed some drivers creating their own left turn lane by moving out towards the center of the street. Drivers may be confused by the dual signal heads, may be attempting to give through traffic more space, or trying to get out of the northbound queue. Given the limited pavement width (29 feet) and on-street parking on the west side (about 8 feet), a left turn pocket could only be accommodated if on-street parking was removed near the intersection. The team also noted that Worrall Ave is used by school and local buses, so ideally the lanes should be 10.5-11 feet wide. This would leave at most 8 feet for a left turn pocket, which is quite narrow.

A driver on northbound Worrall Ave uses the undefined space to create a left turn lane.

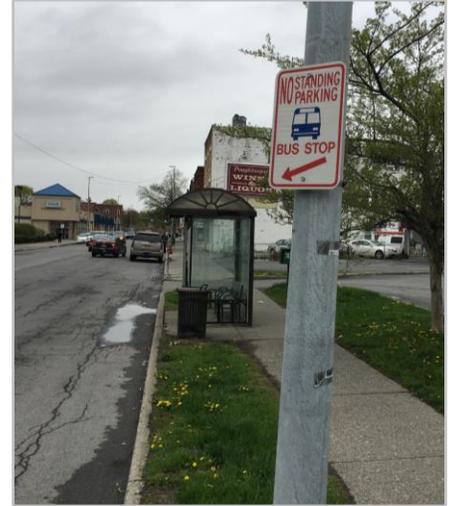
Observations: The team observed what appeared to be an old bus stop sign (“No Standing/Parking: Bus Stop”) east of the bus stop shelter by the TD Bank.

This sign could be replaced when new bus stop signs are installed.

1. Replace the bus stop sign when new Dutchess County Public Transit bus routes and stops in the area are finalized.
Continue to restrict parking in the bus stop area.

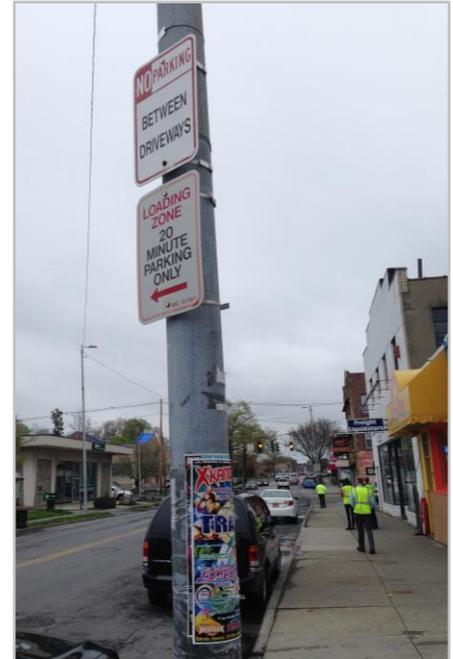
Observations: There are three signs regarding on-street parking on the south side of Main St west of the intersection. A pole just east of the Pickwick Pub has two signs: “No Parking Between Driveways” and “Loading Zone: 20 Minute Parking Only” with an arrow pointing east. Just east of the Gino’s parking lot is a “No Parking Any Time” sign with an arrow pointing towards the intersection. It was somewhat unclear what area the “No Parking Between Driveways” sign covered, as there was not a second sign or any markings to indicate the area between the driveways. In addition, the two signs on that pole seemed contradictory. Was the intent no parking, or 20 minute parking? Were the signs referring to the same area, or different areas along the curb? Was the entire area between the driveways a loading zone?

Parking-related signage on the south side of Main St, west of the intersection.

1. Simplify and clarify the Main St parking signage. Keep the “Loading Zone: 20 Minute Parking Only” sign if the loading zone is desired to be maintained. Replace the other two signs (“No Parking Between Driveways” and “No Parking Anytime”) with one “No Parking Anytime” sign just east of the loading zone with an arrow pointing to the intersection.
2. Consider pavement hatching or curb painting to demarcate the Main St loading zone area.

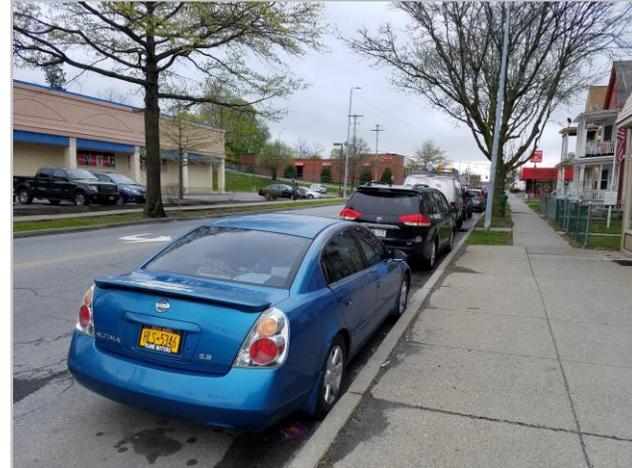
Observations: The team observed vehicles parked just east of the intersection, in front of Kane Motors. Based on discussions with Police Dept staff, it appeared that a “No Parking” sign had been removed from a street light pole approximately 120 feet east of the intersection. The team determined that removing on-street parking for this portion of Main Street would enable the eastbound bus stop to be relocated to this area from the congested location west of the intersection. This would improve operations at the intersection.

On-street parking east of the intersection on eastbound Main St.

1. Replace/install a “No Parking Any Time” sign on the south side of Main St approximately 120 feet east of the intersection.

The missing “No Parking” sign has been replaced.

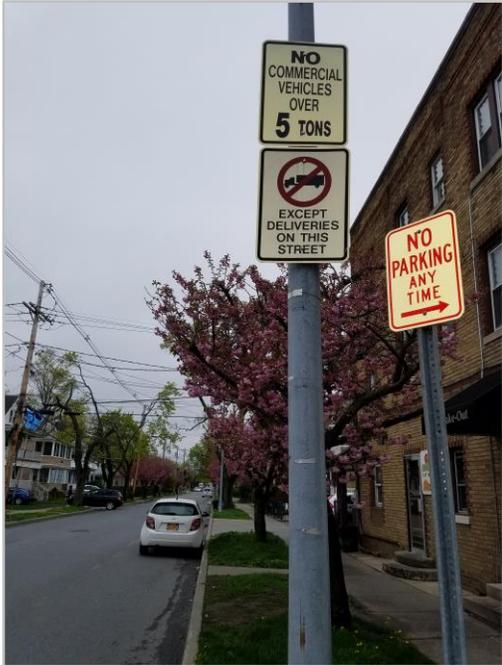
Observations: The mis-alignment of the curbs is exacerbated by on-street parking on the west side of Worrall Ave near the intersection, causing additional weaving and potential conflicts. Currently, on-street parking is restricted only for about 20 feet from the intersection. The team observed that southbound through drivers straddle the left turn and through lanes to avoid weaving back around parked cars on Worrall Ave. In addition, team members stated that some drivers change lanes at the last minute, from the left turn to the through lane and vice versa. At times, parked vehicles made it difficult for traffic to navigate Worrall Ave—particularly trucks and buses turning south onto Worrall Ave. Based on discussions with Police Dept staff, people often park there to pick up to-go orders from the restaurant, and restaurant delivery vehicles also use that space. However, the restaurant has a parking lot accessible from Main St and Worrall Ave. The team determined that restricting on-street parking between the parking lot driveway and the intersection would improve operations and safety on Worrall Ave.

On-street parking is allowed for much of the west side of Worrall Ave.

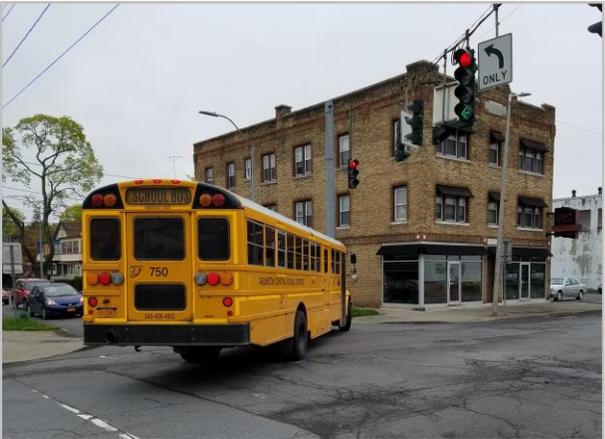
Observations: The team observed that the intersection was tight for trucks and buses, particularly southbound on Worrall Ave near Gino’s restaurant and eastbound approaching the intersection. The team observed a westbound truck turning left onto southbound Worrall Ave that had difficulty making the turn due to a vehicle waiting at

A school bus makes the tight left turn from Main St onto Worrall Ave.

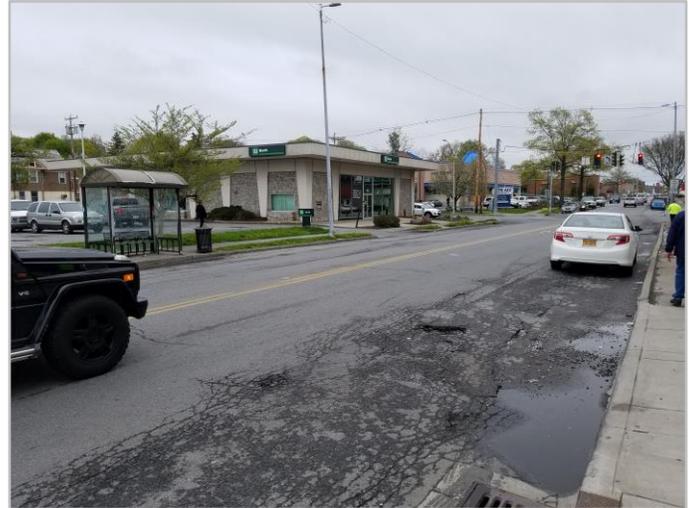
Observations: The team observed damaged pavement and potholes, particularly on eastbound Main St, as well as cracking and deterioration in the center of the intersection and along the street edges. The team also observed ponding at the northwest corner, and several items that were not flush with the pavement surface (a water valve on the west leg of Main St and a loop detector cover on the eastbound left turn).

Significant cracking, potholes, and ponding on eastbound Main St approaching the intersection.

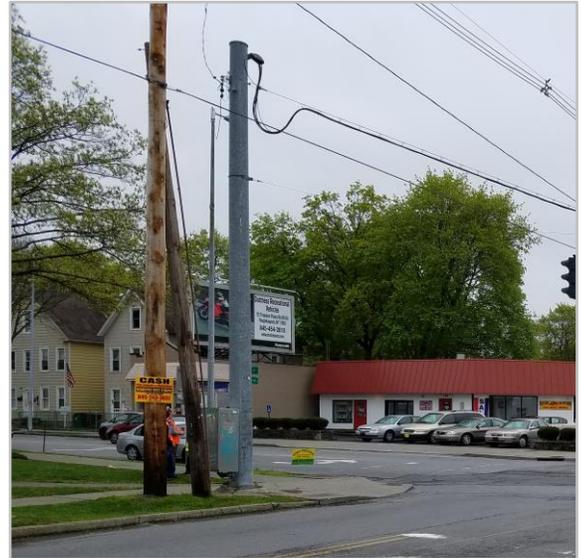
Observations: The team observed an extra wood utility pole on Innis Ave near the northeast corner of the intersection. City staff said they would contact Central Hudson to have to pole removed.

An extra pole was observed on Innis Ave between the metal pole and new utility pole.

1. Remove the unused pole on Innis Ave near the northeast corner of the intersection.
