CR 16 (North Quaker Lane) Safety Assessment ***Forest Drive to Fallkill Road, Town of Hyde Park***

CR16 (North Quaker Lane) Safety Assessment
Forest Drive to Fallkill Road, Town of Hyde Park

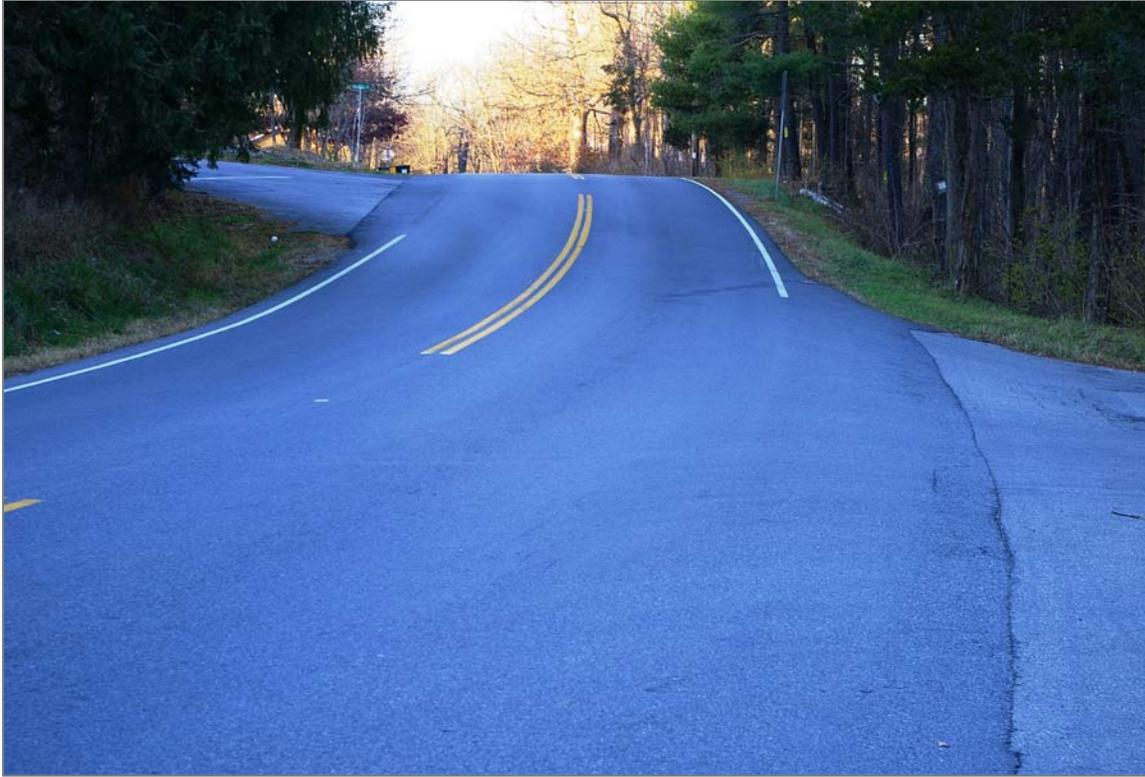
Figure 4. North Quaker Lane at East Fallkill Road looking north towards Fallkill Road. The vertical geometry creates a challenging environment for drivers making turns from the intersections.

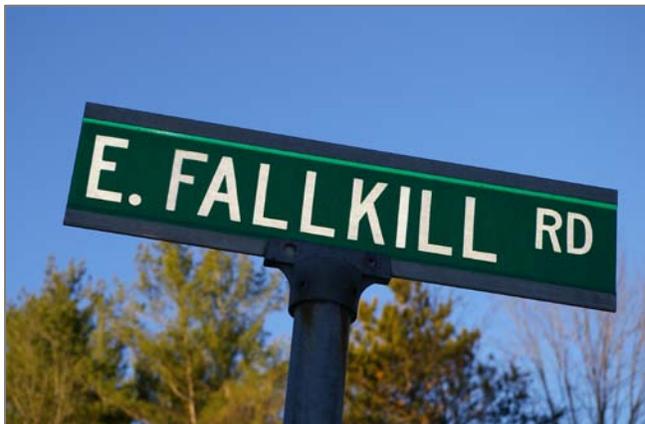
Figure 11. The street name signs in the study area (left) use the old lettering style that has now been superseded by a mixed-case style (above). Source: 2009 MUTCD.

Suggestion: Upgrade street name signs to meet the larger, mixed-case sign standard as per the 2009 MUTCD.

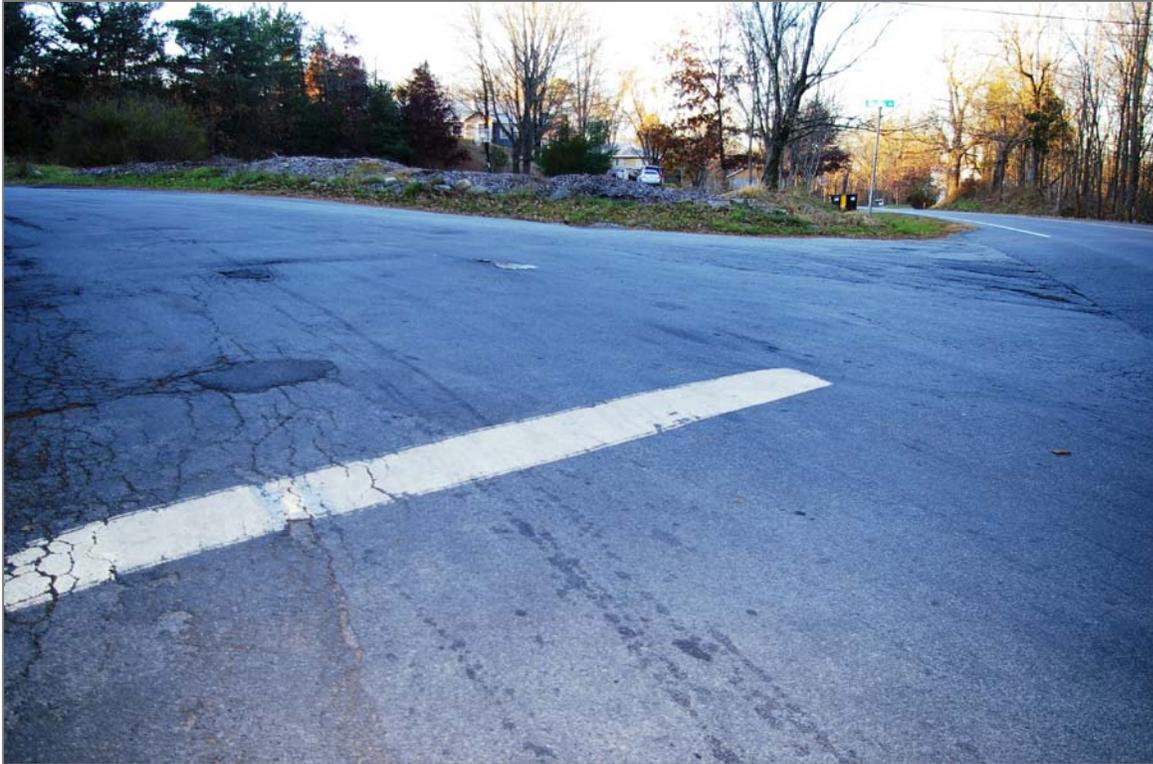
Figure 12. The Fallkill Road approach to North Quaker Lane appears wider than necessary, while the stop line may not be positioned at the optimal point for sight distance.

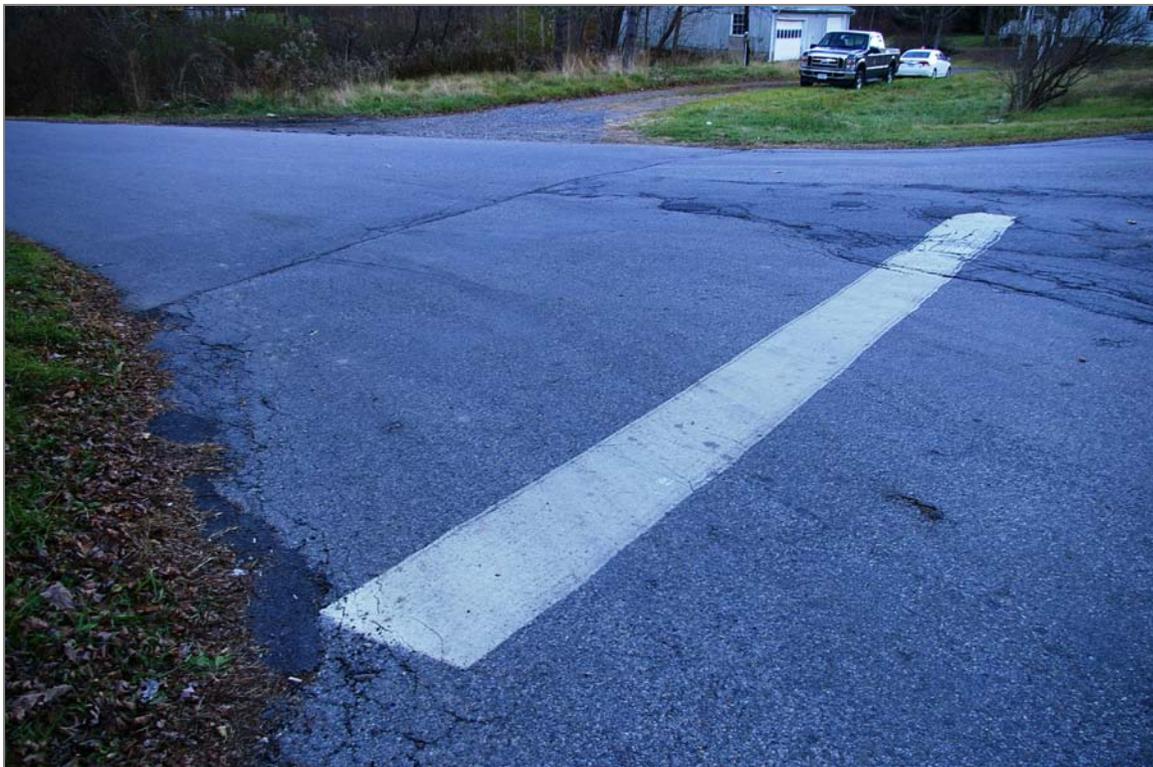
Figure 13. The East Fallkill Road approach to North Quaker Lane is equally wide.

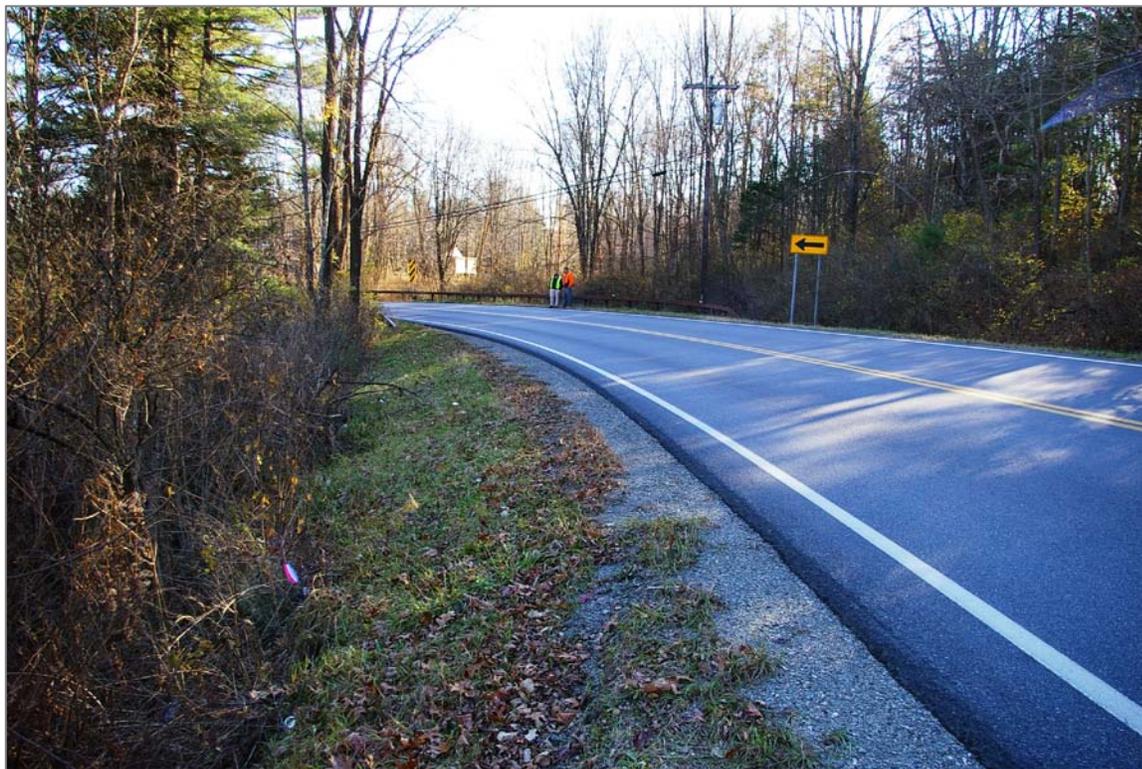
Figure 14. North Quaker Lane looking south towards the curve. The pavement slopes downward through the curve.

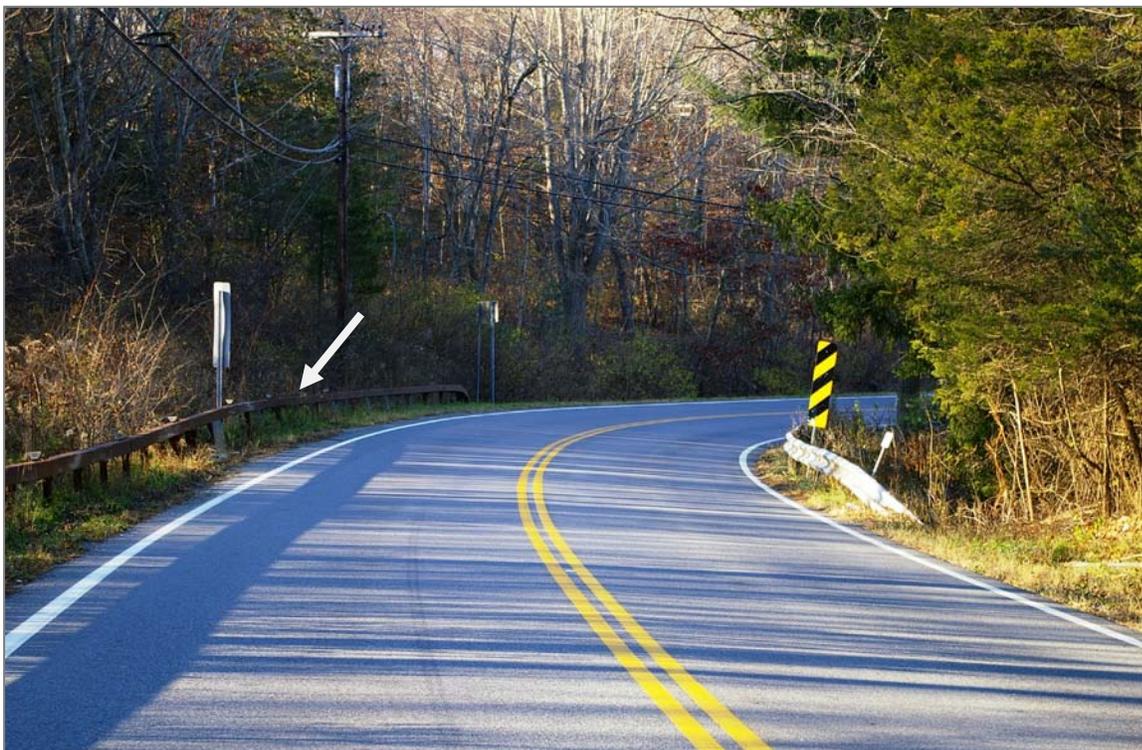
Figure 15. North Quaker Lane looking north towards the curve. Note the damaged box beam guiderail to the left (arrow).

Observations: Recurring vehicle impacts have damaged the southbound guiderail, which is missing some structural members. Several segments of the guiderail are in poor condition and leaning out and away from the road, indicating that they have either been struck by vehicles or suffer from a lack of suitable back-up support. In addition, the southbound guiderail is a box beam, while the northbound guiderail is the older “W” style. The bridge/hazard markers (OM3-L/R) may not be needed, since they compete with other warning signs. Numerous reflective delineators on the southbound guiderail were bent or broken. The SA team also noted that a new guiderail might be needed further north of the curve (northbound lane), where the road abuts a low lying wetland; the field visit uncovered evidence of a road departure into the edge of this wetland.

1. Repair the damaged southbound guiderail.
2. Once the warning chevrons (W-8) are installed, remove the object markers (OM3-L/R) located on both guiderails.
3. Consider upgrading the reflective delineators and/or adding a reflective strip along the side of the guiderails.
4. Replace the northbound guiderail with a box beam style. The SA team noted that the County standard for new installations is box beam guiderail and that DCDPW has a program to identify and replace deficient systems.
5. Consider the installation of a new guiderail on the eastern edge of the northbound lane, in order to prevent vehicles from entering the wetlands. This could be an

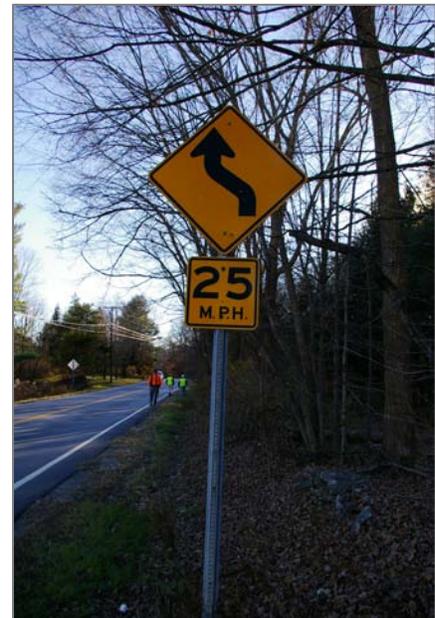
Figure 16. Located approx. 800 feet from the curve (when travelling south), this sign assembly should be moved further south to keep the driver's attention.

1. Relocate the horizontal alignment warning sign (W1-4) and advisory speed plaque (W13-1P) closer to the point of curvature (i.e. closer to the curve), as per current engineering standards.
2. Consider enlarging the warning sign to 36x36 inches and speed plaque to 24x24 inches.
3. Install a series of warning chevrons (W1-8) to alert North Quaker Lane southbound traffic of the approaching curve north of Forest Drive and consider adding reflective vertical strips to the chevron signposts. The existing large arrow warning sign (W1-6) should be removed in conjunction with the installation of the chevrons.
4. If crash rates remain high after lower cost improvements are made, consider the use of flashing beacons or LEDs to increase the visibility of warning signs.

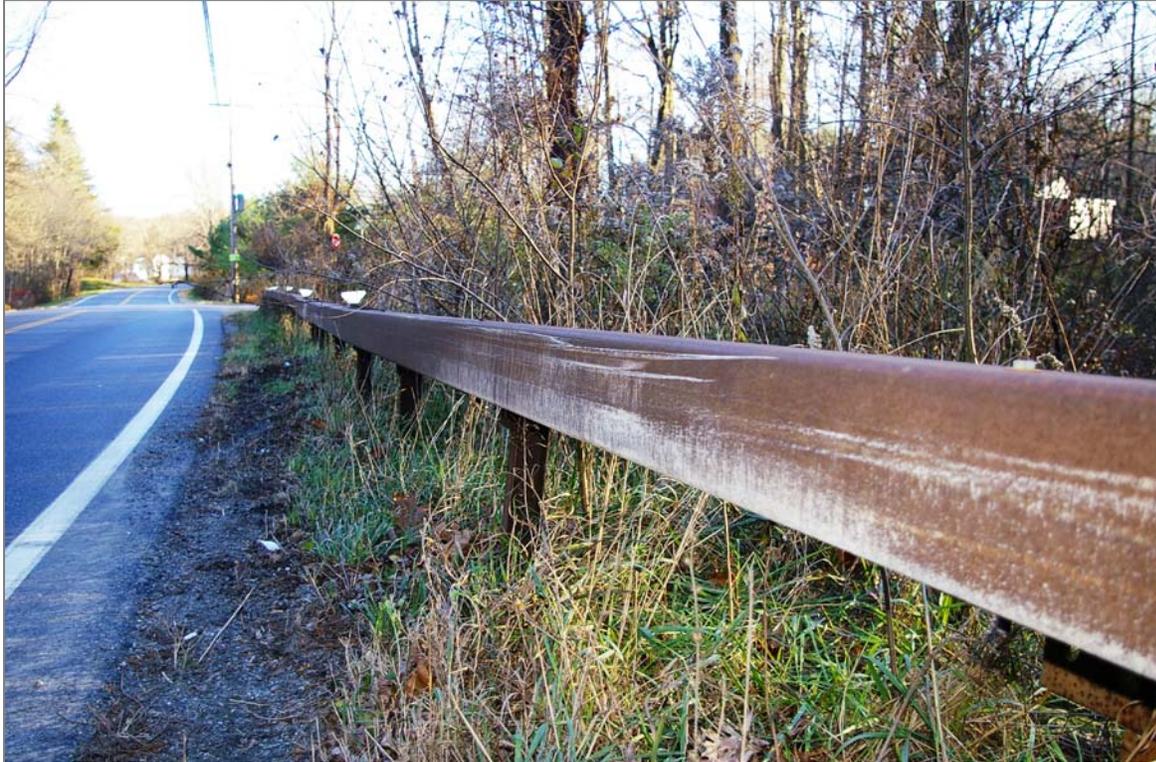
Figure 17. The box beam guiderail along the southbound lane of North Quaker Lane wears the marks of previous crashes.

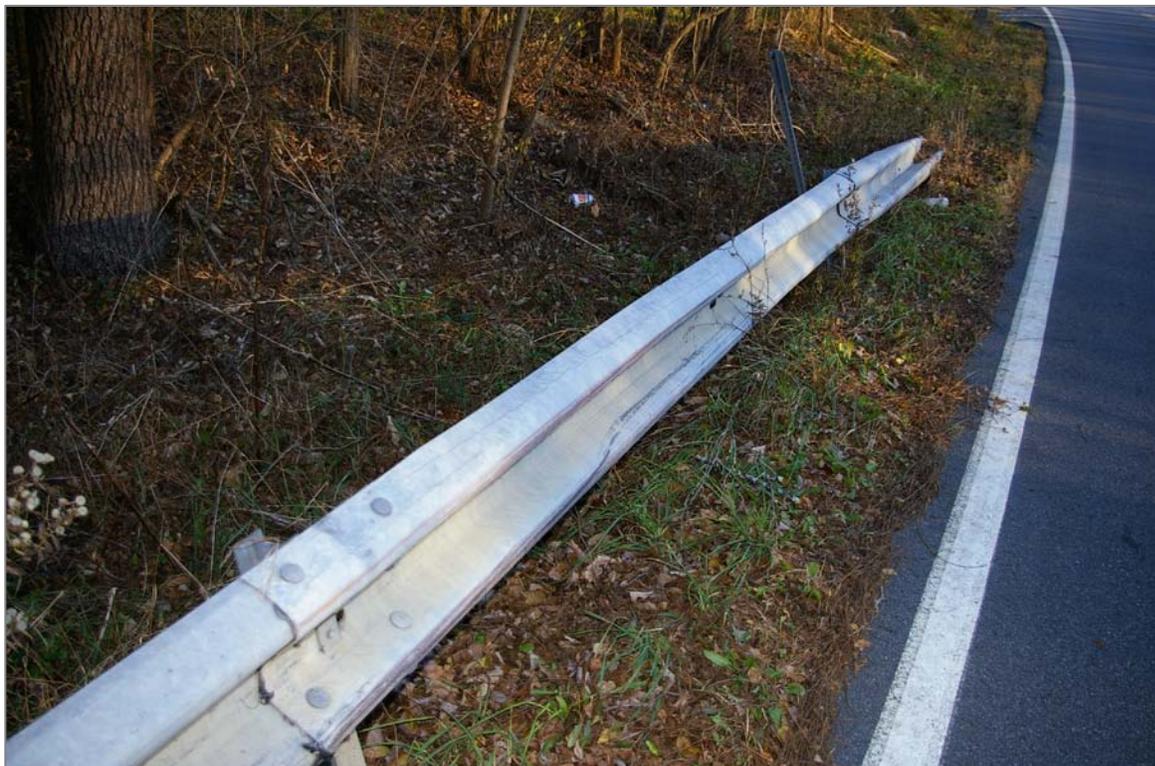
Figure 18. The obsolete "W" style guiderail along the northbound lane of North Quaker Lane should be replaced with a box beam guiderail.

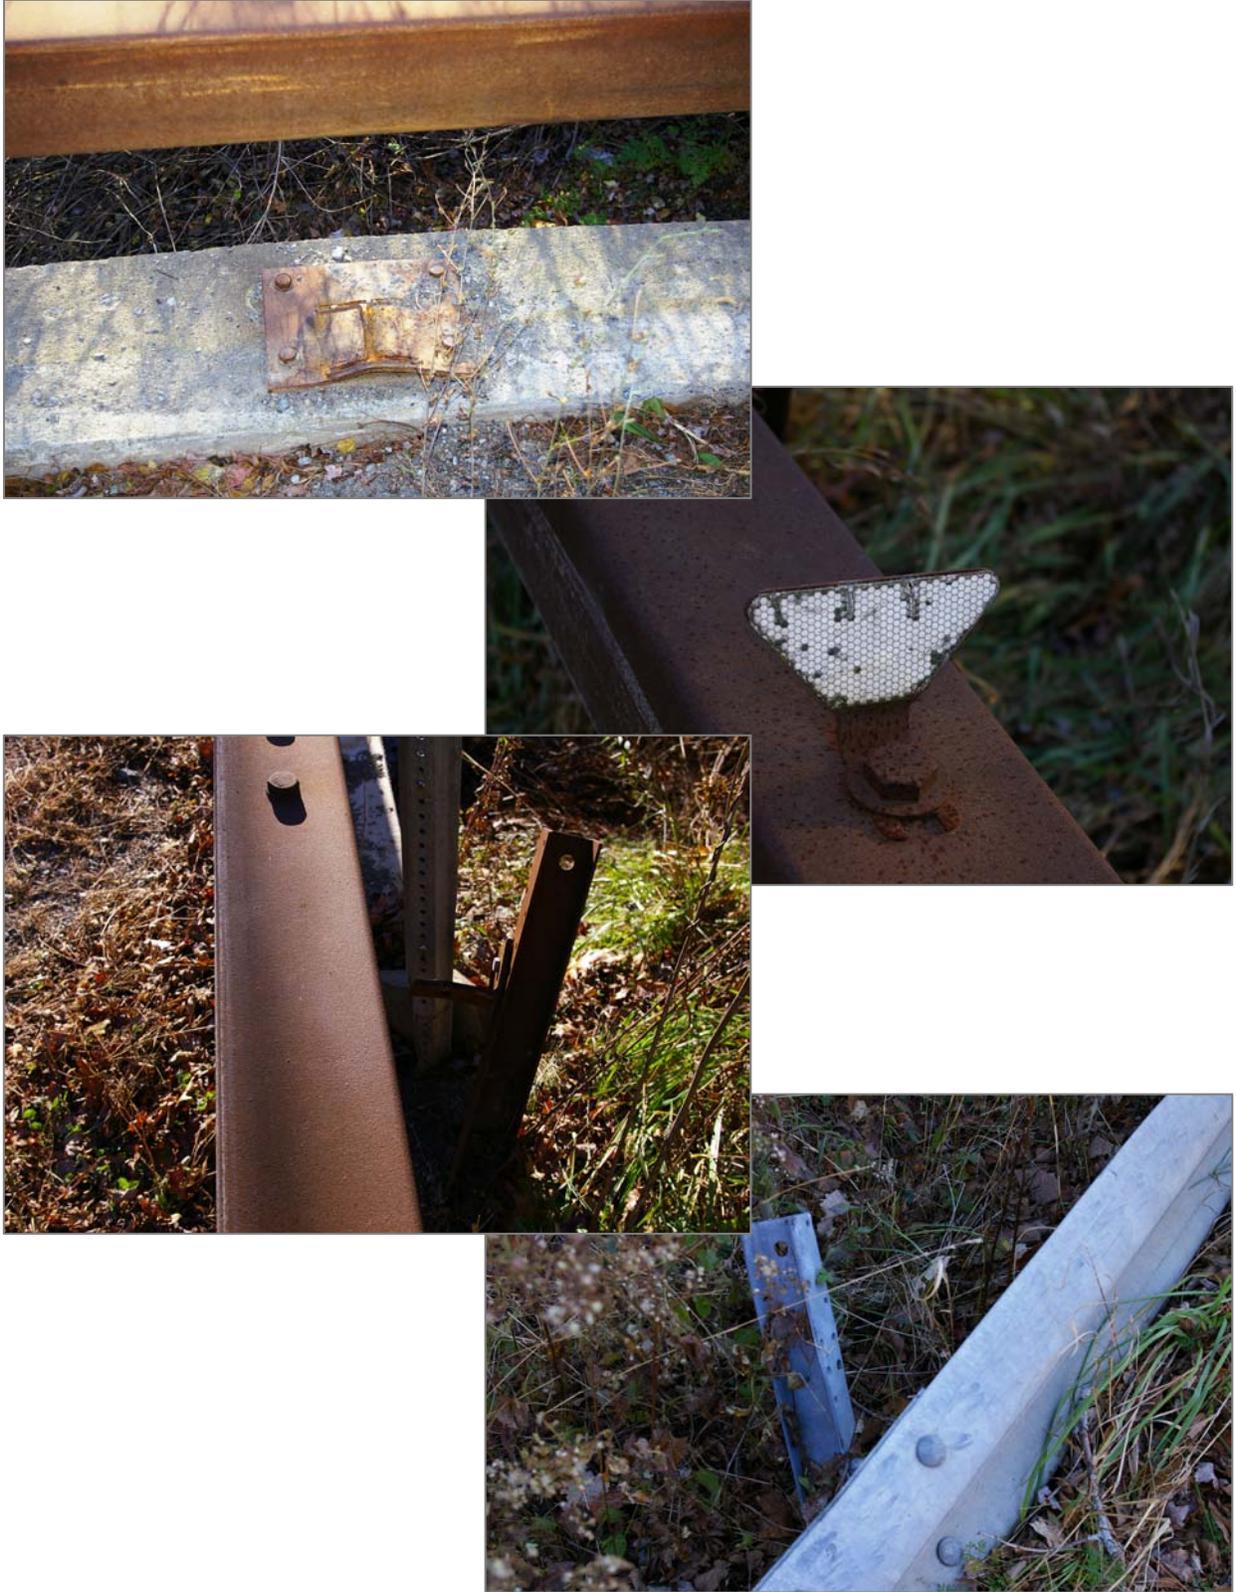
Figure 19. Repeated impacts by vehicles have separated support posts from the guiderails, while some delineators have worn away.

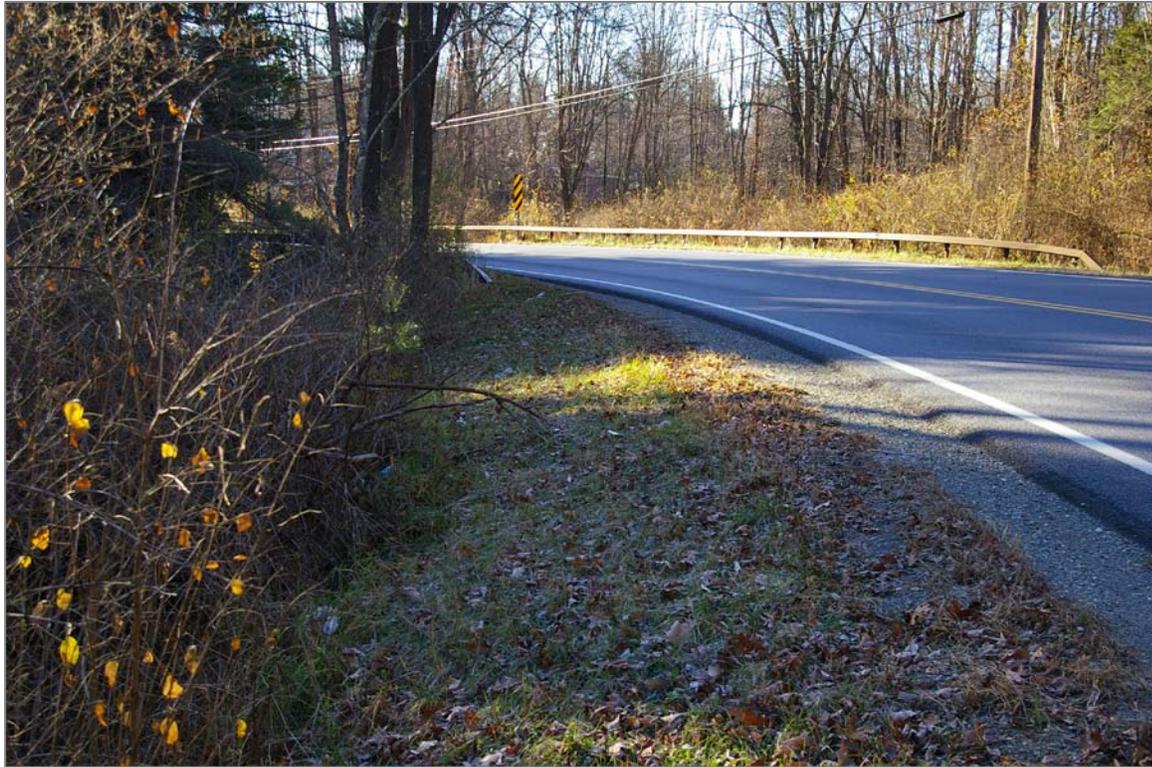
Figure 20. The northbound guiderail along North Quaker Lane could be extended to prevent vehicles from entering the wetland area to the east (left).

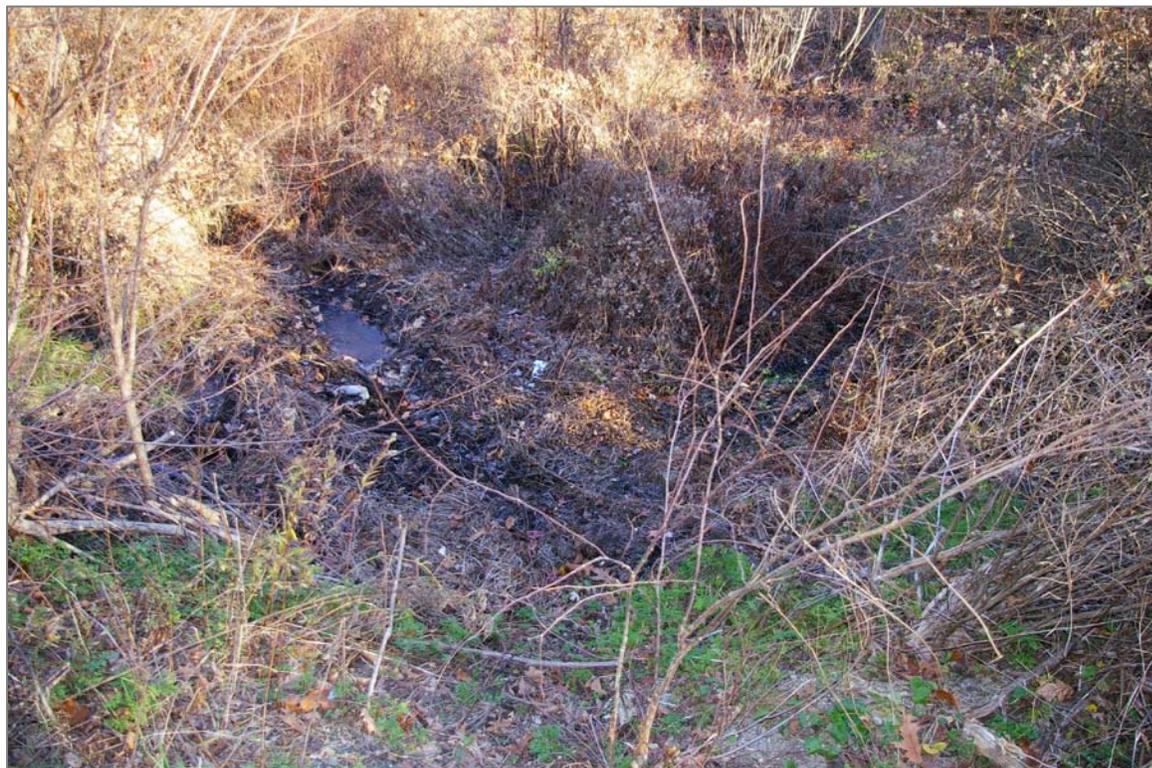
Figure 21. The field visit revealed evidence of a previous roadside departure, with the vehicle resting in the wetland.

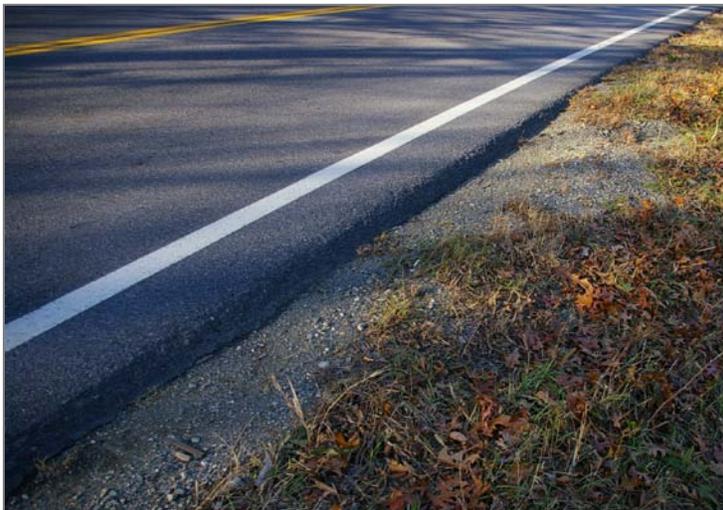
Observations: Paved shoulders vary from 1 to 2 feet, with an additional 2 to 4 feet of unpaved shoulder. Some of these paved shoulders drop off substantially at the edge, particularly on the northbound lane just north of the curve and existing guiderail. The SA team suspected that roadway runoff was cutting a path along the edge of the pavement, resulting in an edge drop-off condition at the shoulder.

Figure 22. Sections of the northbound shoulder have steep edges, likely due to water runoff. Such features can make it difficult for vehicles to recover when departing the pavement.

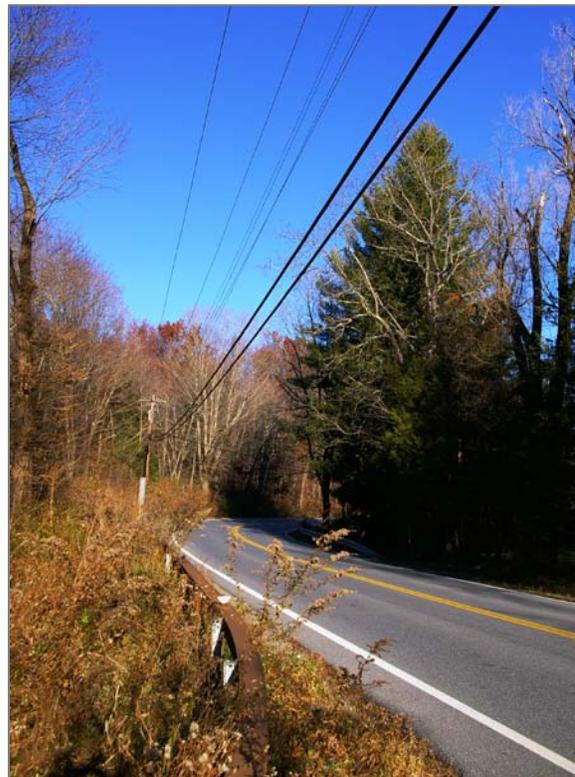
Observations: Trees located on the inside curve of northbound North Quaker Lane restrict visibility northbound, while trees on the west side of the southbound lane (i.e. on the embankment) also restrict visibility. The SA Team reported that the resident of 691 North Quaker Lane had previously complained of poor visibility from their driveway, particularly of northbound vehicles on North Quaker Lane. However, the crash data did not indicate a safety issue related to poor visibility from driveways.

Figure 23. Large trees located on the east side of the curve obscure oncoming traffic and cast shadows on the pavement.

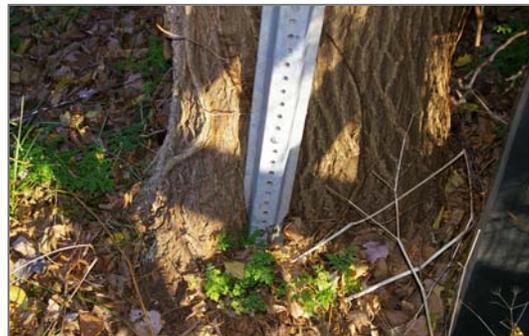
Figure 24. The posts for the STOP sign on Forest Drive have been encased by a tree trunk.

1. Move the STOP (R1-1) sign post away from the large tree at the southwest corner of the intersection (see also Issue #2: Sight Distance).
2. Replace the old 'STOP Ahead' sign with the new pictorial advanced traffic control sign (W3-1) [Completed on November 14, 2013].

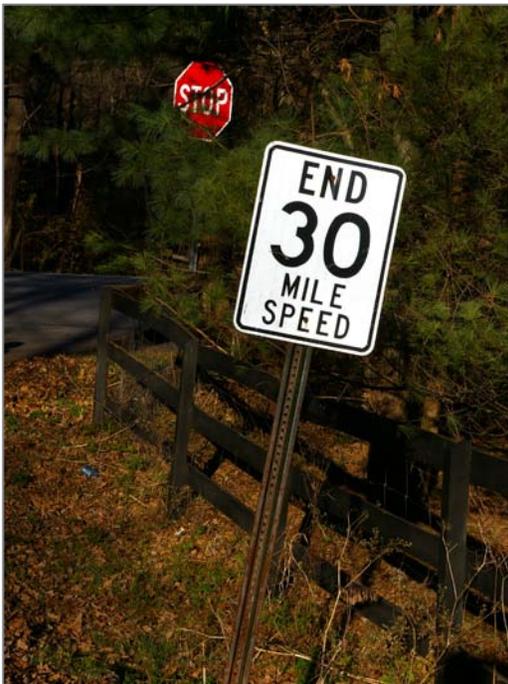
Figure 25. Branches from a large tree, coupled with an approaching speed sign, obscure the STOP sign at Forest Drive.

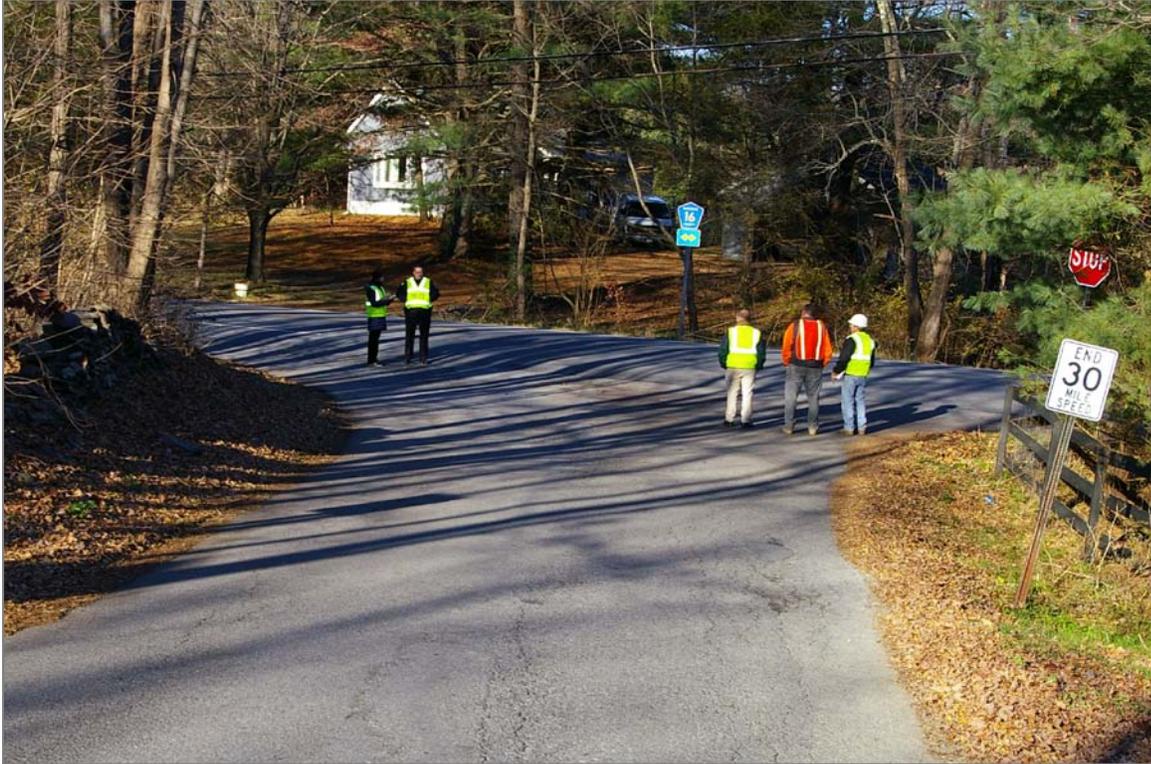
Figure 26. Tree branches obscure the STOP sign on Forest Drive, while another sign distracts drivers as they approach North Quaker Lane. A stop line would improve driver awareness.

5. Install a stop bar on the Forest Drive approach to North Quaker Lane, using the NYSDOT recommended standard width of 18 inches or the wider 24-inches, which would make it consistent with other intersecting roads (e.g. Fallkill Road).

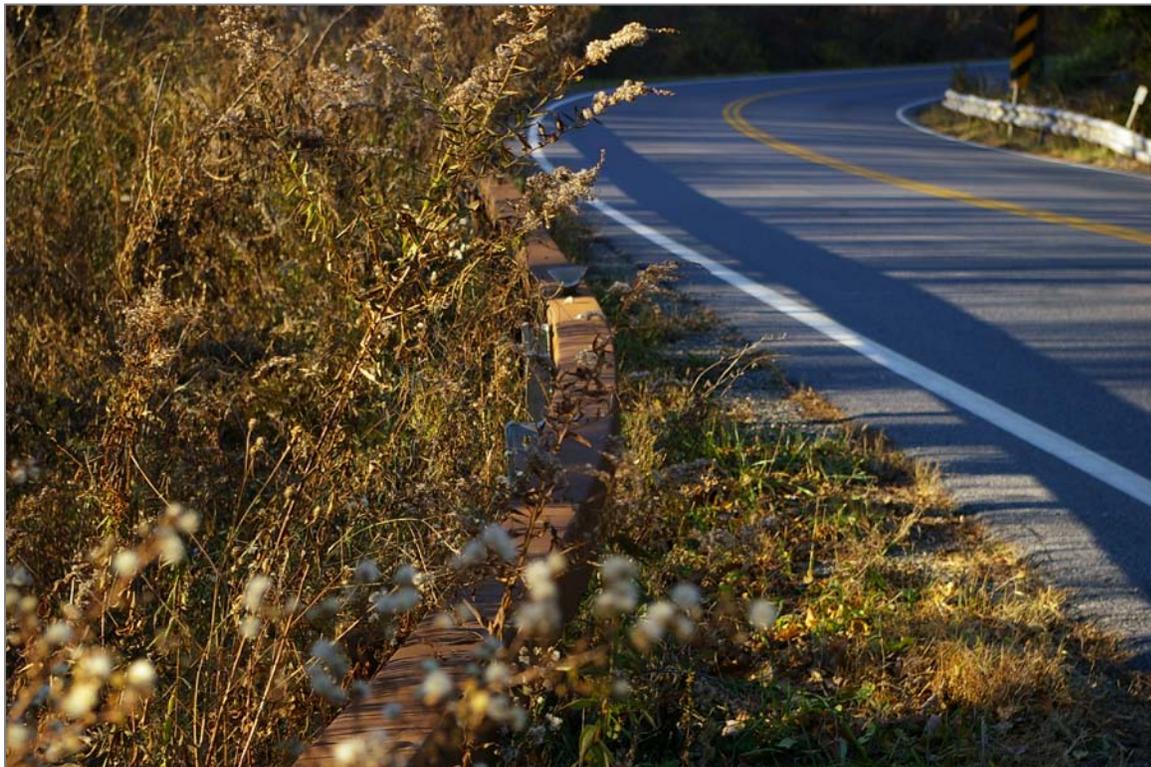
Figure 27. Vegetation along the southbound guiderail on North Quaker Lane impedes the line of sight of drivers looking north from Forest Drive.
