**Road Safety Assessment (SA) Report
FINAL**

**BEEKMAN ROAD (CR 9) SAFETY ASSESSMENT
BEEKMAN-POUGHQUAG ROAD (CR 7) TO NYS ROUTE 55
TOWN OF BEEKMAN, NEW YORK**

**POUGHKEEPSIE-DUTCHESS COUNTY TRANSPORTATION COUNCIL
27 HIGH STREET, 2ND FLOOR
POUGHKEEPSIE, NY 12601**

**FINAL REPORT DATE: MARCH 2013
ASSESSMENT DATE: OCTOBER 24 - 26, 2012**

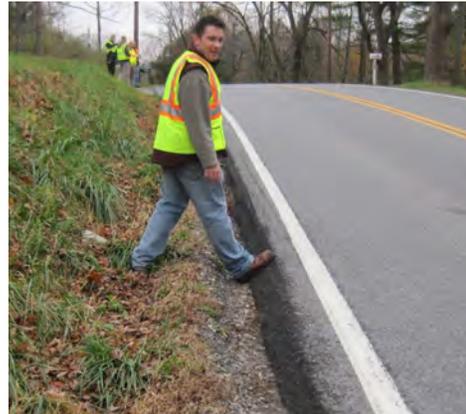
Observations: Roadway runoff is cutting a path along the edge of the pavement, resulting in an edge drop-off condition at the shoulder / backup interface. Shoulder (pavement edge) drop-offs were observed at several locations, primarily on steeper grades. There was a location along southbound Beekman Road, at the reverse curves, where vehicles leaving the pavement have also pushed away the shoulder backup resulting in a drop-off condition. Some drop-offs were measured as deep as 12 inches. Lack of proper shoulder backup was also observed to be contributing to pavement failures.

Exhibit 11: Example of shoulder drop-off, just north of Limbach Road.

Risk Analysis: Edge drop-off can cause loss-of-control when a vehicle drifts toward and off the shoulder. If a driver attempts a sudden correction to regain the roadway, the vehicle can become destabilized resulting in a loss of control. The lack of adequate clear area and high operating speeds along the road elevate the chances of a severe crash.

Suggestions: *Remove the ditch and redirect roadway drainage to other adjacent drainage facilities. Replace the ditch with a shallower asphalt swale or concrete gutter. Install a roadside or field drainage inlet (drop structure) with a direct outlet (pipe and end section) to the watercourse below.*

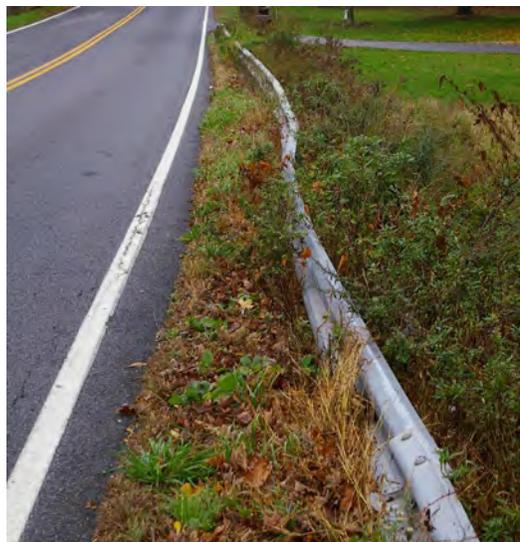
Observations: Several segments of guide rail are in poor condition and leaning outward, away from the roadway. They may have either been struck or suffer from a lack of suitable support for the backup posts. Existing guide rail consists of turned down end sections, poor posts and supports, and some wooden posts. The SA Team also noted several steep side slopes where guide rail should be considered for installation. One included a drainage culvert, over 5 feet deep, located within 4 feet of the traveled way.

Exhibit 12: Example of damaged and leaning guide rail.

Risk Analysis: Lack of adequate guide rail can result in an errant vehicle traversing down a steep, non-recoverable slope. This is of special concern if the area at the toe of slope contains fixed objects or other non-bypassable hazards. Low guide rail systems and turned down end sections can increase the risk of vehicle launching.

Suggestions: *Replace and/or install new guide rail. Existing guide rail that is damaged or leaning should be replaced. New guide rail should be installed in*

locations where steep side slopes or drop-offs exist as determined by the Dutchess County DPW. The SA Team noted that the County DPW standard for new installations is box beam guiderail and the DPW has a program to identify and replace deficient systems.

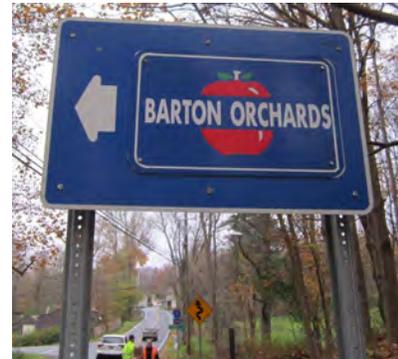
Risk Analysis: In general, warning signs should have higher priority over driver information signs. Leaving the warning sign obscured increases the risk of a driver not recognizing and properly adjusting their driving to accommodate the downstream condition. This increases the risk of a roadway departure incident. A high-speed, head-on collision with a northbound vehicle could also result.

Exhibit 14: Illustration of Barton Orchards sign for relocation.

Suggestions: *Relocate the Barton Orchard directional service sign to a location where it does not obscure the winding road warning sign.*

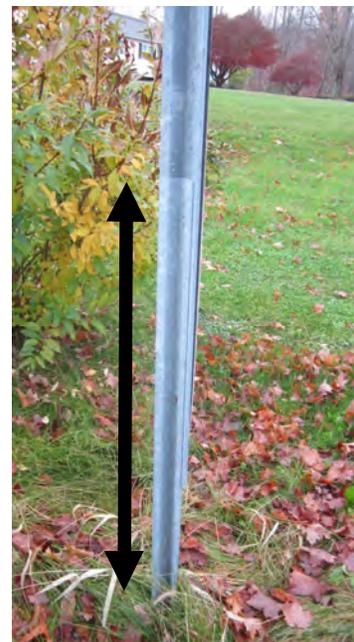
Observations: There are several breakaway sign posts throughout the study area where the segment driven into the ground is excessively long, sticking up too high above the neighboring ground. If a sign were to be hit by an errant vehicle, the embedded post could snag the vehicle's undercarriage. This constitutes an unforgiving roadside feature.

Exhibit 15: Example of high breakaway post base.

Risk Analysis: High breakaway posts within the clear zone could result in vehicular damage in the event of a roadway departure incident.

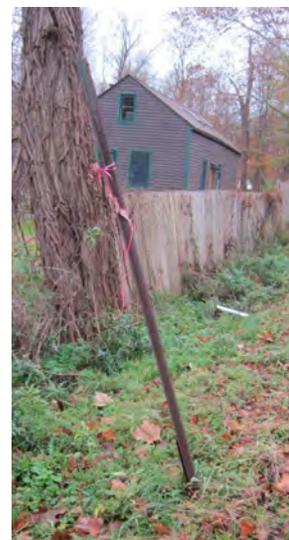
Safety Concern: Abandoned sign posts were observed in several places throughout the corridor.

Risk Analysis: Old posts within the clear zone could damage a vehicle undercarriage in the event of a roadway departure incident or spear the occupant compartment resulting in a severe crash.

Exhibit 16: Example of an abandoned sign post.

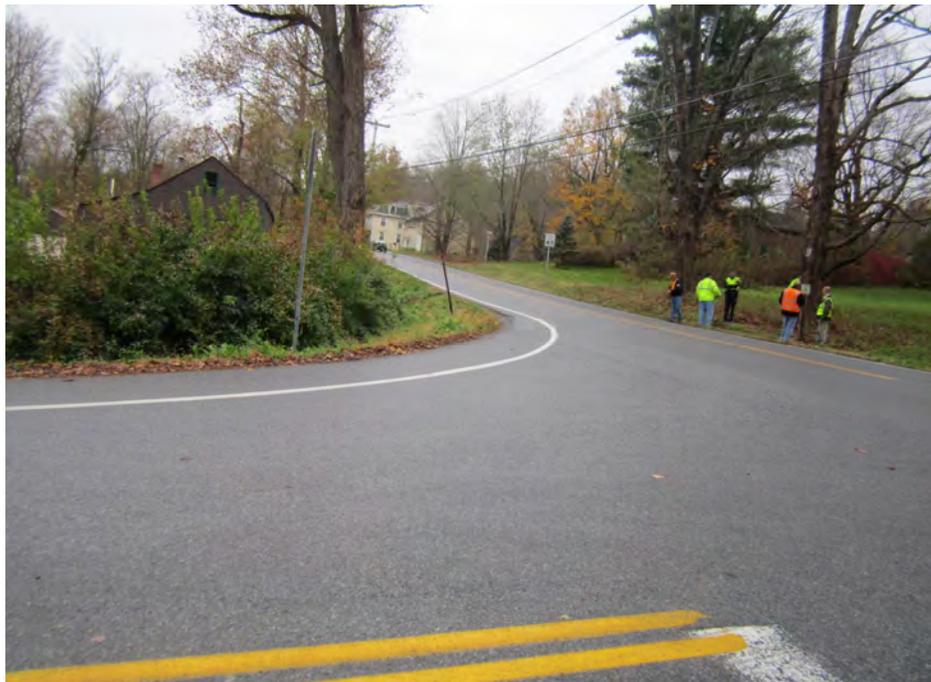
Observations: Westbound vehicles stopped on Beekman-Poughquag Road have difficulty seeing vehicles approaching from the south because of trees and bushes paralleling a private fence line. Additionally, sight lines are restricted by the horizontal and vertical geometry of Beekman Road to the south. Drivers were observed to pause at the stop line and slowly edge out until sight lines were maximized, approximately 5 to 8 feet in front of the stop line. These obstructions also limited drivers northbound on Beekman Road from seeing vehicles stopped at the intersection.

The SA Team noted the private fence in the southeast corner of the intersection does not appear to significantly restrict sight lines given the horizontal and vertical curvature on Beekman Road to the south. One large tree and the bushes in front of the fence actually present a more significant barrier. Anecdotal evidence suggests the County discussed the current placement of the fence with the landowner when recent renovations were made to the property. The SA Team also noted that the stop line on Beekman-Poughquag Road was previously moved closer to Beekman Road.

Risk Analysis: A lack of adequate sight distance for turning maneuvers increases the risk of a collision by affecting the driver's ability to accurately judge and accept gaps in approaching traffic. Operating speeds on Beekman Road increase the probability of a severe incident.

Exhibit 17: Sight line to the south as viewed from westbound Beekman-Poughquag Road at stop line.

1. **Trim and/or Remove Existing Vegetation.** Discuss the trimming or removal of the bushes and trees in the southeast corner with the adjacent property owner. The SA Team noted that if the sight obstructions were removed, particularly the large tree adjacent to the fence, the existing stop line would be located in the optimal position for sight distance.

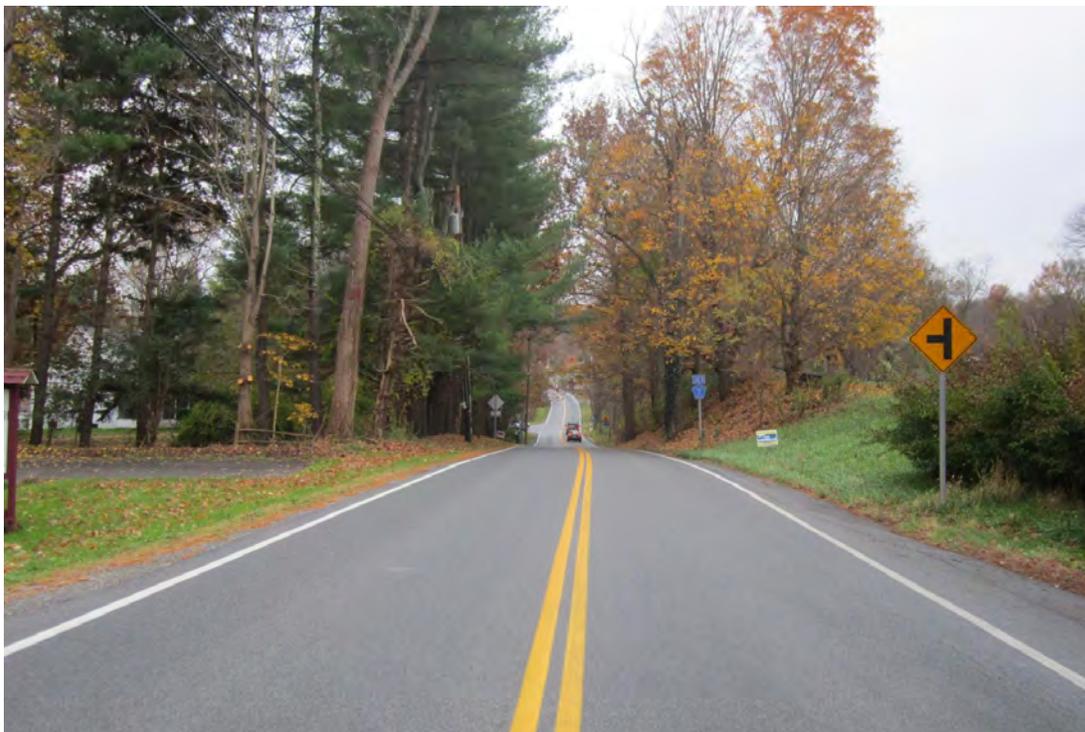
Risk Analysis: A lack of adequate stopping sight distance could result in high-speed, rear-end collisions with a severe outcome given prevailing operating speeds on Beekman Road.

Exhibit 18: View of southbound Beekman Road from Baker Road.

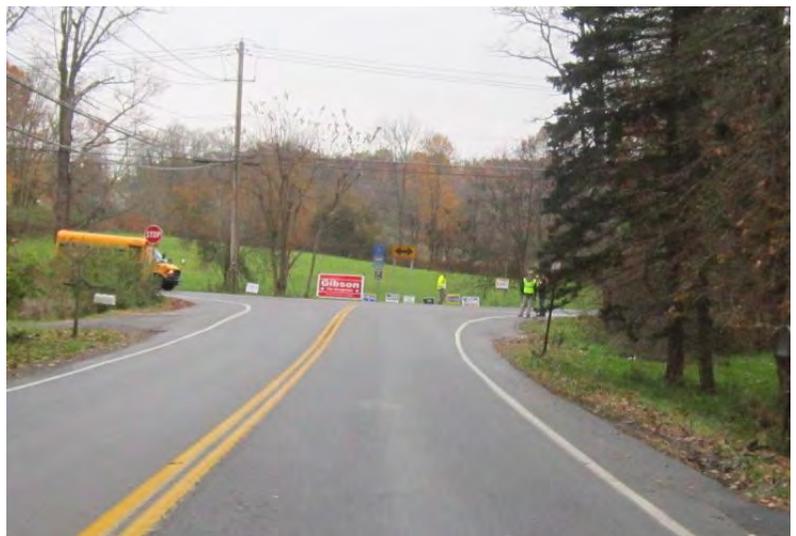
Observations: STOP signs on the westbound Beekman-Poughquag Road approach are

Exhibit 19: Illustration of poor stop sign visibility and width of westbound approach.

difficult to see. Existing vegetation blocks the STOP sign on the right side of the road; however the STOP sign on the left side is highly visible. Both STOP signs appear widely spread given the size of the intersection throat (29 feet).

Risk Analysis: Inadequate STOP sign visibility can result in a high-speed, severe right angle collision.

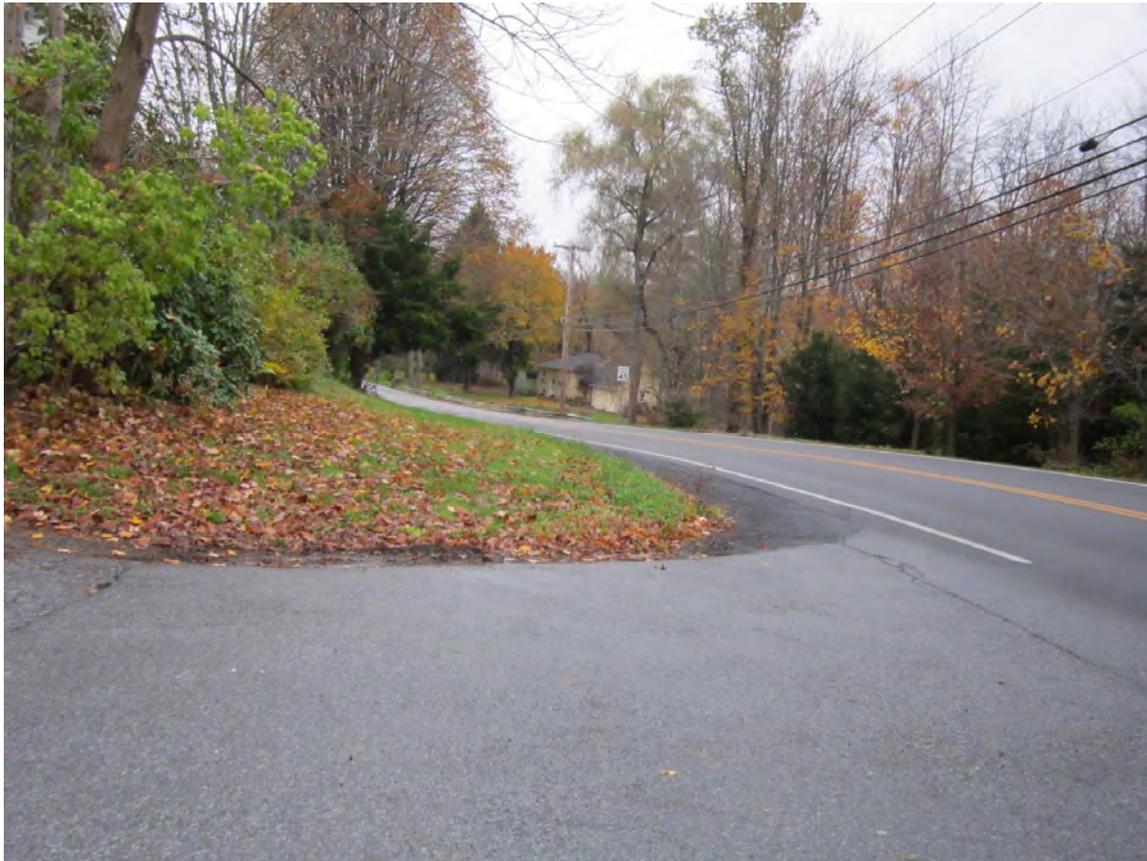
The SA Team noted a private, temporary sign, placed on the roadside embankment, further restricted sight distance.

Exhibit 20: Sight line to the north from eastbound Baker Road at stop line.

Risk Analysis: A lack of adequate intersection sight distance increases the risk of a collision by affecting the driver's ability to accurately judge and accept gaps in approaching traffic. Operating speeds on Beekman Road increase the probability of a severe collision.

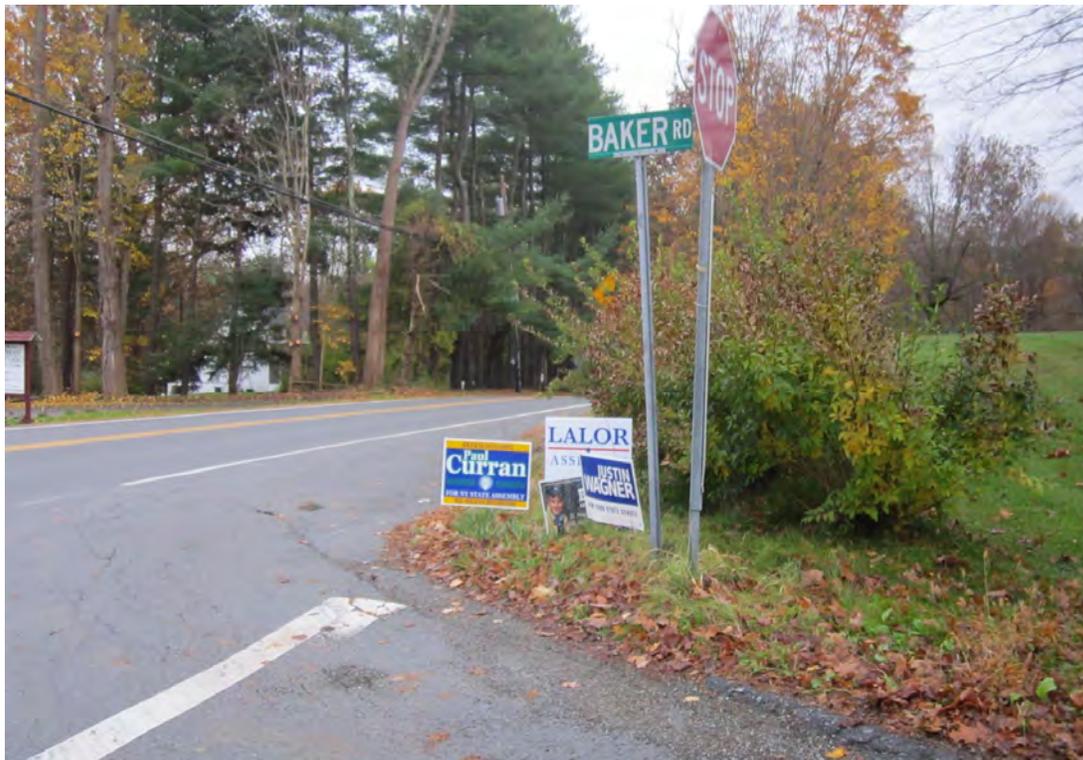
Observations: Eastbound motorists stopped on Baker Road have their sight lines blocked by a row of shrubs in the southwest quadrant. Vehicles must pull out beyond the stop line in order to see traffic approaching from the south.

Exhibit 21: Sight line to the south from eastbound Baker Road at stop line.

Risk Analysis: A lack of adequate intersection sight distance increases the risk of a collision by affecting the driver's ability to accurately judge and accept gaps in approaching traffic. Operating speeds on Beekman Road increase the probability of a severe collision.

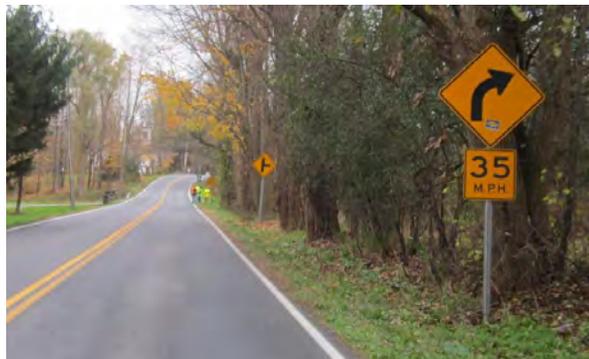
Observations: The southbound approach to the Baker Road intersection has three warning signs in series. They include a curve warning (W1-2) with supplementary speed panel (W13-1P), intersection warning (W2-2), and a LIMITED SIGHT DISTANCE warning sign. These three signs can overload drivers on Beekman Road. Given the proximity of these three signs, the most important message for approaching drivers may be lost.

Exhibit 23: Illustration of existing warning signs on southbound approach.

Several of these signs were blocked by adjacent vegetation. In addition, the LIMITED SIGHT DISTANCE warning sign is no longer an acceptable message by MUTCD standards.

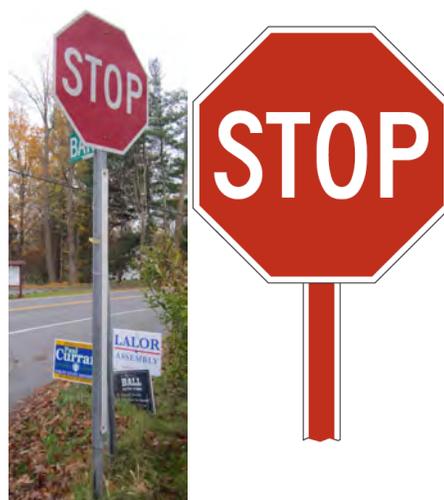
Risk Analysis: Retroreflective strips with an incorrect color do not send a consistent message to drivers and thus reduce their overall effectiveness. The SA Team also

Exhibit 24: Existing retroreflective strip and example of correct retroreflective strip on STOP sign.

noted that the proliferation of these devices could cause them to lose their effectiveness.

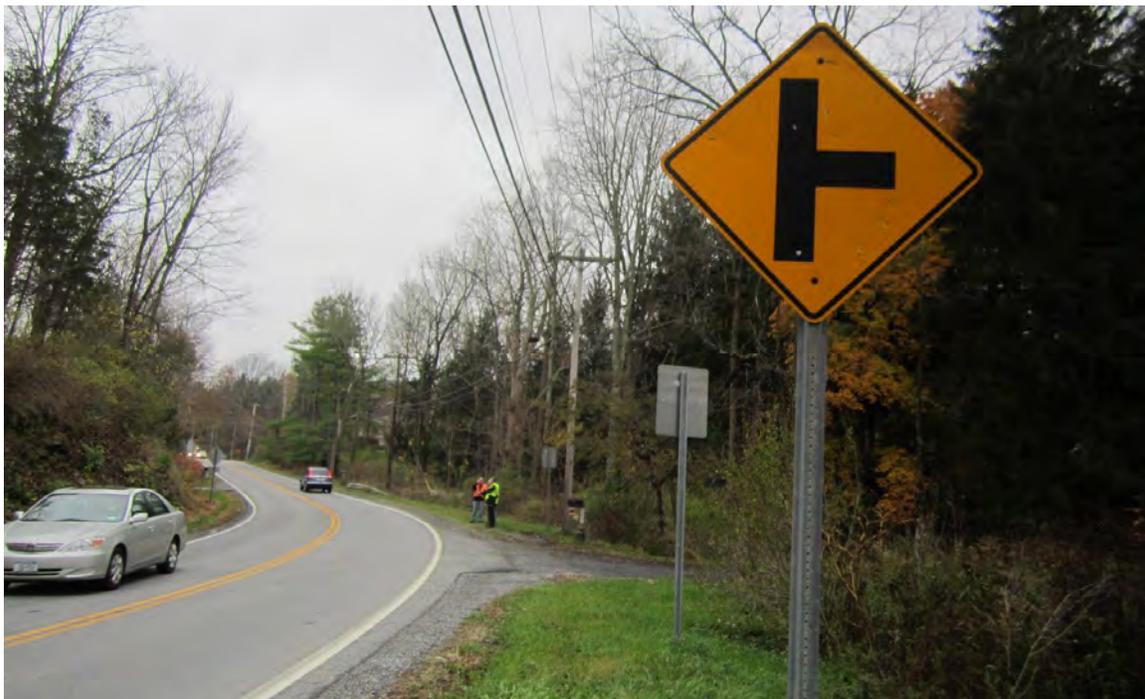
Risk Analysis: The position of the existing warning sign may take a driver's attention away from the more pertinent task of negotiating the reverse curves, leading to a roadway departure incident. As previously noted, the consequences of a roadway departure could be serious given the generally unforgiving roadside environment. Alternatively, the sign might be missed or forgotten by the time a driver reaches Walker Road. In the latter case, the sign does not provide useful, timely information. In the former, missing the sign elevates the probability of a rear-end or right-angle collision at the intersection.

Exhibit 25: Illustration of intersection warning sign within reverse curves.

Suggestions: *Remove and/or relocate intersection warning sign. The warning sign could be removed if a study indicates there is sufficient visibility and sight distance available upon approach (in accordance with Section 2C.05 and 2C.46 of the National MUTCD as amended by the New York State Supplement) after exiting the reverse curves. If the warning sign is warranted, it should be repositioned, balancing the recommended advance placement distance for the posted speed limit with its relationship to the reverse curves.*

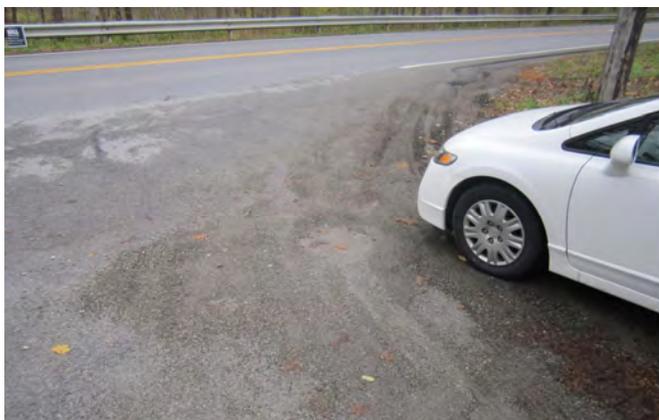
Observations: There is an accumulation of loose gravel and stone on the approach to Beekman Road. The location corresponds to where vehicles stop and start on Walker Road as they enter Beekman Road. It appears that runoff from Walker Road is eroding the shoulders and ditches, depositing gravel on the pavement just before Beekman Road.

Exhibit 26: Illustration of gravel within intersection.

Risk Analysis: Loose stone and gravel may cause low traction when entering and exiting an intersection. Vehicles could slide into Beekman Road. Additionally, startup time could be increased, consuming valuable gap time as a driver tries to complete a left or right turn. This result could be a high speed, severe collision. However, the overall exposure is low due to relatively low volumes on Walker Road.

1. ***Remove Loose Gravel Within Intersection.***

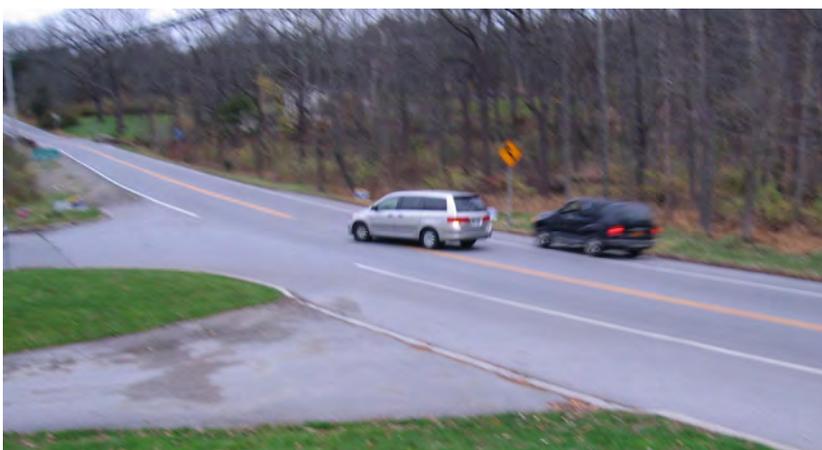
Lastly, the SA Team observed a number of vehicles traveling between Recreation Road and the Stop & Shop during the evening peak. Many vehicles entered Beekman Road from Stop & Shop and then quickly turned left onto Recreation Road.

Exhibit 27: Illustration of vehicles using the existing shoulder to bypass left turning vehicles.

The frequency of these movements likely contributes to the rear-end collision pattern as drivers on Beekman Road, coming from NYS Route 55, are surprised by the starts and stops.

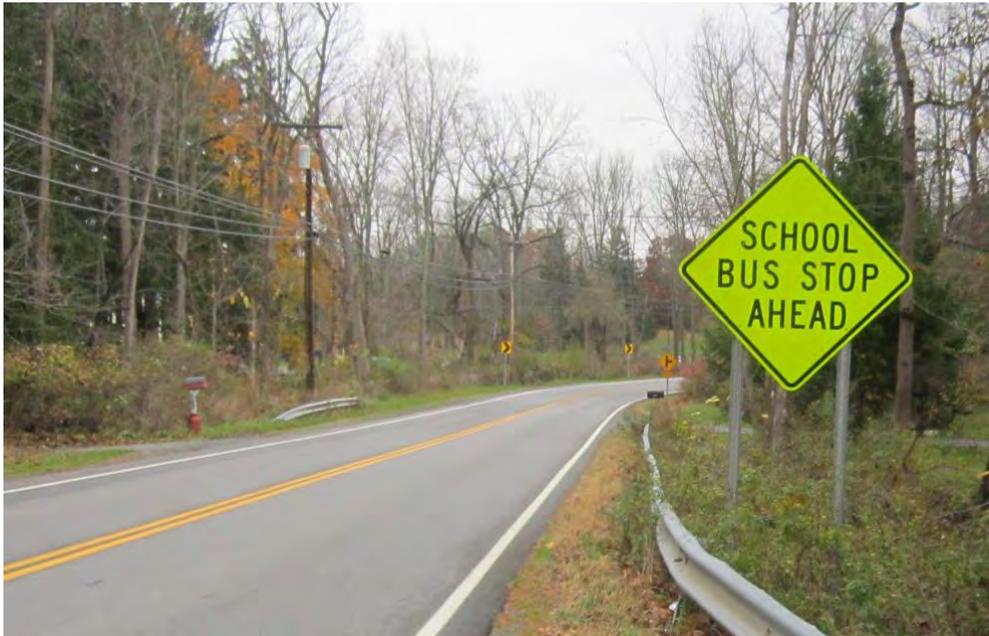
The SA Team felt that the risk of a severe crash was greatest within this segment of the corridor as compared to any other location. It was agreed to be the portion of Beekman Road most deserving of attention. The SA Team recommends that the Dutchess County DPW strive to implement suggested improvements incrementally, installing those it believes have the best potential to improve safety and reduce the frequency of crashes, and then adding other improvements if/as needed. This would allow for an understanding of which changes are most effective and would divide the overall treatment into manageable packages. This approach would also reserve options for future treatment should the first package of changes not be as effective as initially hoped.

Exhibit 31: Illustration of warning sign dominance in the northbound direction.

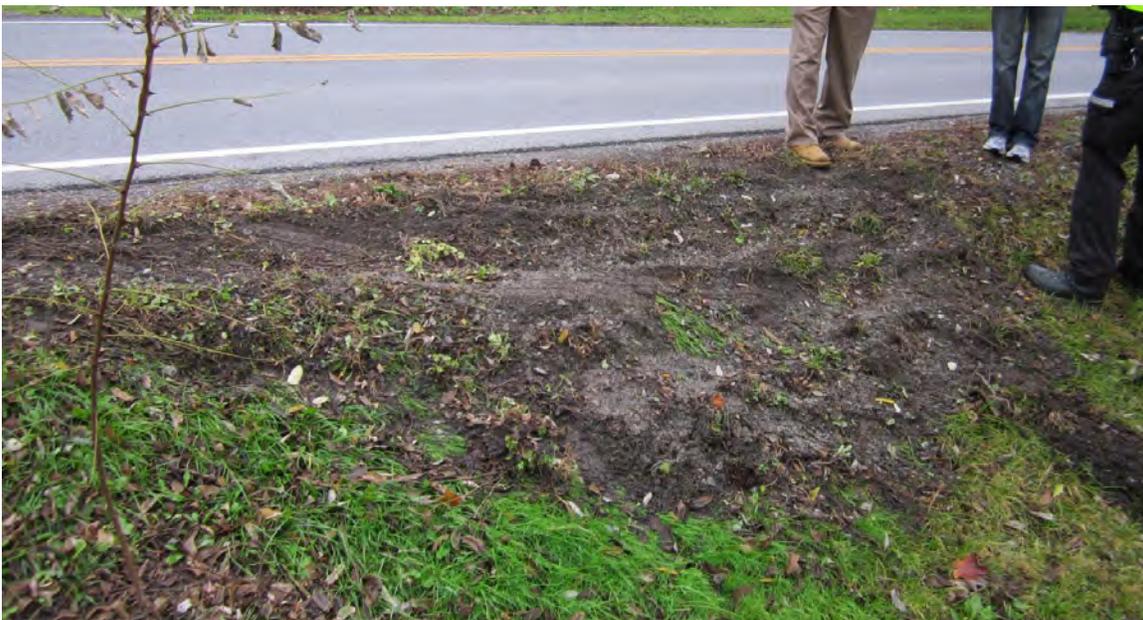
Exhibit 32: Illustration of evidence from a recent roadway departure collision.

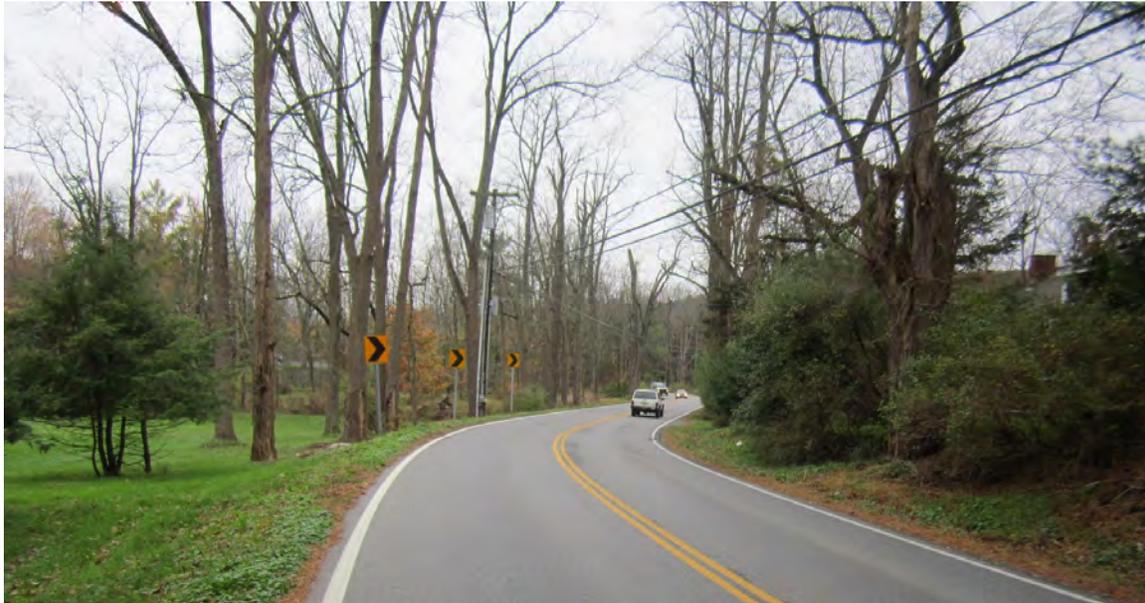
Exhibit 33: Illustration of southbound chevron signing, tight geometry, and numerous roadside elements.
