# Beacon-Hopewell Rail Trail Study

## Existing Conditions Report

DUTCHESS COUNTY  
TRANSPORTATION COUNCIL

October  
2024

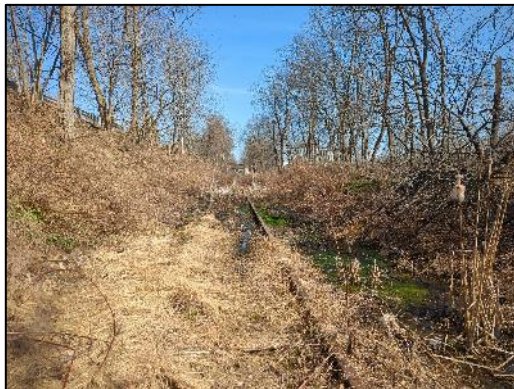
**Ballast Condition 1 (Poor)** – 416 feet (1%) within corridor. Exhibits high fines (small rock fragments) content, silt or sediment, or no or minimally visible ballast stone. Sediment within the ballast is saturated. Heavy vegetation overgrowth. Ballast may no longer support foot traffic.

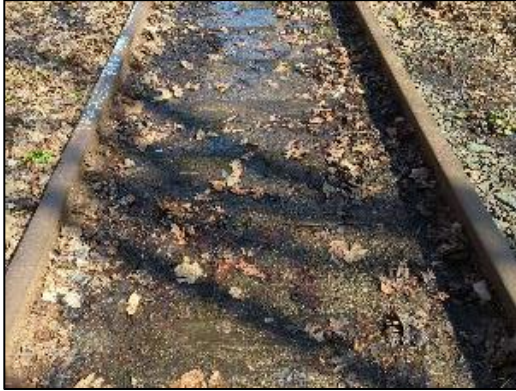
Ballast Condition 2 – 2,831 feet (5%) within corridor. Exhibits fines content, silt or sediment within the ballast stone. Ballast stone is visible. Sediment within the ballast may be saturated. Some vegetation growth. Ballast is firm underfoot.

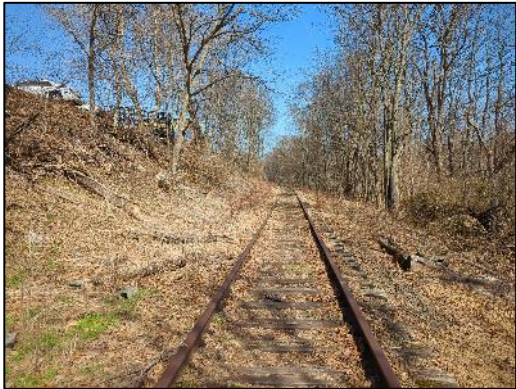
Ballast Condition 3 – 11,462 feet (18%) within corridor. Exhibits minor fines or organic content within the ballast stone. Ballast stone is mostly visible, no saturation within the ballast. Minor vegetation growth within or at the edge of ballast.

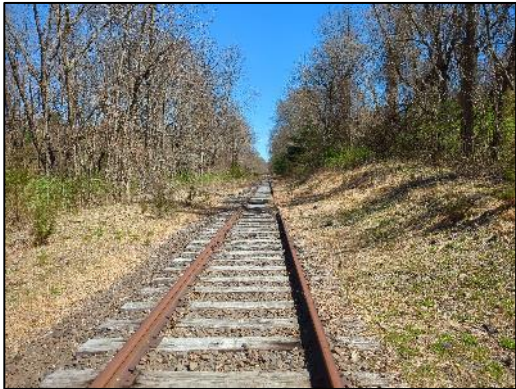
Ballast Condition 4 – 24,330 feet (39%) within corridor. Exhibits no fines or organic content within the ballast stone. Ballast stone is highly visible. Minor vegetation growth encroachment at the edge of ballast.

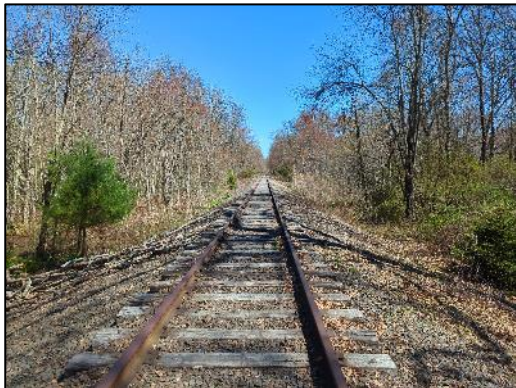
Ballast Condition 5 (Excellent) – 23,491 feet (37%) within corridor. Ballast stone is highly visible with no fines or organic content, no vegetation growth, or encroachment at the edge of ballast.

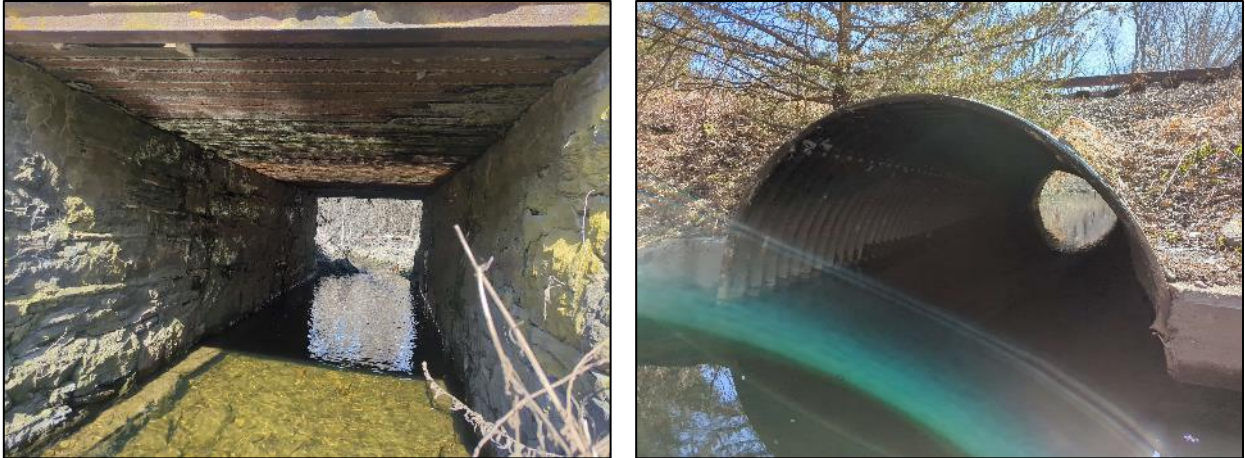
For six of the stacked stone culverts, the top slabs appear to be made of railroad ties laid side by side across the culvert's walls. Some of other stone culverts had large stone top slabs spanning the full width of the structure. These top slabs should be further investigated during the design phase of any potential trail, particularly if the rail-to-trail option is selected, to ensure they can support a trail and withstand construction; replacements may be needed.

**Figure 3: Stacked stone culvert with steel railroad rail top slab (left) and inlet of 9-foot-wide corrugated steel three-sided arch structure (right).**

Some of the large culverts exhibited evidence of large volume flows and erosion or overtopping. A hydraulic analysis of each culvert should be performed during the design phase of any potential trail to determine if the culvert should be replaced to improve its hydraulic capacity and future resilience. Almost the entire railroad corridor is constructed on the north side of the Fishkill Creek. An undersized culvert or blocked culvert could cause a significant buildup of stormwater and severe erosion or property damage to structures along the corridor.

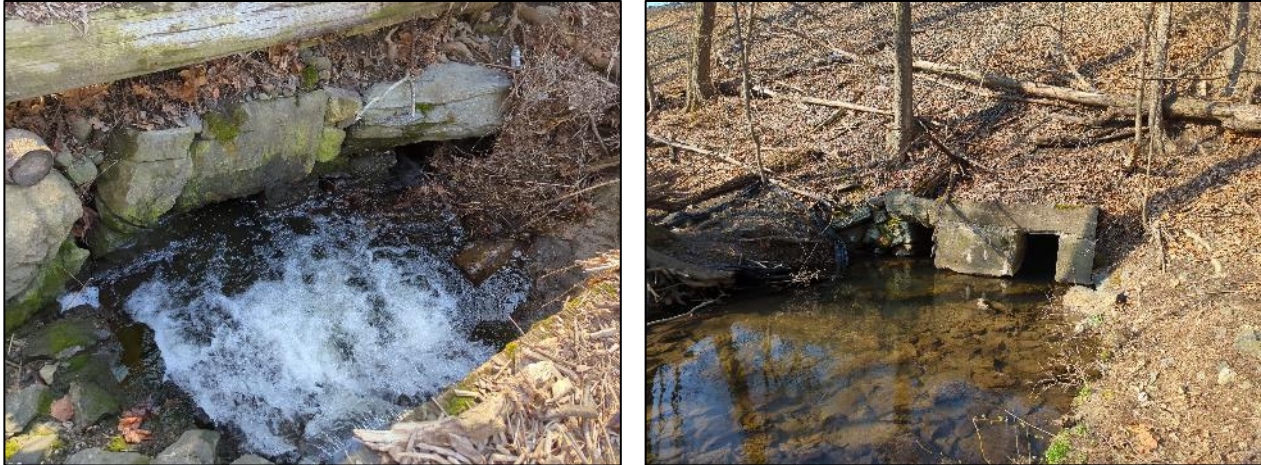
One large, stacked stone culvert located about midway between Fishkill Ave (Route 52) and Bridge #3 (Fishkill Creek) should be rehabilitated or replaced. This culvert is a side-by-side (double barrel) system constructed of stacked stone and mortar culverts with both originally measuring 3x2 feet at the outlet. The inlet side is almost completely blocked with wood debris and sediment that appear to severely restrict the flow of water into the pipes (see Figure 4). Evidence of water backing up and pooling at the inlet of the culvert was found, as were erosion and floatable wooden debris noticed above the inlet to the culvert. Rehabilitation to improve water flow through this culvert could be feasible by cleaning the debris at the inlet to restore the hydraulic opening. The interior of this culvert is stacked stone, which is a rough surface and slows water as it flows through the culvert. Lining the culvert with a smooth interior pipe would reduce the hydraulic opening but would increase the velocity of the water through the culvert.

**Figure 4: Blocked inlet of double barrel stone culvert surrounded by wooden debris (left) and outlet of double barrel stone culvert flowing under railroad (right).**

A hydraulic analysis should be performed to determine the appropriate rehabilitation method during the design phase of any potential trail. Replacing the culvert would be the best approach to improve stormwater flow and provide future resilience. However, the culvert is approximately 25 feet below the grade of the railroad and would require a significant amount of earthwork to replace.

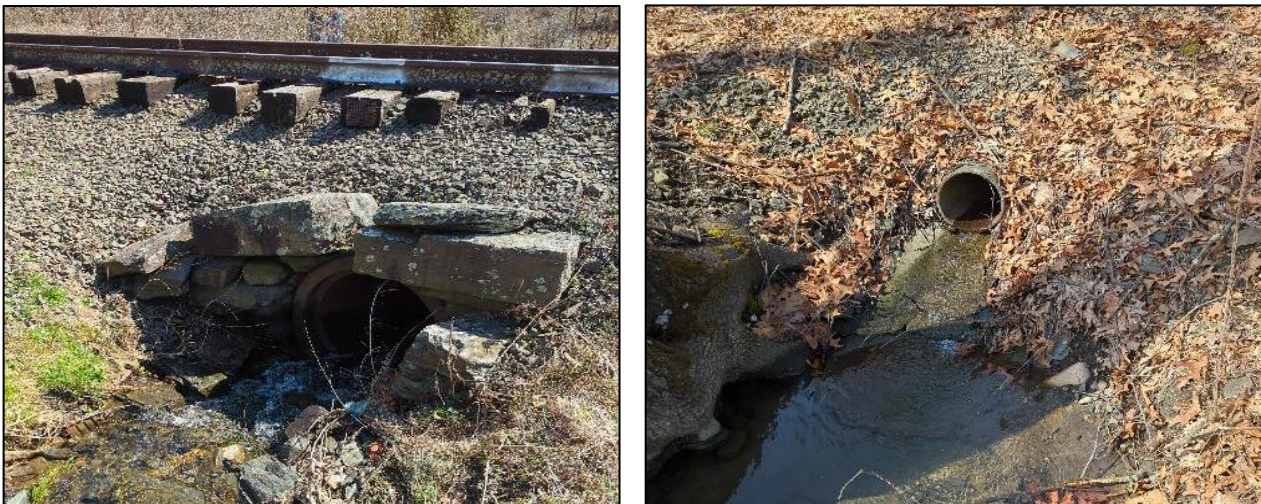
**Figure 5: Small smooth steel culvert pipes representative of those found throughout the corridor.**

The nine small culvert pipes found along the railroad corridor vary in diameter from 12 to 36 inches and are made of reinforced concrete, round plate steel, corrugated steel, or High-Density Polyethylene (HDPE) (see Figure 5). Most of these pipes are in good condition and appear to be functioning properly. However, some show signs of erosion at the inlet or outlet and should be rehabilitated with stone aprons to reduce water velocity and prevent further erosion.

The headwalls at the end of these small culverts, which provide erosion protection, are primarily made of stacked stone and are in fair condition (headwalls are concrete or masonry walls, typically built at the inlet or outlet of a drainpipe or culvert, essentially acting as a retaining wall to protect against erosion and direct water flow properly). The headwalls should be re-stacked or replaced (see Appendix B). Some culvert pipes were noticeably undersized or partially blocked by debris and

should be replaced with larger pipes. Replacement of the failed or undersized pipes with larger, more durable HDPE pipes would ensure a long lasting, functional drainage system. A hydraulic analysis of each culvert pipe to be replaced should be performed during the design phase of any potential trail to determine the appropriate size for the new pipes, considering changes in drainage patterns and rainfall since the original installation.

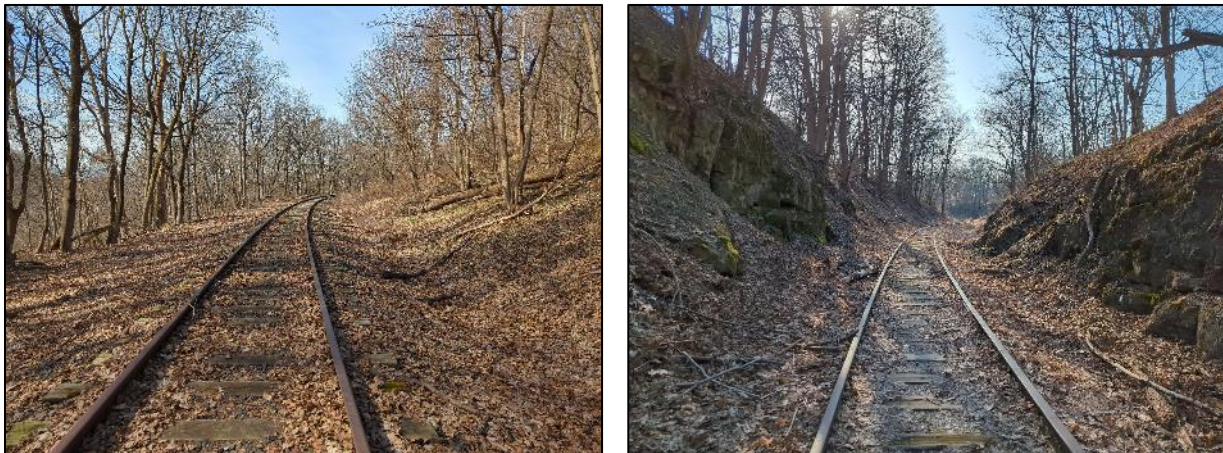
**Figure 6: Defined swale on the right side of the tracks (left photo) and both sides of the tracks (right photo) with no visible signs of drainage flows.**

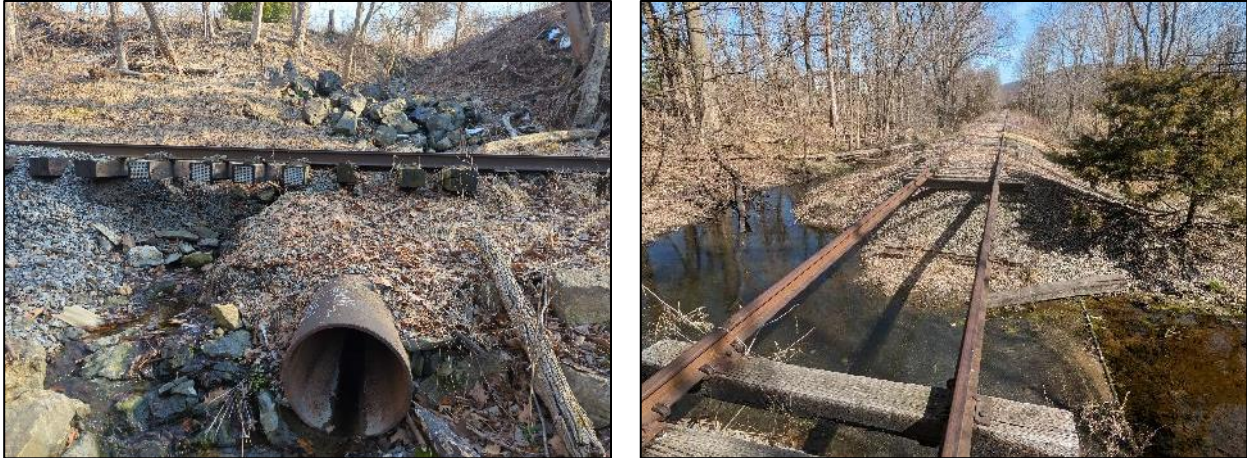
Two moderate sized washouts were found within the corridor (see Figure 7). Both appear to be caused by drainage flows that originated outside of the railroad corridor. The source of the flow that caused the washouts should be further investigated during the design phase and either mitigated at the source or accommodated in a repair. In areas where the washout occurs in an active drainage channel, or within a clear seasonal drainage channel, a culvert pipe or box culvert should be installed to convey any future drainage flows that may re-enter the corridor.

**Figure 7: Washout 0.25 miles west of Washington Ave (left) and large washout 0.20 miles east of Route 9 (right).**

The left photo of Figure 7 was taken just west of the Washington Ave crossing in the Town of Fishkill, where it appears that a series of storm events have washed out the culvert several times. There is evidence of repairs being performed here, such as newer railroad ties attached to the steel rails and smaller ballast stone under two inches in diameter that does not match the rest of the stone along the corridor. There is a large drainage channel or ravine upstream of the washout that appears to originate from houses on Washington Ave. The existing 24-inch diameter steel culvert could have become blocked, or the drainage flows could have exceeded the capacity of the culvert and overtopped the railroad tracks.

The photo on the right of Figure 7 shows a large washout approximately 20 feet in length measured along the tracks. This washout also appears to have been repaired in the past. The active stream that runs parallel and then across the corridor appears to originate at the housing development at Vandidoort Dr in the Village of Fishkill. It is possible that changes to the housing development resulted in this washout.

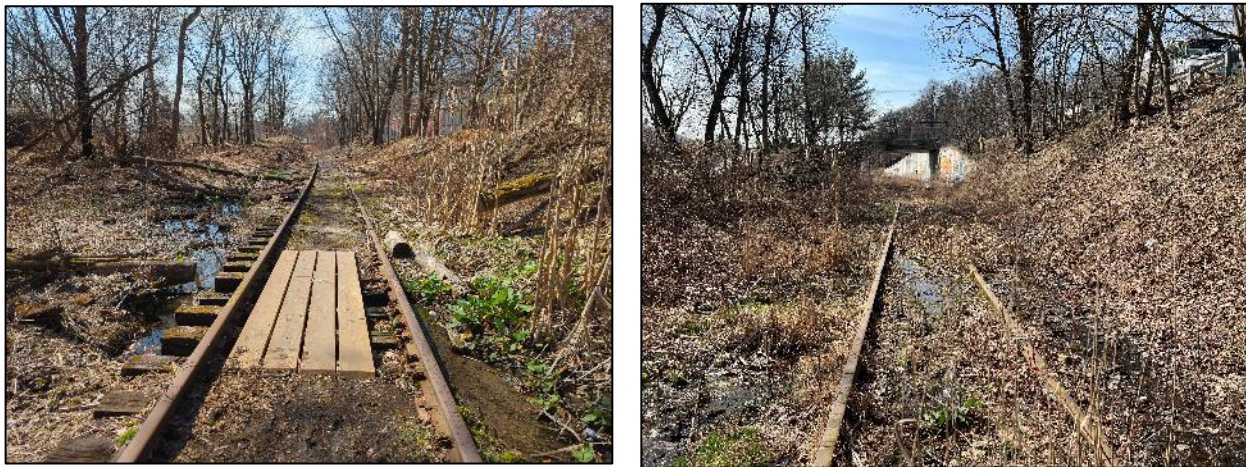
Figure 8 (left photo) shows an uncontrolled stream crossing running perpendicular to the railroad rails, where a drainage outlet from an adjacent developed property is discharged into the railroad corridor in Beacon. The water flows across the railroad tracks and then flows west parallel to the rails toward Main St. Sediment observed between the railroad ties had filled in the voids in the ballast in this section. Evidence of past drainage flows adjacent to and within the railroad rails was also observed downstream of this drainage outlet.

Figure 8 (right photo) shows a similar situation where stormwater runoff from Tioronda Ave in Beacon has been discharged and collected along the railroad corridor. The stormwater in this area does not seem to flow as well and has formed a potential wetland within the tracks. A wetland delineation should be performed during the preliminary design phase of any future trail to determine if a USACE or NYSDEC permit is needed for construction. These were the only two locations within the corridor where stormwater flows were observed within the railroad tracks and had caused the subgrade of the tracks to become saturated.

**Figure 8: Uncontrolled stream crossing 500 feet east of Main Street (left) and possible wetland area 300 feet east of the Route 9D (Wolcott Ave) overpass.**

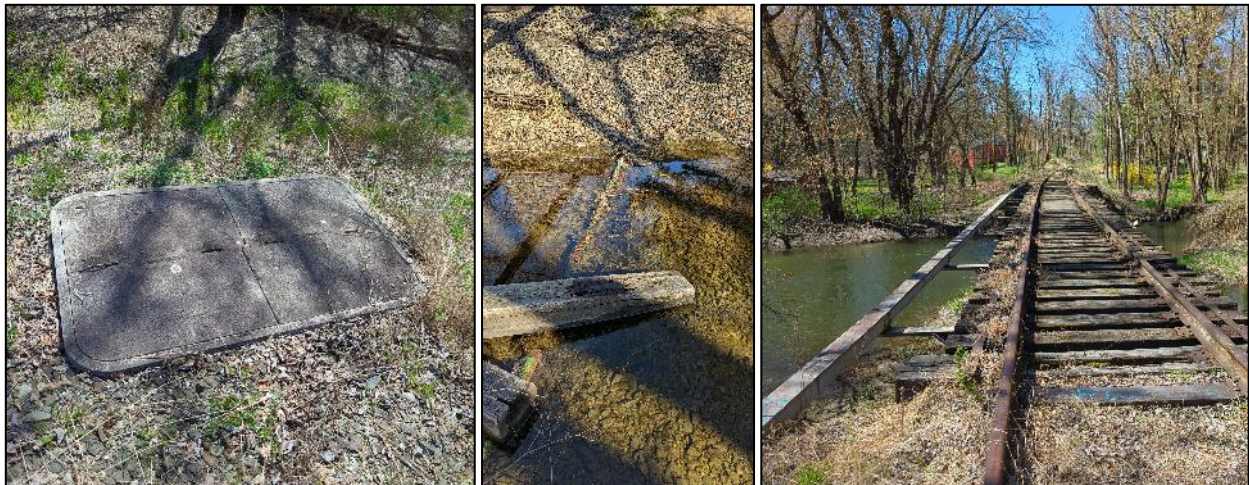
A buried utility conduit runs parallel to the railroad tracks for the entire length of the study corridor. Mostly buried, it was observed in locations where the ballast had been washed out. Across the six bridge structures and some of the large culverts, the conduit is carried within a protected casing along the surface of the ballast. Several large plastic pullboxes were also observed adjacent to the railroad tracks throughout the corridor with “MNR Communication” printed on the cover. Additionally, concrete posts, which are assumed to be related to the

**Figure 11: Metro-North fiber optic pullbox (left), exposed fiber-optic conduit from a washout (middle), and conduit hanger on Bridge #5 (right).**

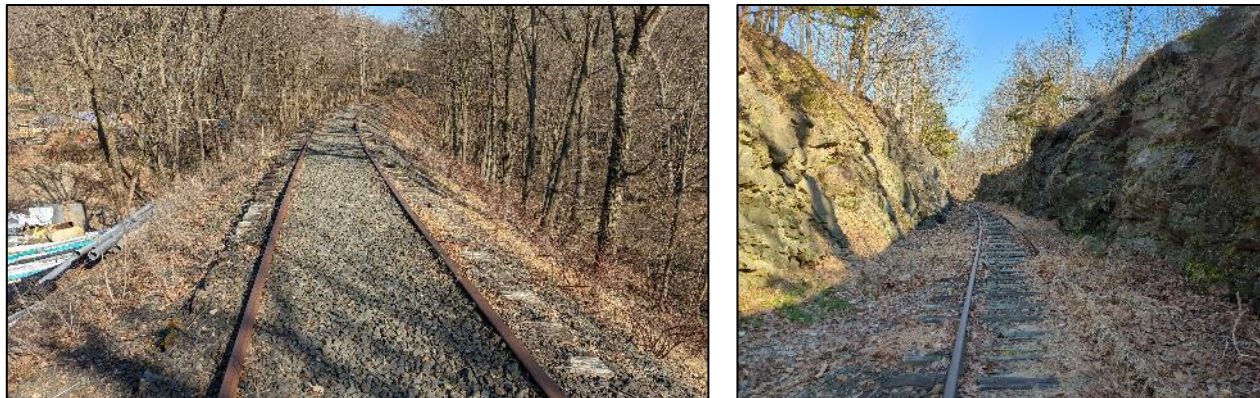
In some locations, the slopes (embankments) supporting the tracks are very steep on both sides of the corridor (constructed at 1.5 Feet Horizontal:1 Foot Vertical or 66% slope) (see Figure 13). Based on the field assessment, there are also 7.2 miles of steep fill slopes (50% or greater)

**Figure 13: Steep fill slopes and a narrow railroad corridor (left) and rock cut and narrow railroad corridor (right).**

adjacent to the railroad tracks -- these slope downward from the tracks. No notable slope failures were found within the railroad corridor, only relatively small washouts caused by meandering streams or failed culverts (see the Washouts section for a description of the washouts).

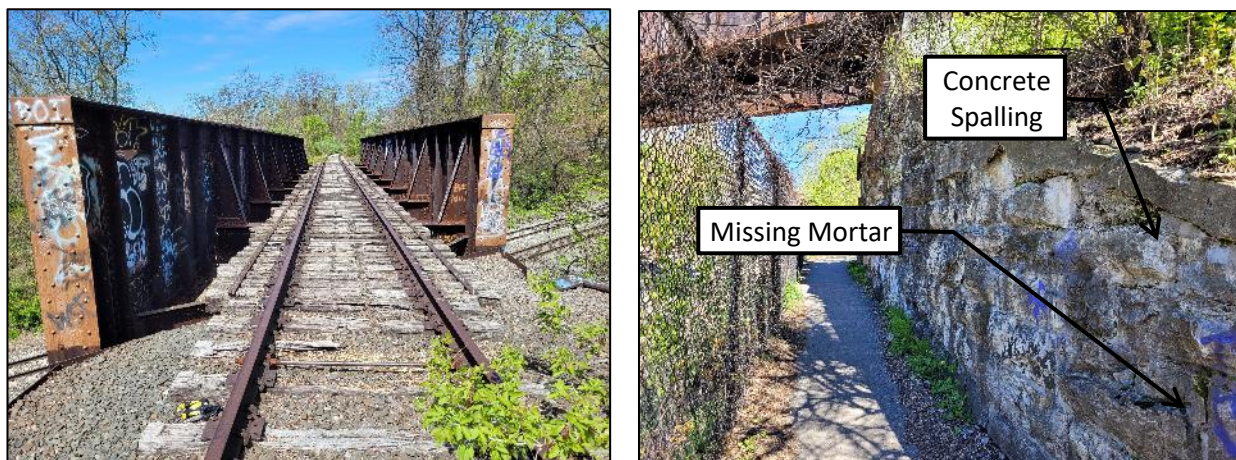
This bridge was constructed at an unknown date and carries the inactive Beacon Line over the active Hudson Line in the City of Beacon. The structure consists of a 107-foot, single span through girder bridge with stone masonry abutments and steel sheet pile wingwalls installed behind the original stone masonry wingwalls (see Figure 20). The deck consists of timber rail ties and steel rail tracks. The total out-to-out width of the bridge (distance from the outermost points of the superstructure) is 20 feet. At both through girders, various locations exhibit moderate to heavy corrosion and section loss. The girder web stiffeners exhibit up to 100% section loss at their base.

There is a large amount of railroad ballast covering the bridge seat and obstructing the view of the bearings at both abutments. There is moderate deterioration to the mortar between the stone masonry blocks at both abutments. The west abutment has spalling up to 6” deep along the concrete cap of the stone abutment stem. The wingwalls at both abutments have moderate horizontal cracking and exhibit areas of spalling up to 6” deep, most notably at the top of the northwest and southeast wingwalls.

The bridge was given an overall Condition Score of 11/100 and a Load Score of 99/100 in the 2023 Metro-North Bridge Inspection. The 2012 Metro-North Rating indicates a rating of E-85.

**Figure 20: Bridge No. 1 through girder superstructure (left) and stone masonry substructures (right).**

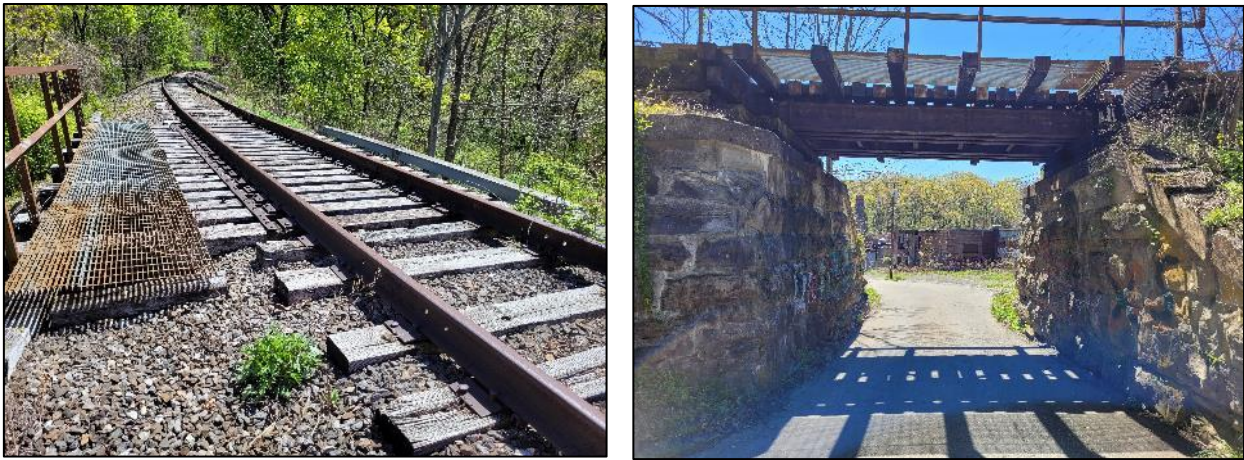
This bridge was constructed at an unknown date and carries the Beacon Line over South Ave in Beacon (see Figures 21 and 22). The structure consists of stone masonry abutments and wingwalls with a 19'-6" simple span steel multi-girder superstructure carrying an open deck of timber rail ties and steel rail tracks. There is a steel open grate walkway carried on the north side of the bridge. At both abutments, the girders bear on stacked timber ties that sit on the concrete bridge seat. The clear span between the masonry abutments is 14'-6" with a 12-foot minimum vertical clearance between the roadway and the low beam. The total out-to-out superstructure width is approximately 12 feet. There are brackets mounted on the south fascia girder supporting a utility conduit being carried over the bridge.

**Figure 21: Bridge No. 2 superstructure (left) and stone masonry substructures (right).**

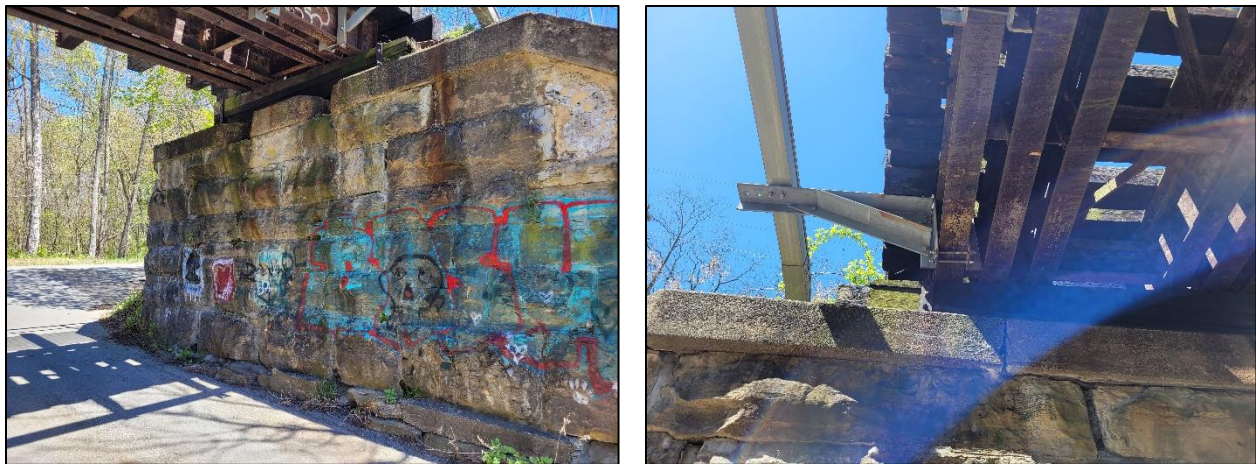
**Figure 22: Bridge No. 2 concrete spalling at abutment (left) and rotated fascia girder due to utility hanger (right).**

The girders appear to be in good condition; however, the south fascia girder appears to be rotating outward due to the load from the utility conduit and hanger brackets. The west abutment backwall and bridge seat have full height cracks, up to 1" and ½", respectively. The north side of

the west abutment backwall is displaced up to 1". The east abutment bridge seat has two spalls, 2 square feet each, beneath the girders. Both the east and west abutment bridge stems have isolated areas of mortar loss between the stone masonry blocks. The northeast and southeast wingwalls have areas of spalling along the concrete cap up to 1' and 4" deep, respectively. Along the north side of the tracks at both approaches, there are timber retaining walls supporting the tracks and ballast. At the northwest approach, the wall is failing and is leaning outward.

The bridge was given an overall Condition Score of 62/100 and a Load Score of 90/100 in the 2023 MNR Bridge Inspection. The 2012 MNR Load Rating indicates a rating of E-64.

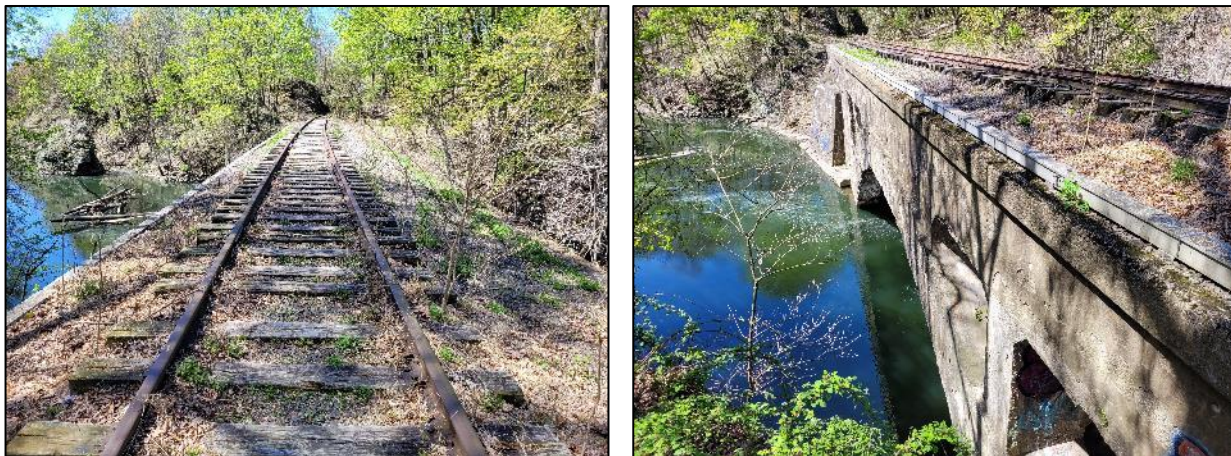
This structure was constructed at an unknown date and carries the Beacon Line over Fishkill Creek in the Town of Fishkill (see Figures 23 and 24). The structure consists of a 78-foot single span concrete spandrel arch with concrete abutments and wingwalls. The total structure length is approximately 171 feet with an out-to-out superstructure width of approximately 22 feet. The superstructure consists of a concrete slab topped with railway ballast, timber rail ties and steel rail tracks. A utility conduit is carried on the south edge of the bridge deck. The underside of the bridge was inaccessible during the field visit due to the steep terrain along the banks of the Fishkill Creek. The existing conditions of the concrete arch are based on previous inspections, as indicated in the 2023 Metro-North Bridge Inspection Report.

**Figure 23: Bridge No. 3 superstructure (left) and concrete spandrel arch substructures (right).**

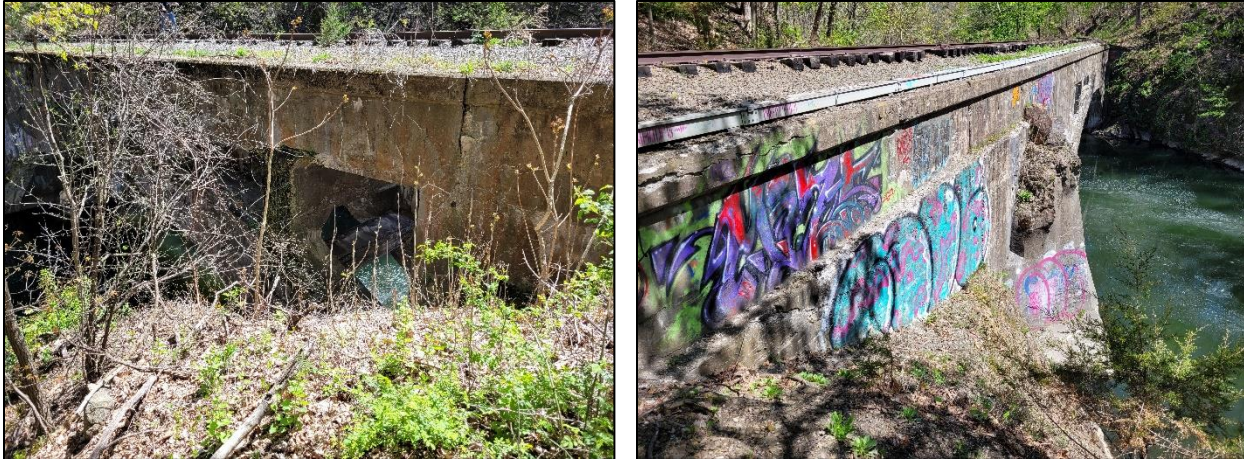
There are scattered cracks with heavy efflorescence throughout the underside of the deck and along the spandrel walls. The north and south deck fascia have areas of hairline cracking and efflorescence. Efflorescence is the migration of water, salts, and minerals from inside the concrete to the surface of the concrete. Efflorescence is not a structural defect, but it does signify there are cracks in the concrete. The bottom of the deck along the north edge is spalled for several feet above a column near the west abutment. The south fascia has several shallow spalls up to six square feet around mid-span.

**Figure 24: Bridge No. 3 north spandrel wall cracking and efflorescence (left) and south spandrel wall cracking (right).**

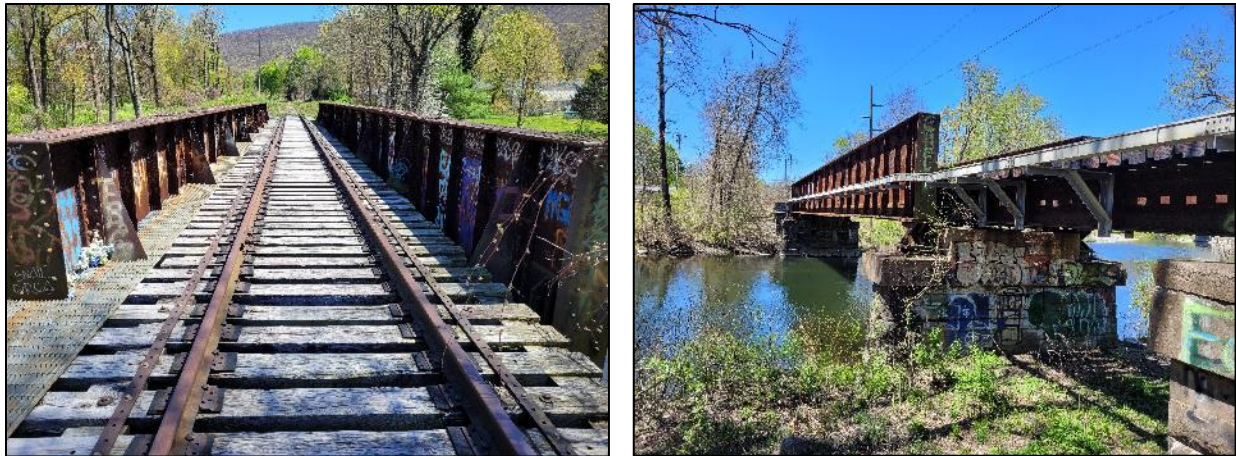
The west abutment bearings exhibit moderate to heavy corrosion and minor section loss on the anchor bolts. There are isolated areas of small spalls and medium sized cracks on the west abutment bridge seats.

**Figure 25: Bridge No. 4 superstructure (left) and concrete spandrel arch substructures (right).**

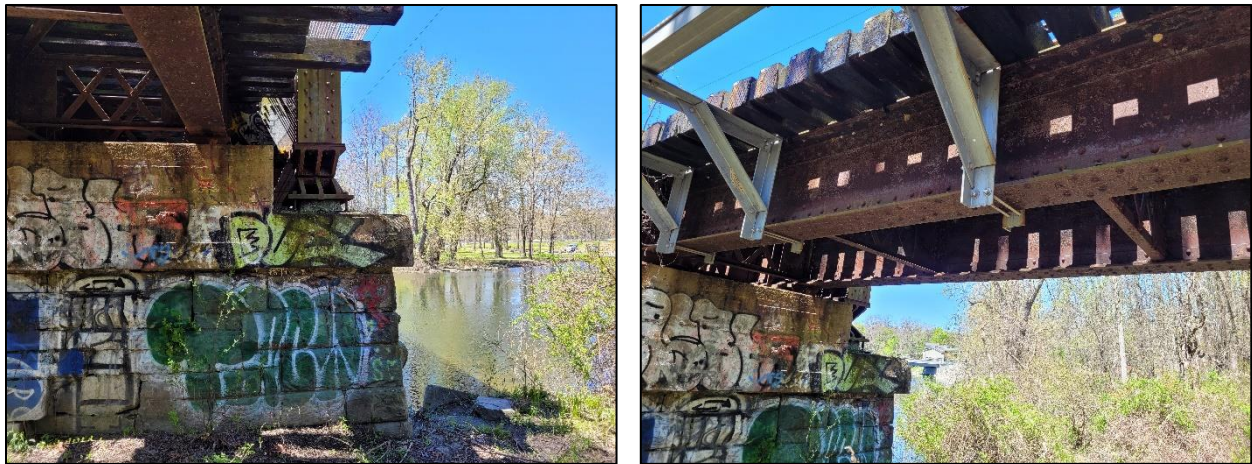
**Figure 26: Bridge No. 4 pier 2 rotated stones (left) and surface corrosion at steel girders (right).**

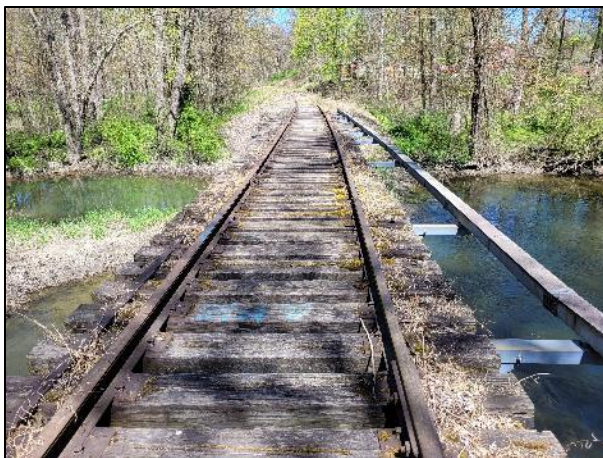
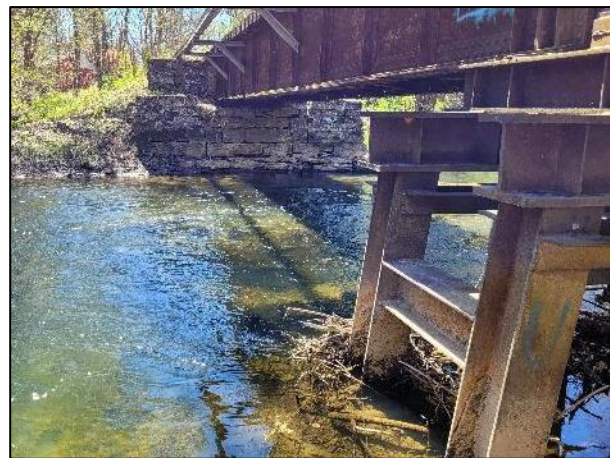
There is a buildup of debris on the west abutment seat which obstructs the view of the bearings. The exterior anchor bolts are tilted or bent at the east abutment, and the east abutment bearings exhibit minor corrosion throughout. The bridge seat stones at the top of the west abutment are undermined up to 1.5 feet deep due to missing mortar. The lower section of the pile bent pier exhibits heavy to severe delaminating corrosion, pitting, and section loss. There is an accumulation of branches and debris at the base of the pier.

**Figure 27: Bridge No. 5 superstructure (left) and stone masonry abutment and pile bent substructures (right).**

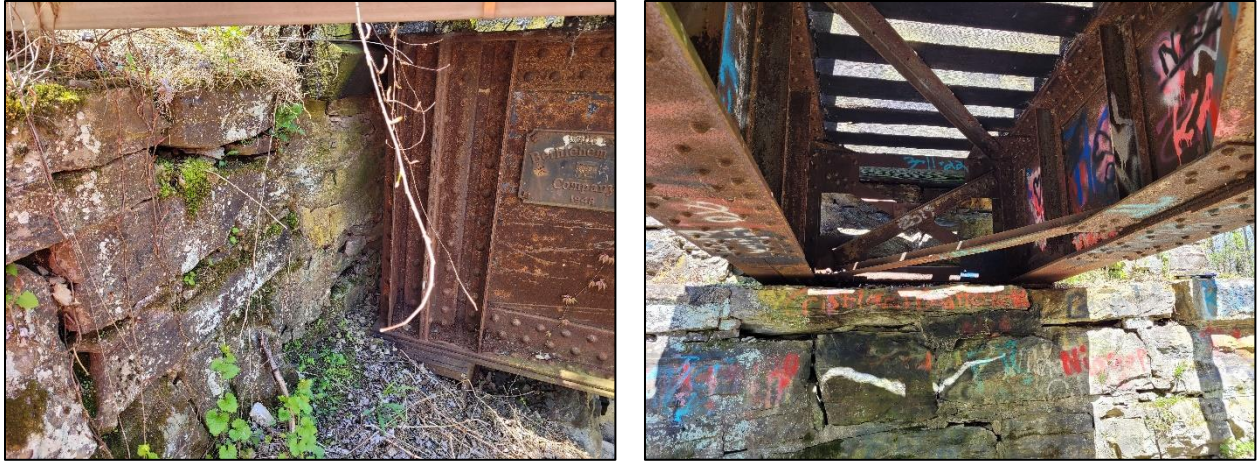
**Figure 28: Bridge No. 5 west abutment backwall – missing mortar (left) and east abutment stem – missing mortar (right).**

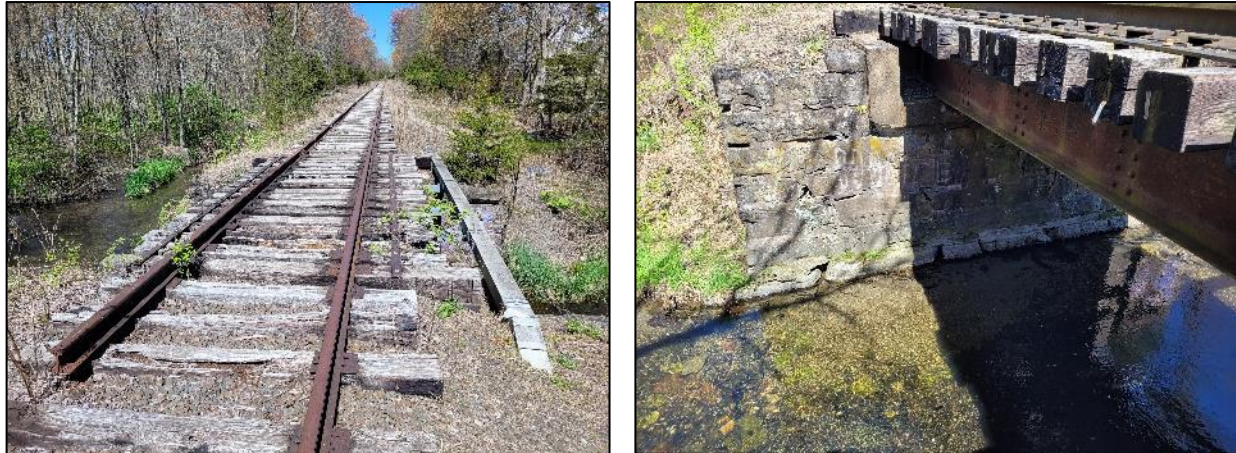
The bridge was given an overall Condition Score of 43/100 and a Load Score of 86/100 in the 2023 Metro-North Bridge Inspection. The 2012 Metro-North Load Rating indicates a rating of E-61.

**Figure 29: Bridge No. 6 superstructure (left) and substructure (abutment and wingwall) (right).**

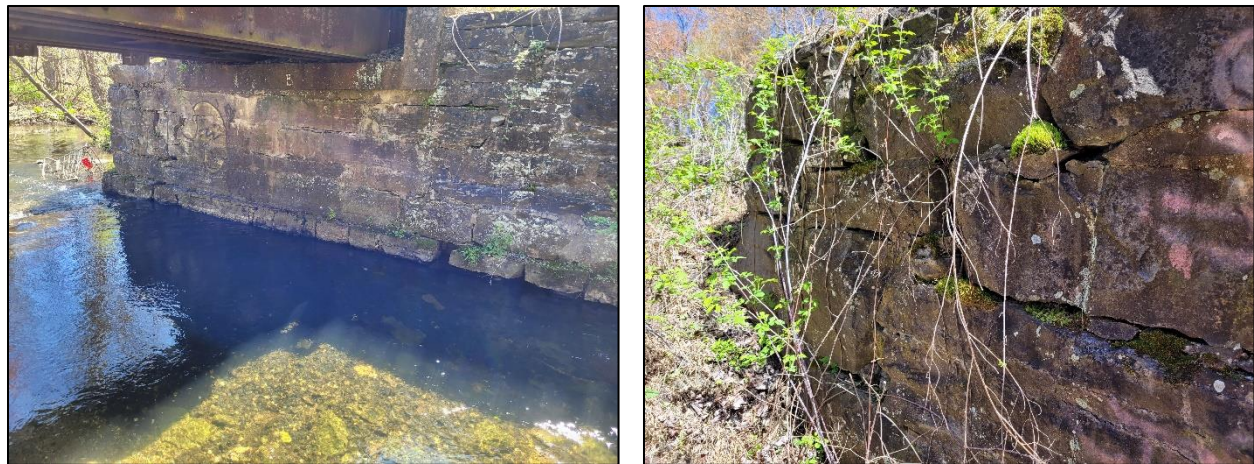
no undermining elsewhere along the abutment. There are scattered voids elsewhere throughout the each of the wingwalls, up to one foot deep due to missing mortar.

**Figure 30: Bridge No. 6 west abutment – void in footing stone (left) and east abutment – missing mortar (right).**

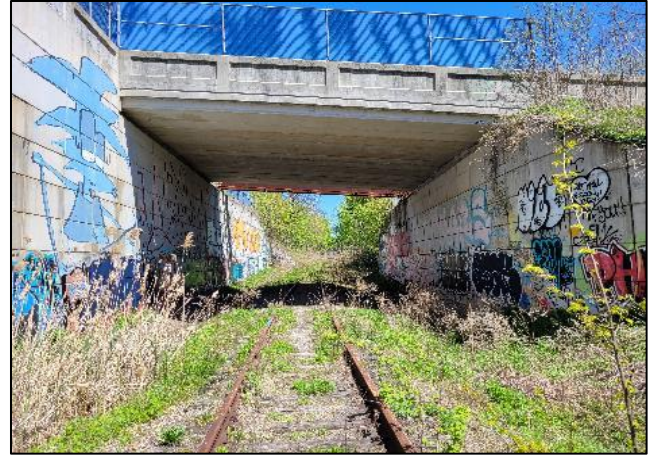
Figure 31: Overpass No. 1.

This overpass (BIN 1006350) carries Wolcott Ave (NYS Route 9D) over the Beacon Line in Beacon (see Figure 31). The structure was reconstructed in 1998 and appears to be in good condition. It is owned and maintained by the City of Beacon. The vertical clearance between the tracks and the low chord of the bridge is more than 15 feet. The clear span between abutments is approximately 37 feet.

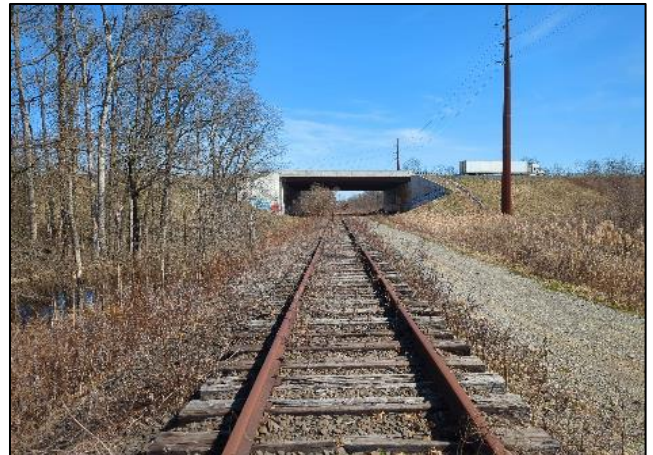
Figure 32: Overpass No. 2.

This overpass (BIN 1032480) carries I-84 over the Beacon Line in the Town of Fishkill (see Figure 32). The structure was reconstructed in 2018 and appears to be in excellent condition. It is owned and maintained by NYSDOT. The vertical clearance between the tracks and the low chord of the bridge is at least 15 feet. The clear span between abutments is approximately 80 feet.

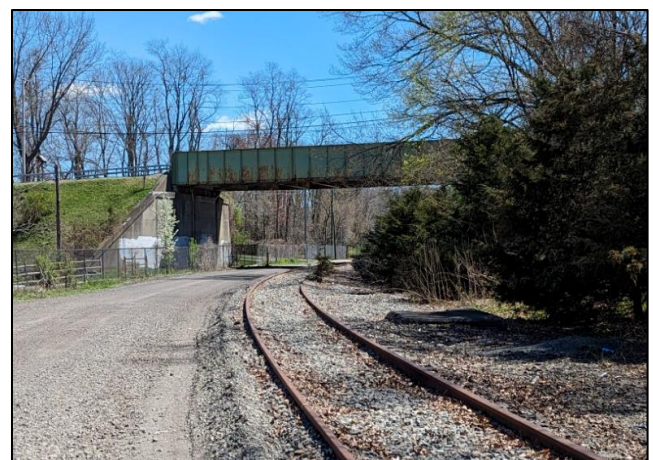
Figure 33: Overpass No. 3.

This overpass (BIN 1032300) carries NYS Route 82 over the Beacon Line in East Fishkill (see Figure 33). The structure was constructed in 1936. The superstructure is in poor condition with visible deterioration. The abutments appear to be in fair condition. It is owned and maintained by NYSDOT. The vertical clearance between the tracks and the low chord of the bridge is at least 15 feet. The clear span between abutments is approximately 100 feet. NYSDOT intends to remove this bridge and make Route 82 at grade, with the project currently scheduled to start in 2026.
