## CHAPTER 2 – EXISTING CONDITIONS

## INTERCHANGE CHARACTERISTICS

POUGHKEEPSIE 9.44.55  
CITY AND TOWN OF POUGHKEEPSIE  
DUJTCHESS COUNTY, NEW YORK

PROJECT: 119-084

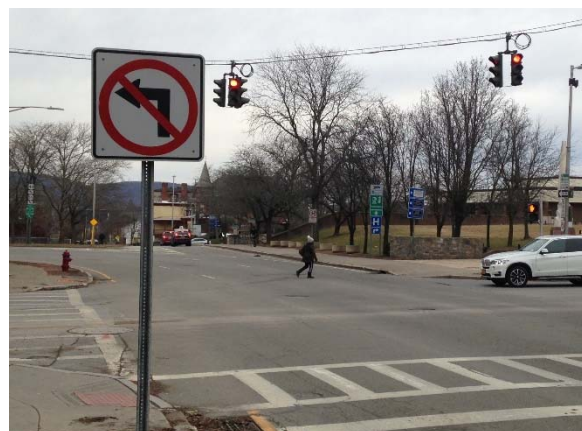
*Pedestrian crossing westbound Arterial, west leg of Market Street / Civic Center Plaza intersection where there is no crosswalk or pedestrian signal*

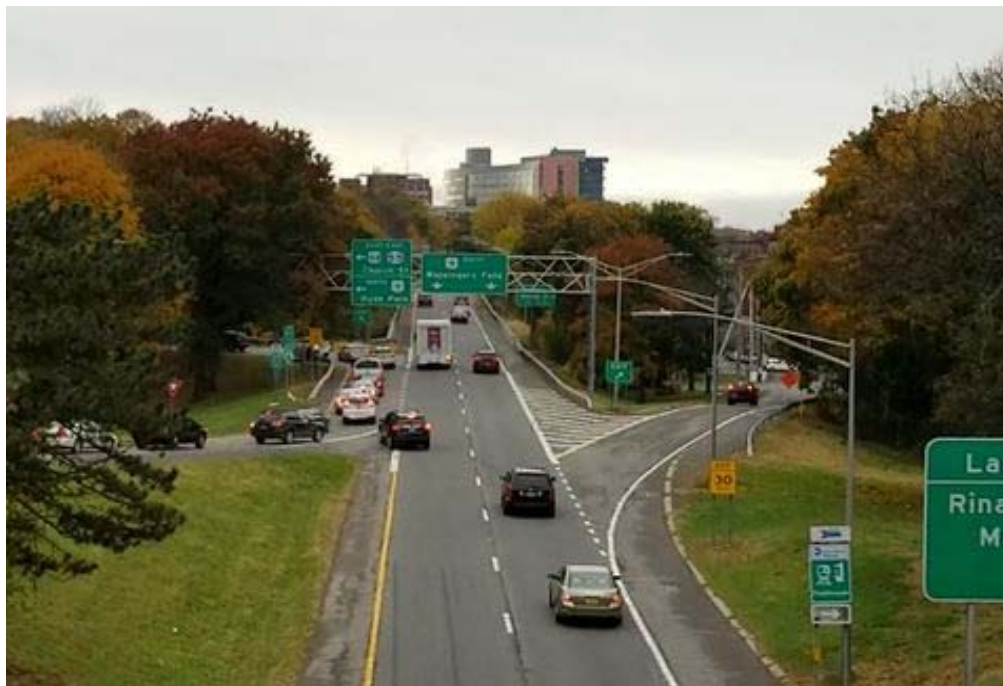
The image below shows typical congestion in the left side weaving area southbound on Route 9, south of Route 44/55. Figure 2.10 and the following page highlight some of the characteristics of the Interchange that make it problematic for drivers.

*Congestion at the Route 9 weave south of Route 44/55*

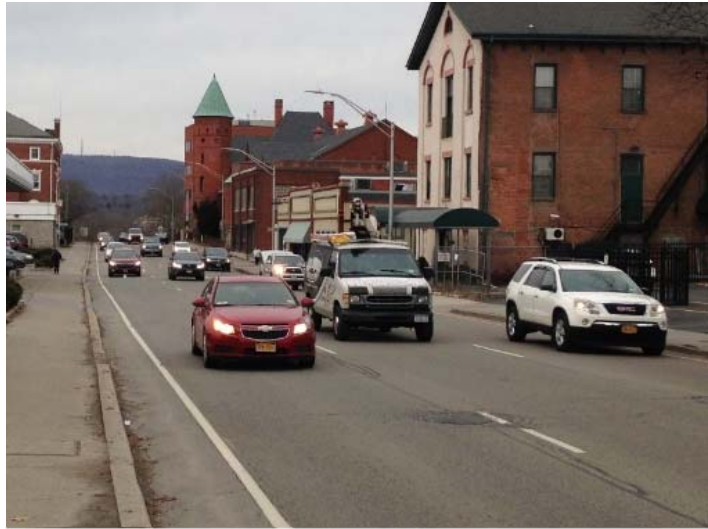
*Eastbound Arterial east of Columbus Drive*

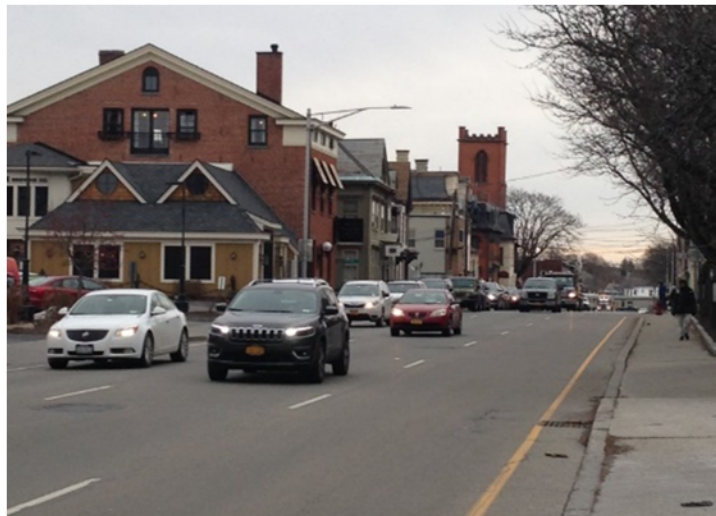
*Westbound Arterial east of Market Street / Civic Center Plaza*
