### EXECUTIVE ORDER NO. 5 OF 2012

## Building Conditions Assessment

28 Market Street  
Poughkeepsie, NY 12601

RE: 28 Market Street  
Poughkeepsie, NY  
Structural Conditions Survey  
RSA Project #: 14361.00

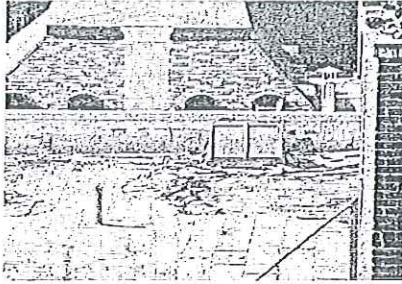
The South facade is the worst effected. A large section of the masonry wall appears to be saturated, visible by its overall deep color tone. This could be due to several reasons - parapet wall leakage, roof leakage, thru slab internal waterfall damage leading to water running into the

wall from inside. There is a serious risk, due to freeze/thaw cycles that the masonry may dislodge and fall off.

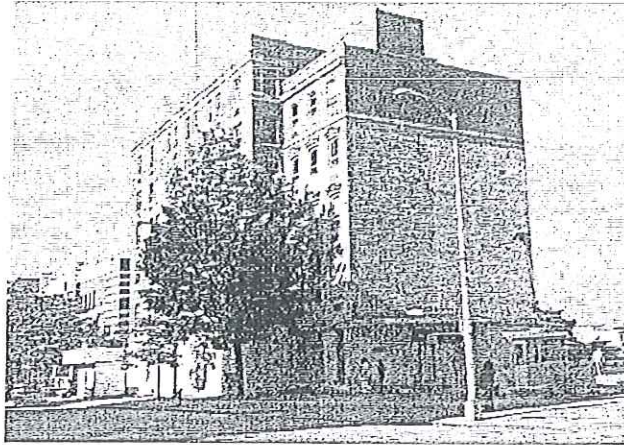
Photo 01: General view of Nelson House (town house in the foreground) and Nelson House Annex (larger building behind tree) showing the north and east walls of the building.

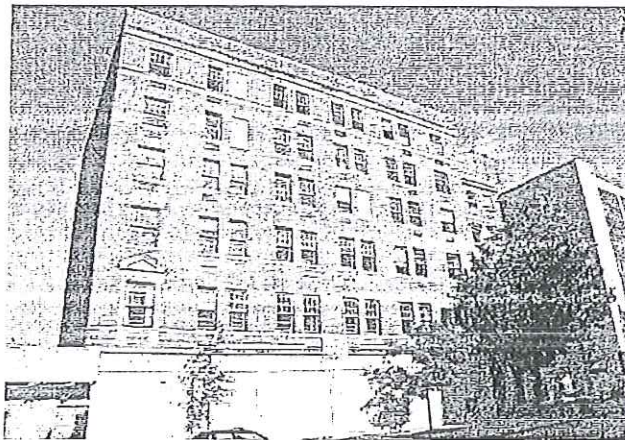
Photo 02: General view of east elevation of Nelson House Annex. The Nelson House is obscured by the tree in the right of the image.

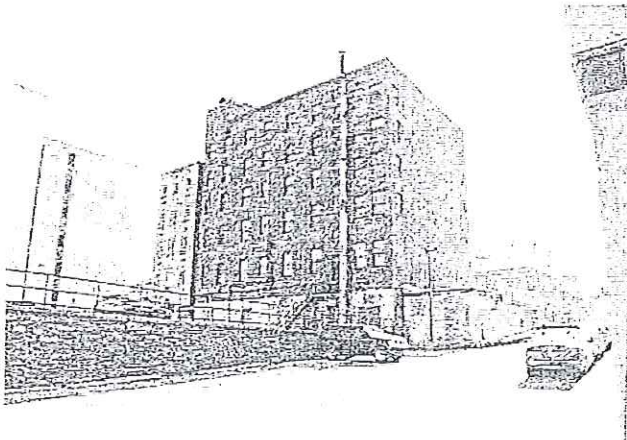
Photo 03: General view of south and west elevations of the Nelson House and the Nelson House Annex.

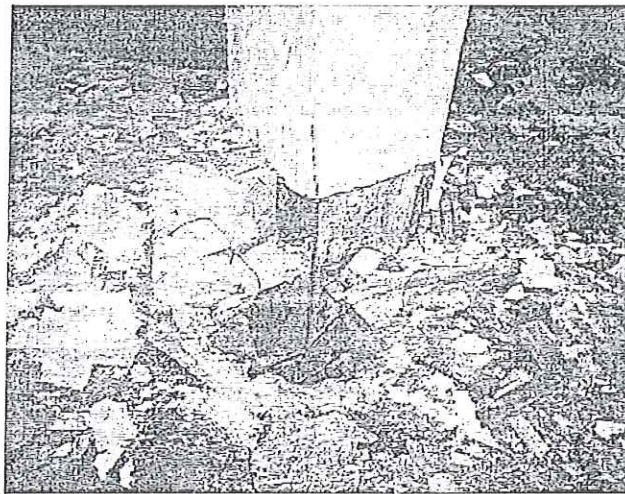
Photo 17: View of the concrete and steel structure at the Nelson House Annex. This probe was probably opened as part of a prior study of the building.

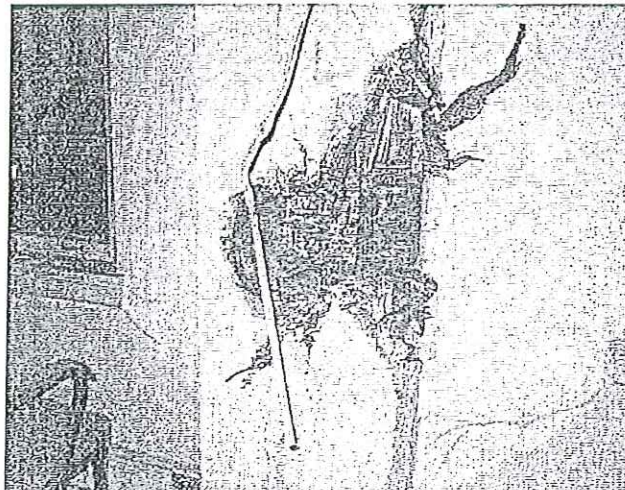
Photo 18: A second probe in the east wall of the building shows a steel column and the masonry enclosure wall. This probe was also probably opened as part of a prior study of the building.

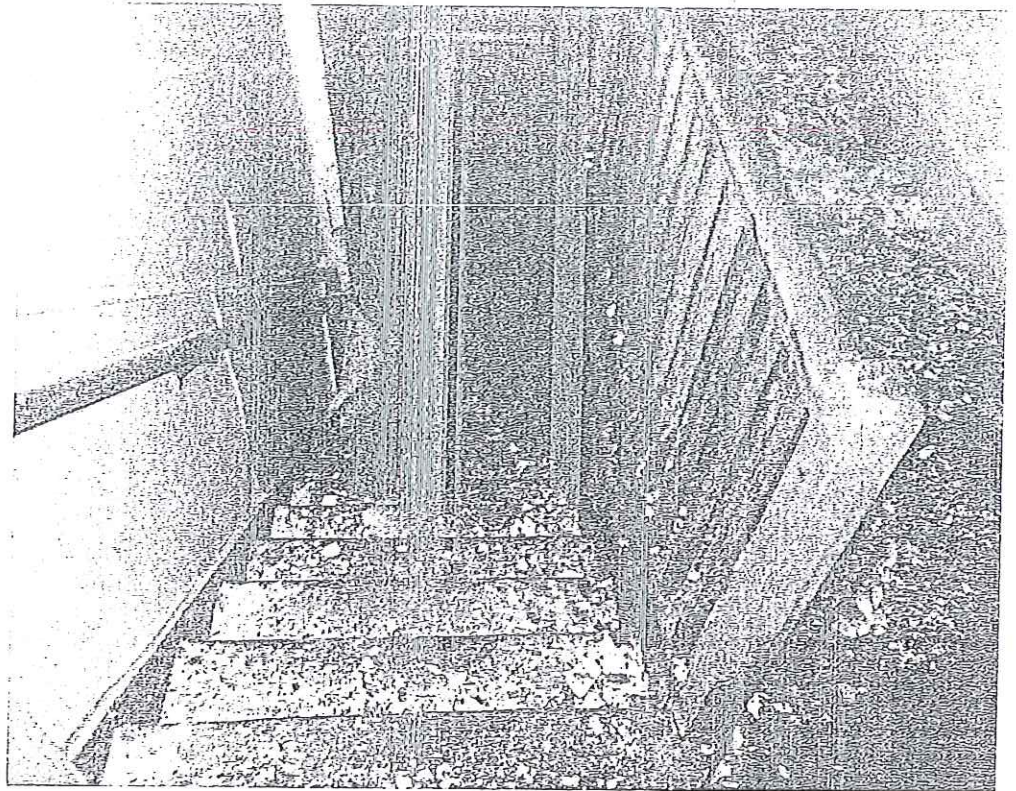
INTERIOR WOOD STAIR AT 1876 STRUCTURE

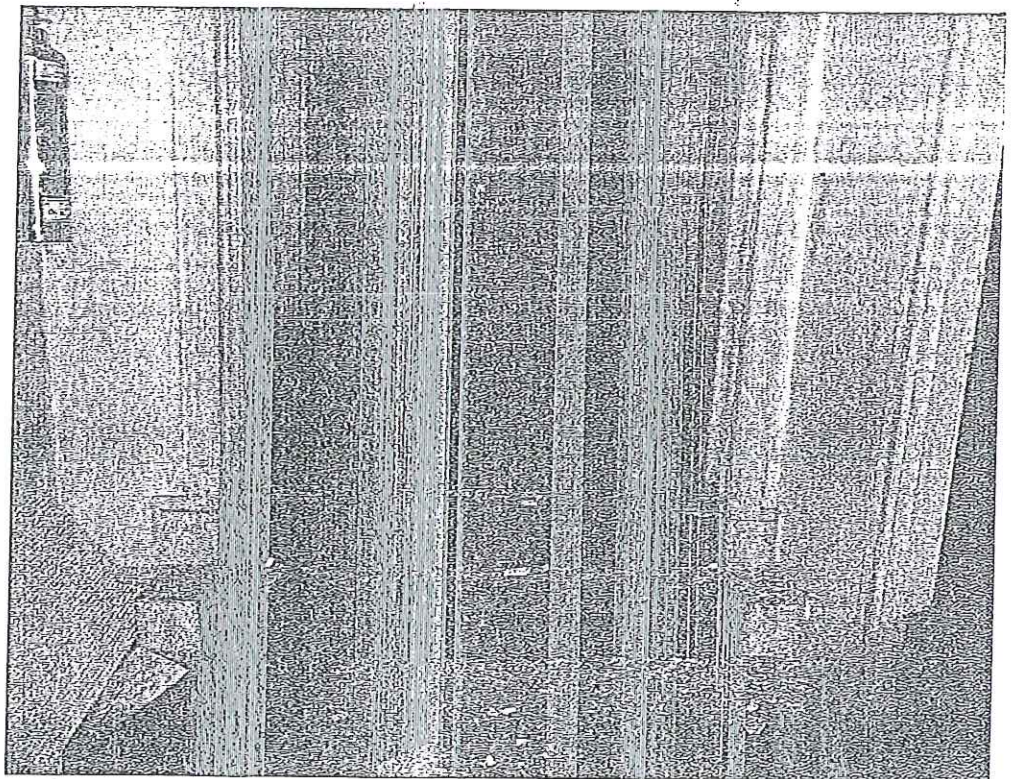
TRANSITION FROM 1930 BUILDING TO 1876 BUILDING
