**Dutchess County
Public Works**

Nelson House Annex

Building Conditions Assessment

28 Market Street
Poughkeepsie, NY 12601

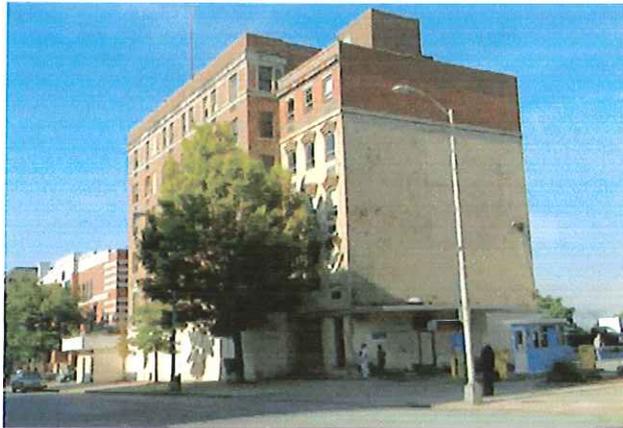
Photo 01: General view of Nelson House (town house in the foreground) and Nelson House Annex (larger building behind tree) showing the north and east walls of the building.

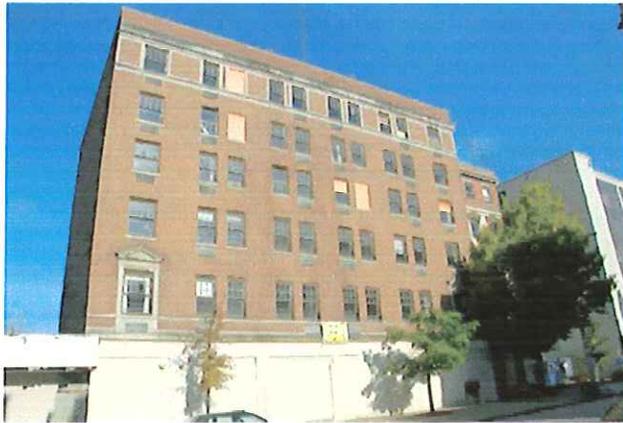
Photo 02: General view of east elevation of Nelson House Annex. The Nelson House is obscured by the tree in the right of the image.

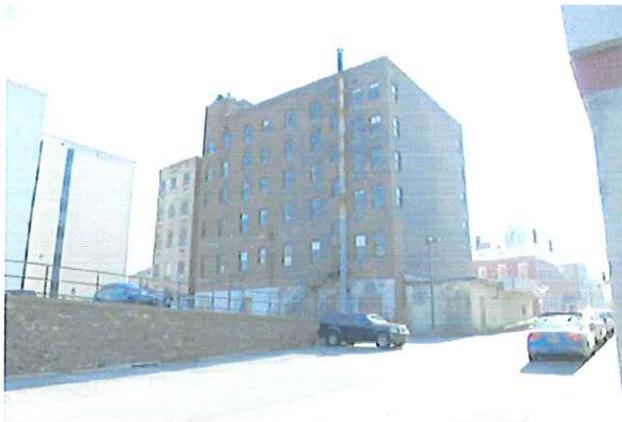
Photo 03: General view of south and west elevations of the Nelson House and the Nelson House Annex.
