CR 14 (Hollow Rd) Safety Assessment

S Creek Rd – W Cookingham Rd, Town of Clinton

December 2021

Dutchess County Transportation Council

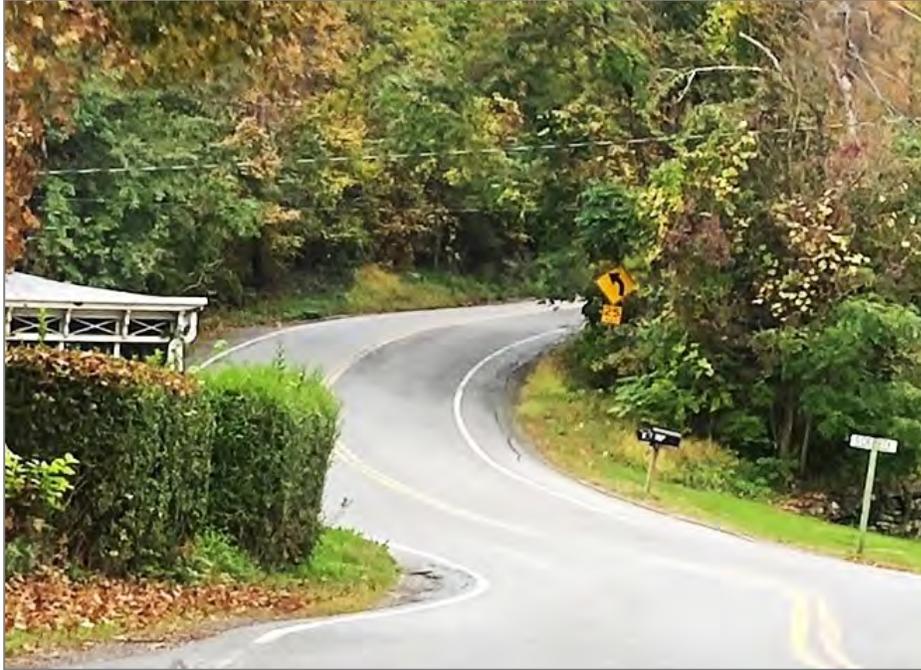
Figure 2: View from N Creek Rd facing east.

used: curve warning signs (W1-2 and W1-3), some with speed advisory plaques (20 and 25 mph), arrow (sharp turn) warning signs (W1-6), and warning chevrons (W1-8). Guiderails are also present along some sections of the road. Due to the road curvature and some areas of overgrown brush, sight distances are limited in spots.

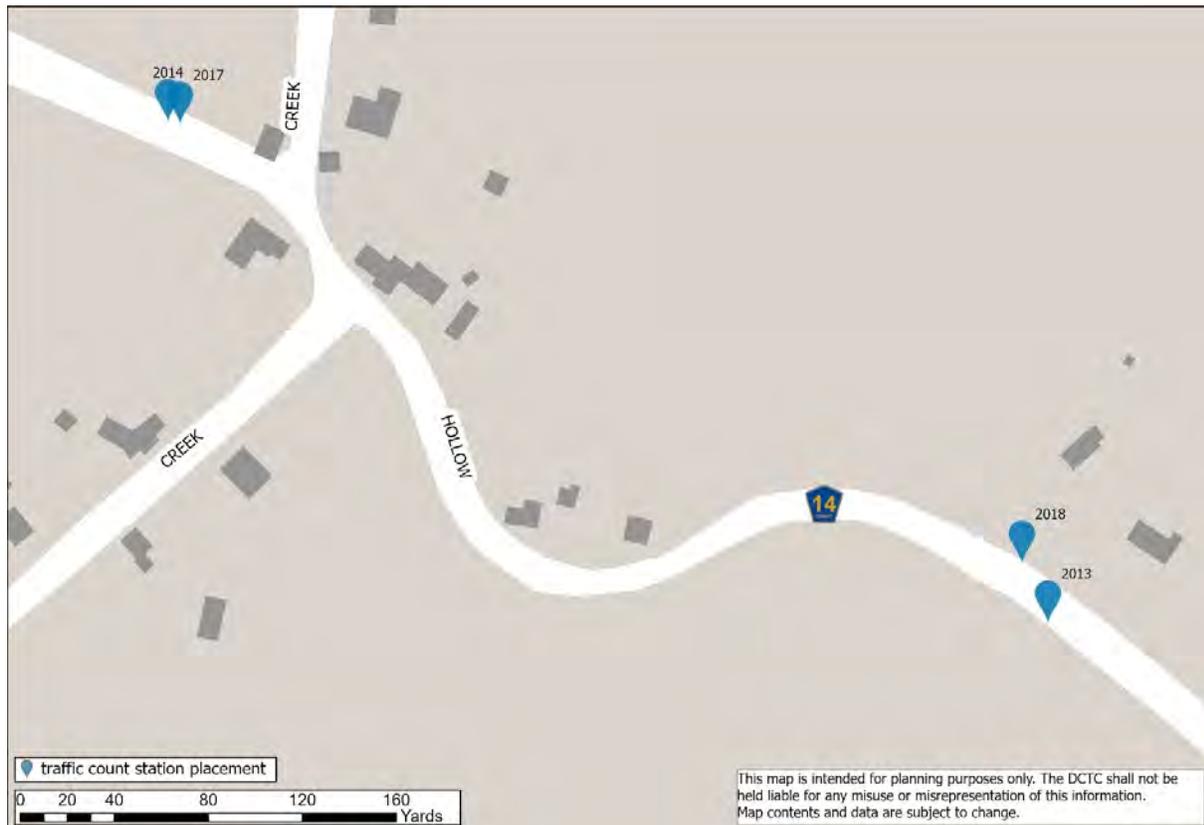
Figure 8: Traffic count station placement on Hollow Rd.

* The 2013 and 2018 traffic counts were east of the curve (just west of West Cookingham Rd). The 2014 and 2017 counts were west of North Creek Rd. (See Figure 8.)

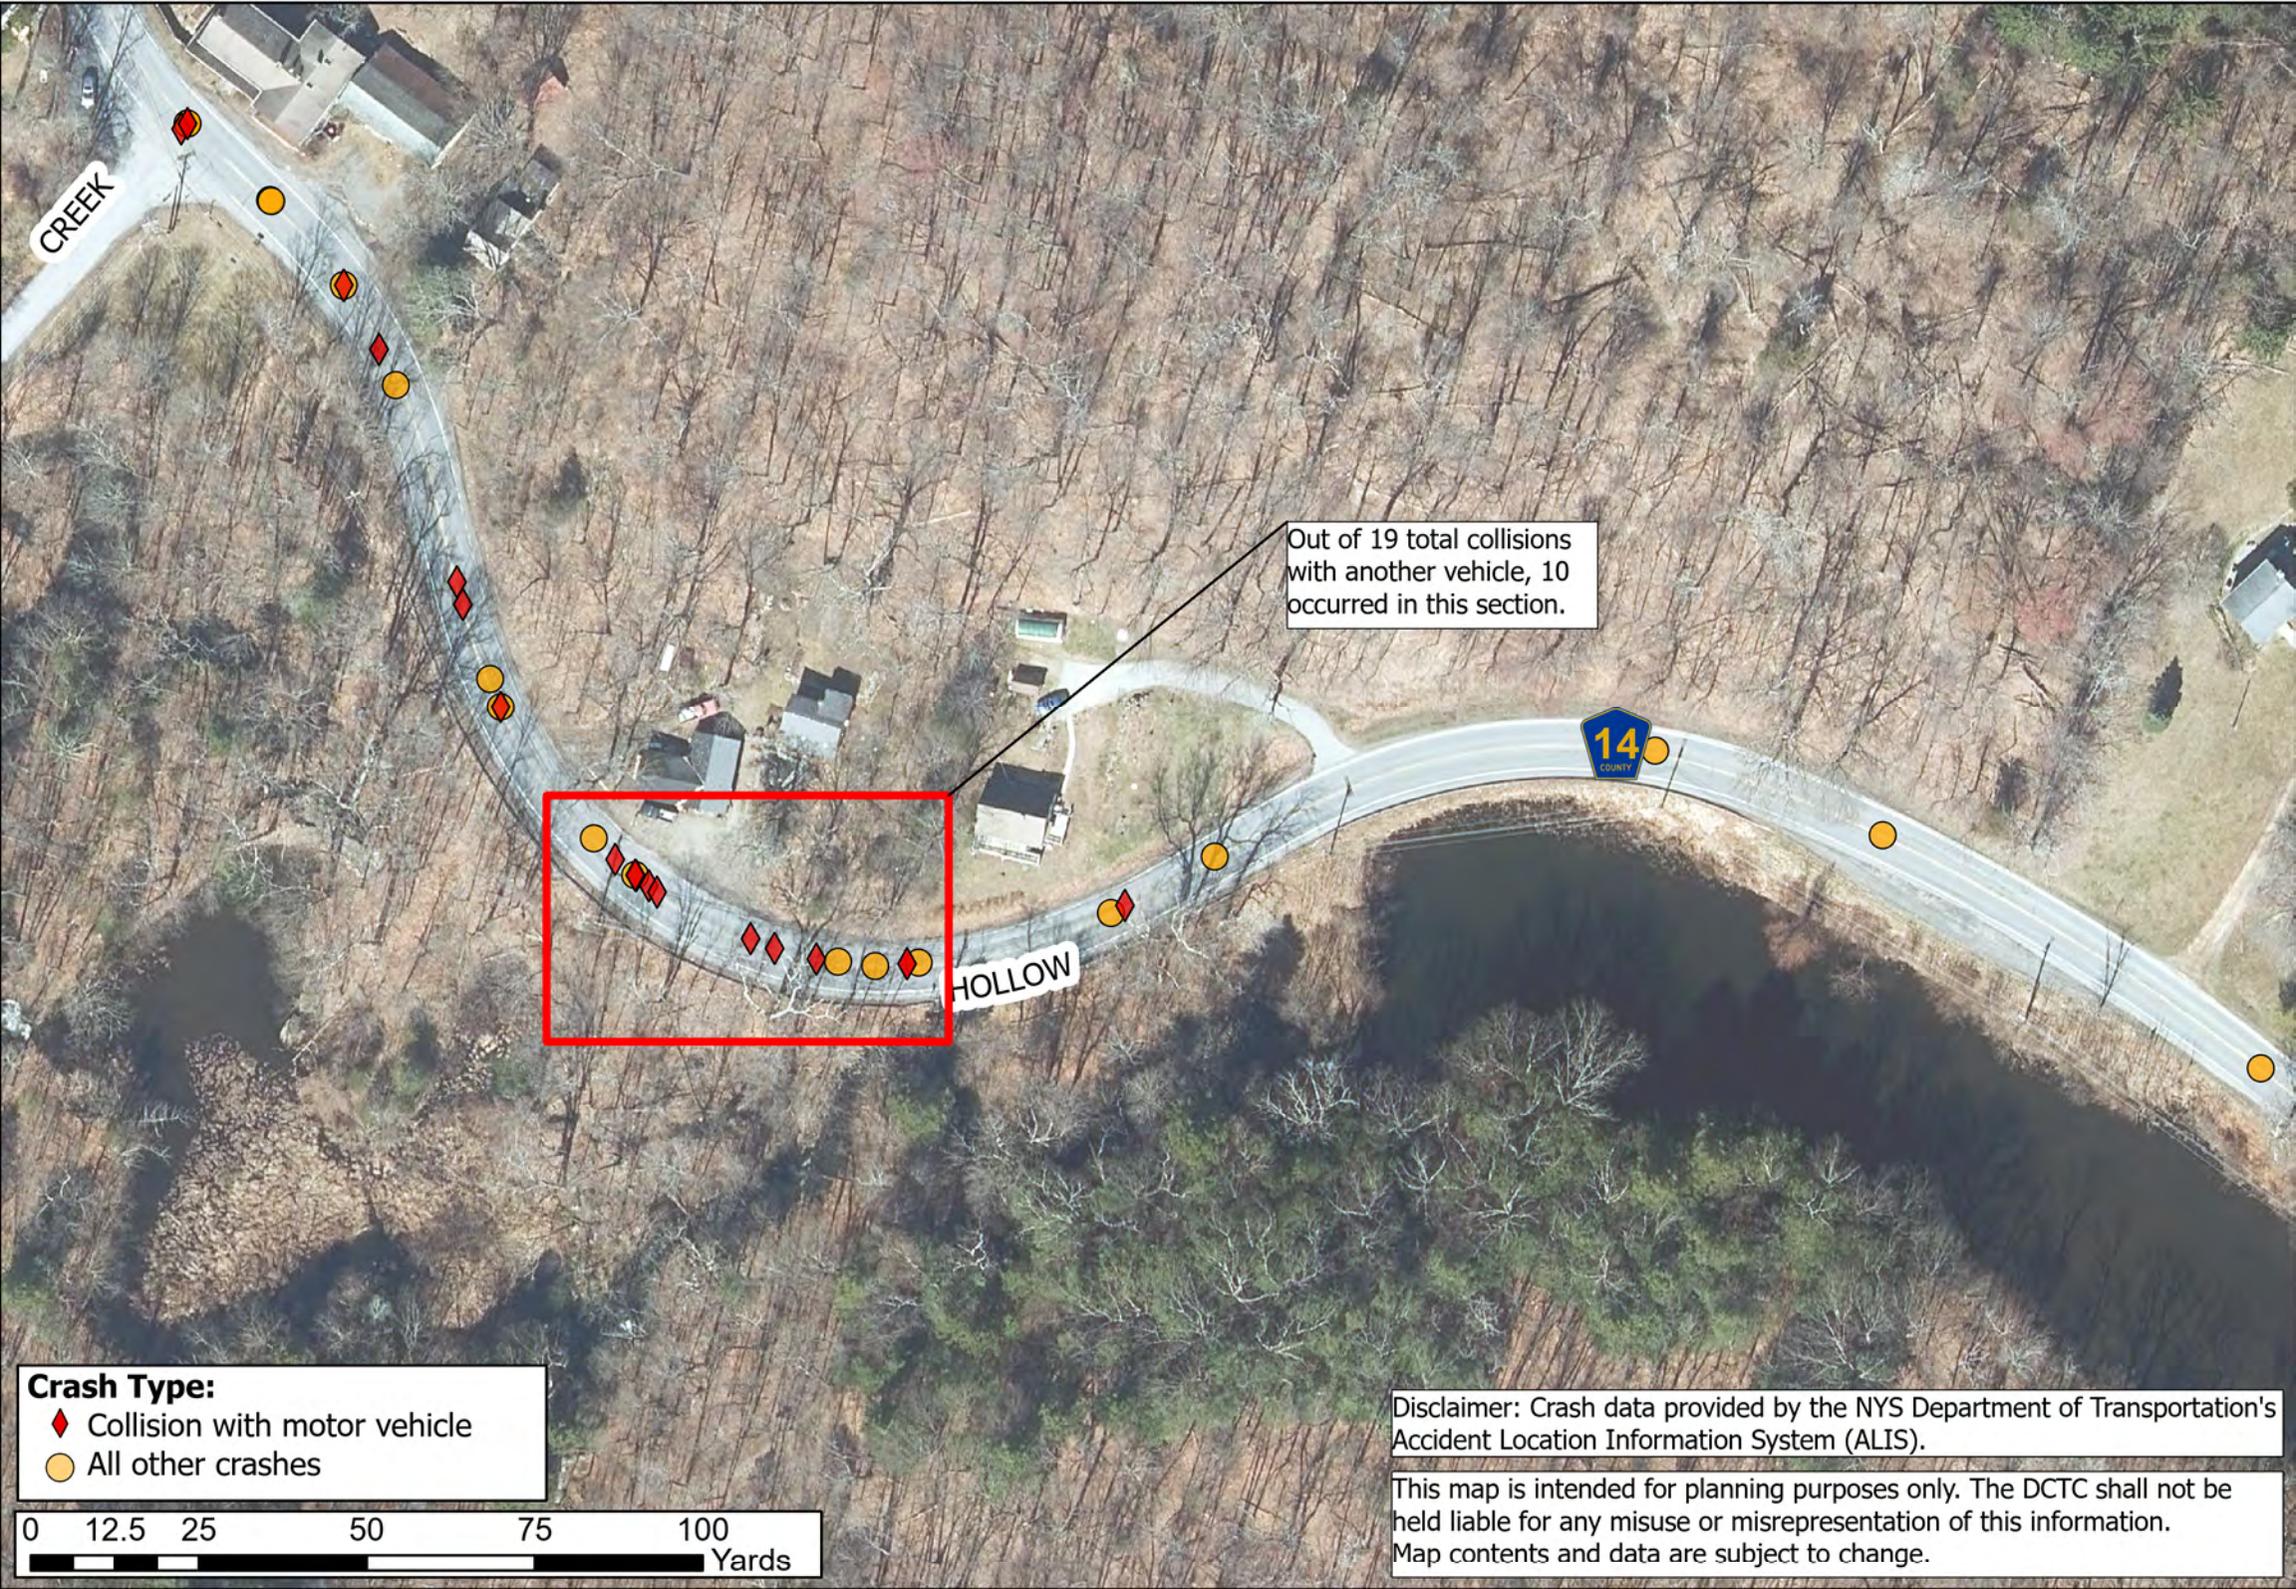
Crash Type: CR 14 (Hollow Rd), S Creek Rd - W Cookingham Rd

Out of 19 total collisions with another vehicle, 10 occurred in this section.
