CR 9 (Beekman Rd) Safety Assessment

CR 29 (Carpenter/Clove Branch Rd)-Taconic State Parkway, Town of East Fishkill

January 2019

Dutchess County Transportation Council

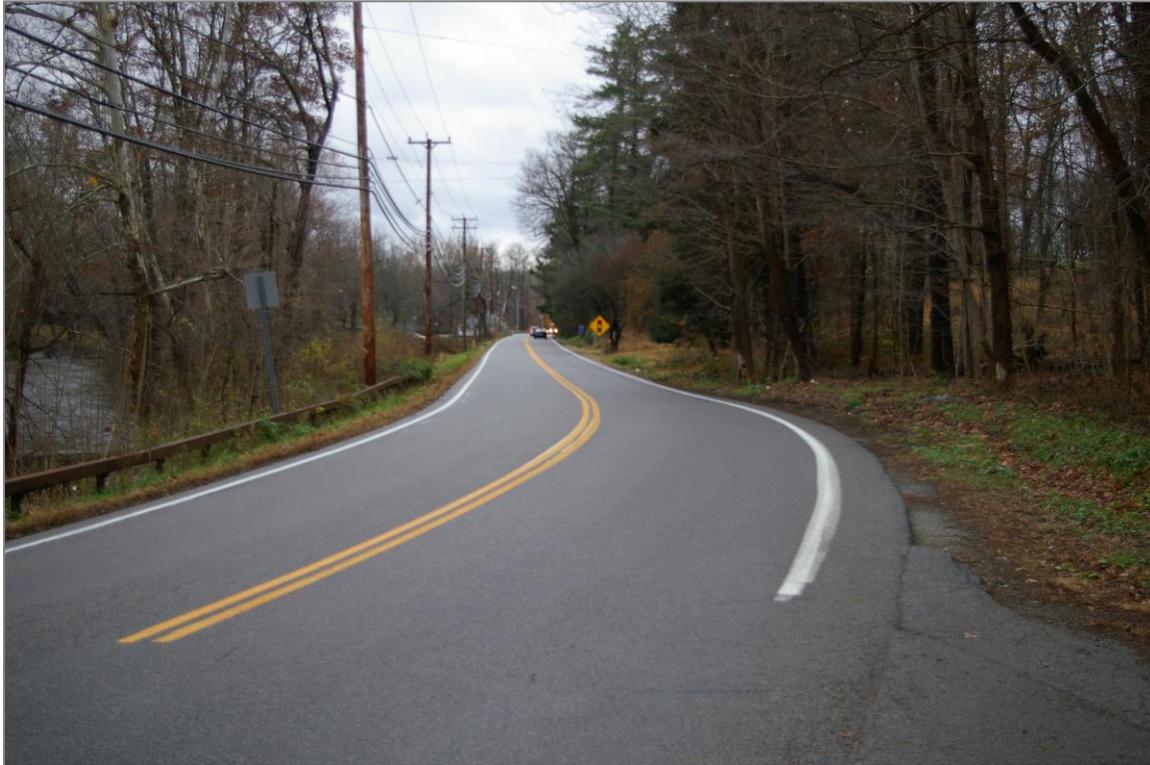
Fig. 2. CR 9 (Beekman Rd) looking west from Augusta Dr (West) towards CR 29 (Carpenter/Clove Branch Rd).

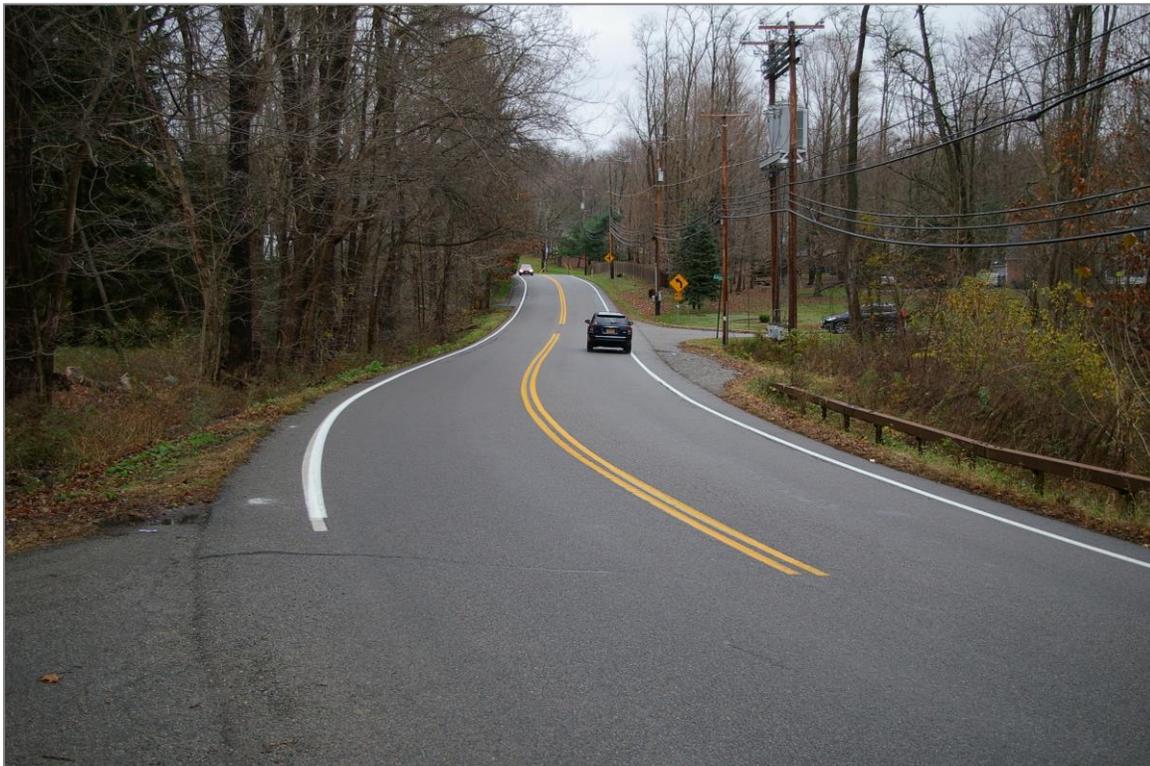
Fig. 3. CR 9 (Beekman Rd) looking east from Augusta Dr (West) towards Willow Dr.

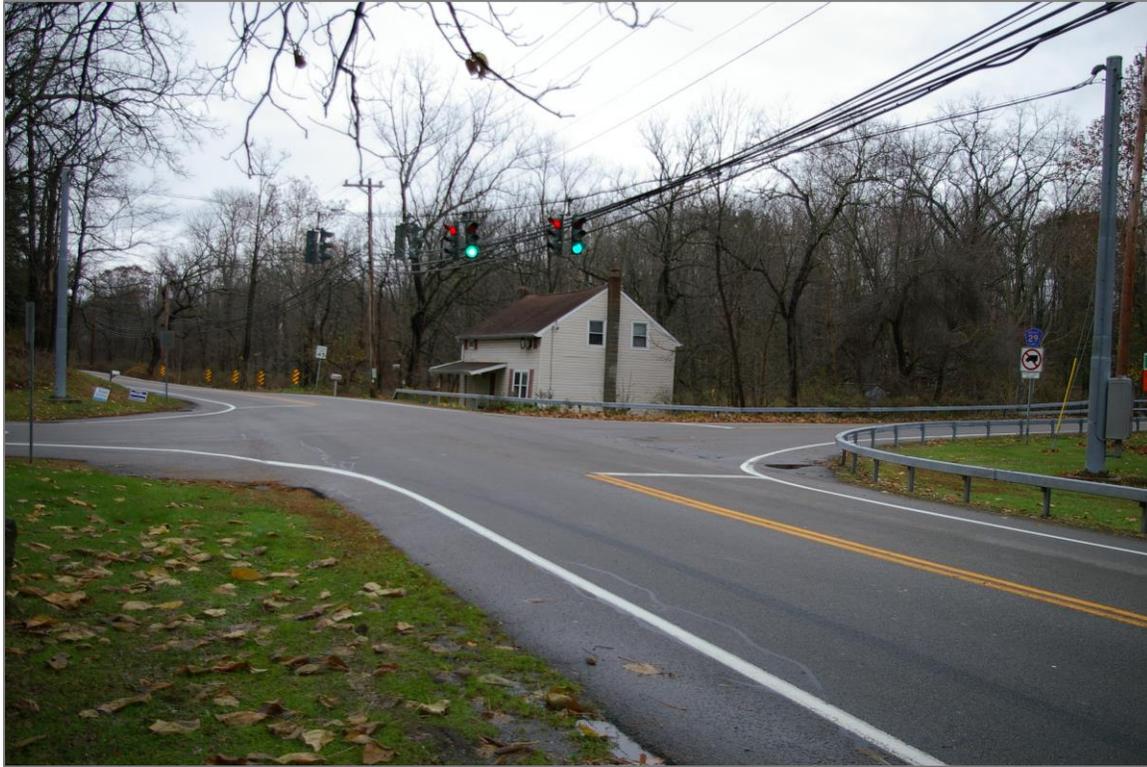
DCDPW intends to replace the traffic signal at this intersection, to include the installation of video detection, high-visibility backup plates, and far-side mast arms. The intersection has street lights co-located on existing utility poles. There is no right-turn on red for southbound and westbound traffic due to limited visibility; the SA Team suspects that the turn restrictions have helped reduce crashes at the intersection. Given the planned improvements, the SA Team did not evaluate signal timing at the intersection. However, they identified several guiderail-related issues. See Fig. 12 and 13.

Fig. 12. CR 9 (Beekman Rd)/CR 29 (Carpenter Rd/Clove Branch Rd) intersection looking east from CR 9 (Beekman Rd).

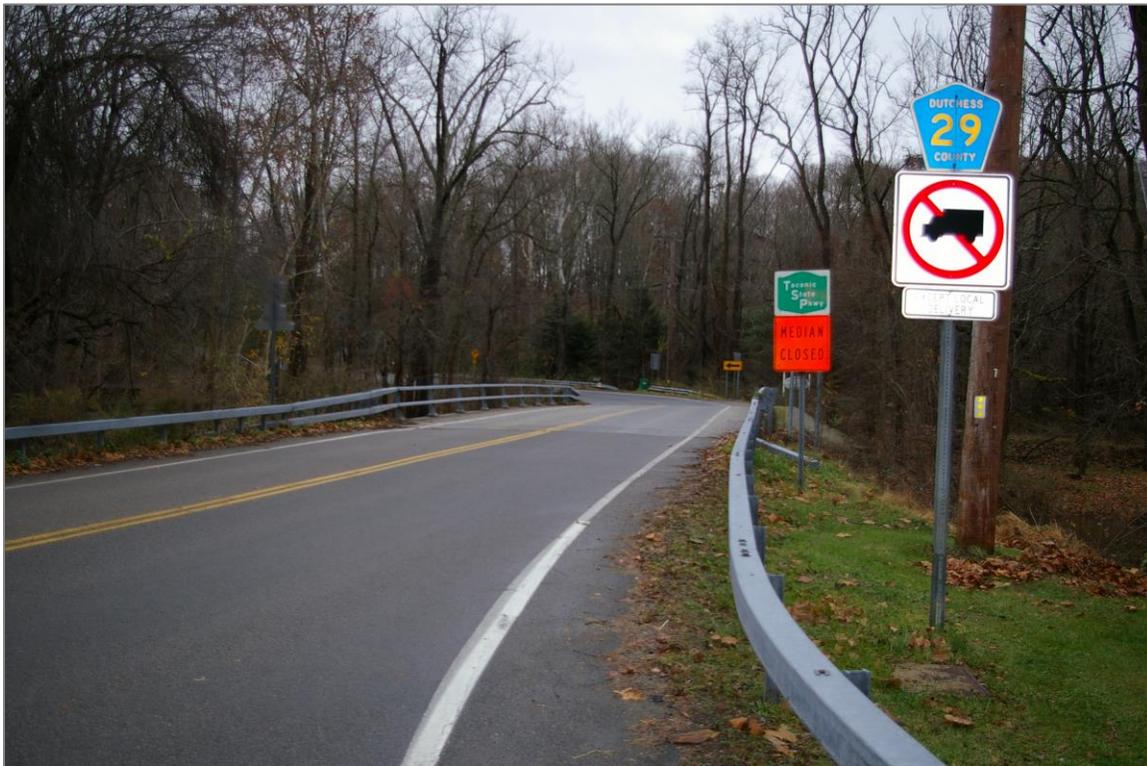
Fig. 13. CR 29 (Carpenter Rd) looking south, towards the TSP, from CR 9 (Beekman Rd).

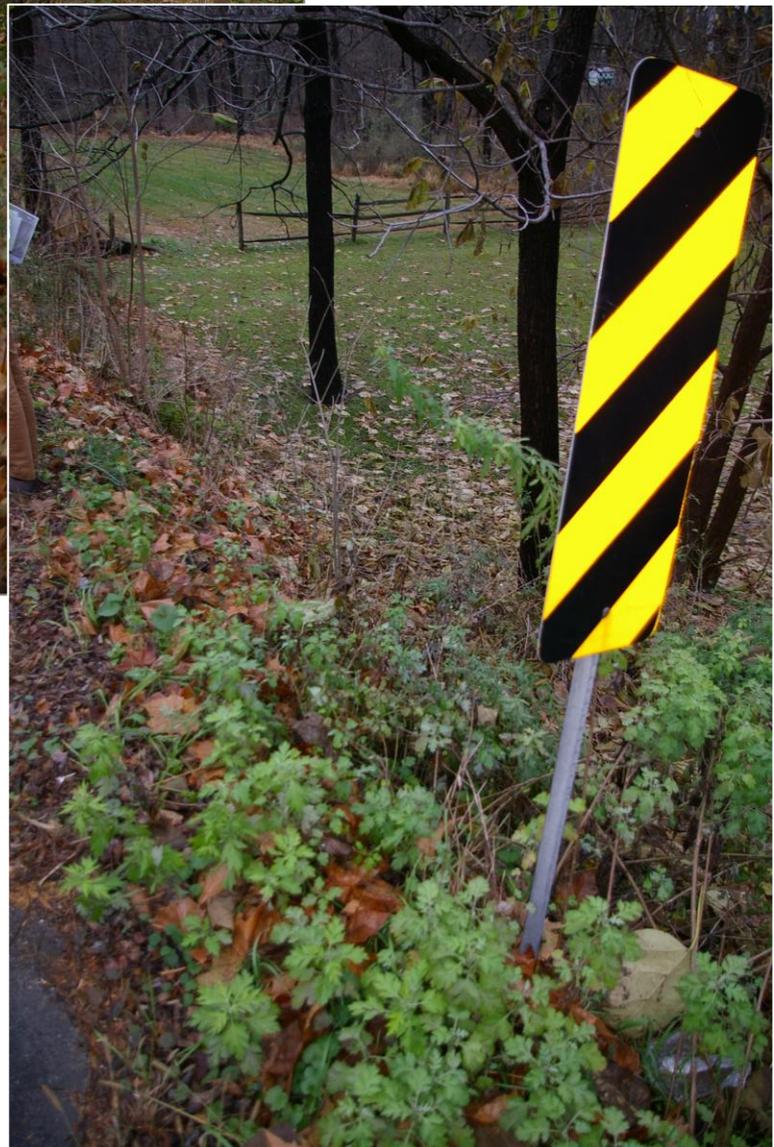
Observations: The SA Team noted that there was a steep drop-off from the southern edge of Beekman Rd, approximately 150 feet east of the Carpenter Rd intersection, down to a low lying area near the Fishkill Creek. This drop-off is marked by a series of object markers (OM3-R) that denote the roadside hazard. However, the SA Team noted that a guiderail might be warranted at this location to prevent errant vehicles from travelling down the embankment and possibly over-turning. The Team noted that there may not be space for a guiderail at the location, but should be evaluated. See Fig. 14.

Fig. 14. The southern edge of CR 9 (Beekman Rd), just east of the CR 29 (Carpenter/Clove Branch Rd) intersection, abuts a steep slope that is marked by a series of object markers. Due to the significant grade change from the road, DCDPW might consider installing a guiderail at this location to prevent errant vehicles from travelling down the embankment towards Fishkill Creek.

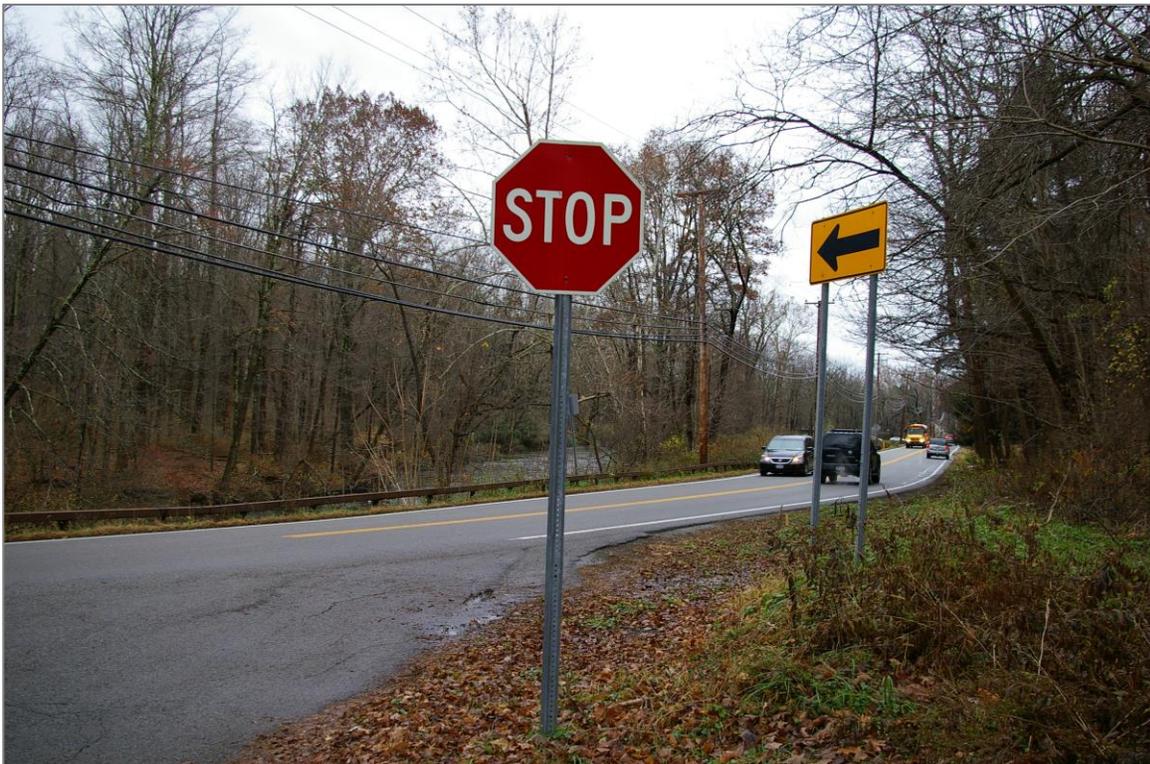
Fig. 17. The view from Augusta Dr (West), looking west towards CR 9 (Beekman Rd).

The segment of Beekman Rd near Augusta Dr (West) had the highest number of crashes in the study area. Unsafe speeds during wet weather, coupled with the road's geometry, have resulted in numerous road departures and multiple-vehicle crashes. Beyond short-term improvements such as better signage and pavement treatments, DCDPW might consider creating a larger clear zone on the northern edge of the curve just west of the intersection. See Fig. 16 and 17.
