Main Street/Innis Avenue/Worrall Avenue Safety Assessment
City of Poughkeepsie

FINAL REPORT

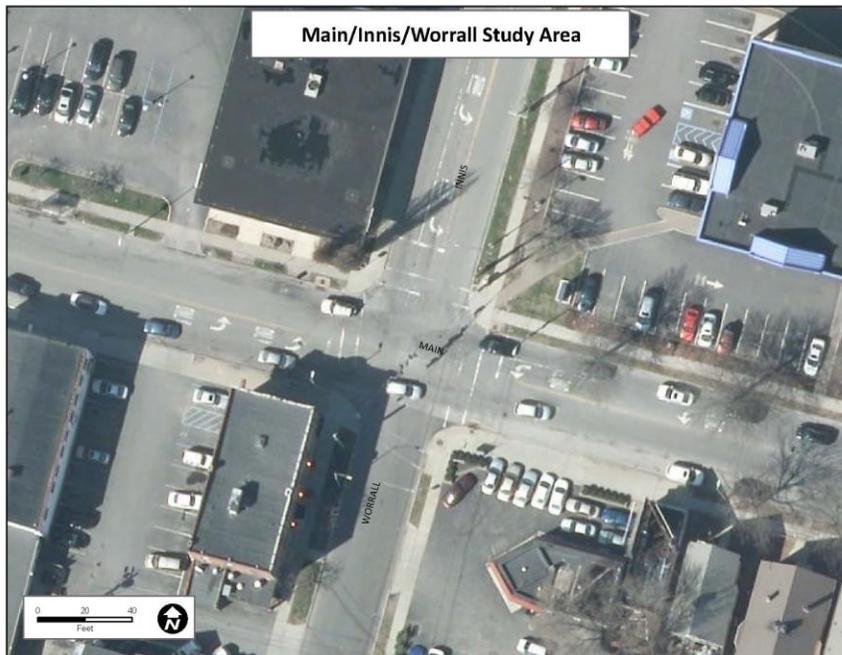
Figure 1. Study Intersection

At the study intersection, Main St is an urban major collector with one through lane and a left turn pocket in each direction. Worrall Ave is an urban minor arterial with one lane in each direction, and Innis Ave is an urban minor arterial with one lane in each direction and a southbound left turn pocket. See Figure 1.
