CR 16 (North Quaker Lane) Safety Assessment ***Forest Drive to Fallkill Road, Town of Hyde Park***

CR16 (North Quaker Lane) Safety Assessment
Forest Drive to Fallkill Road, Town of Hyde Park

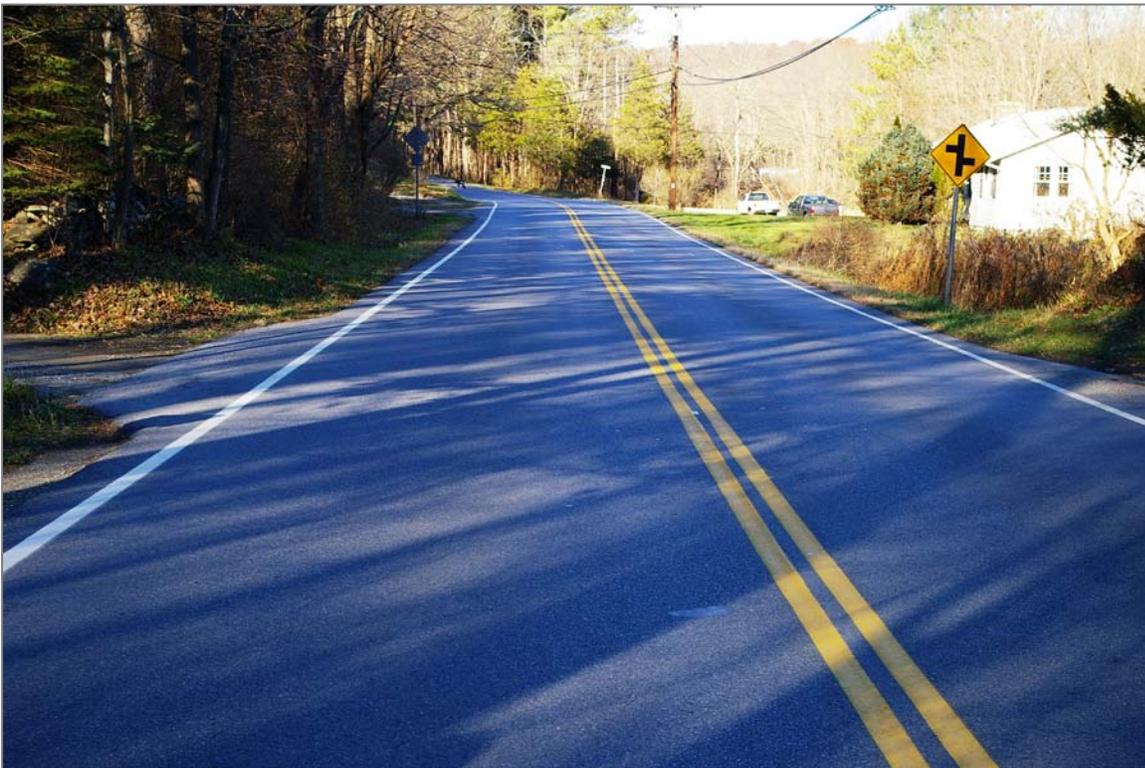
Figure 5. North Quaker Lane looking north towards East Fallkill Road.

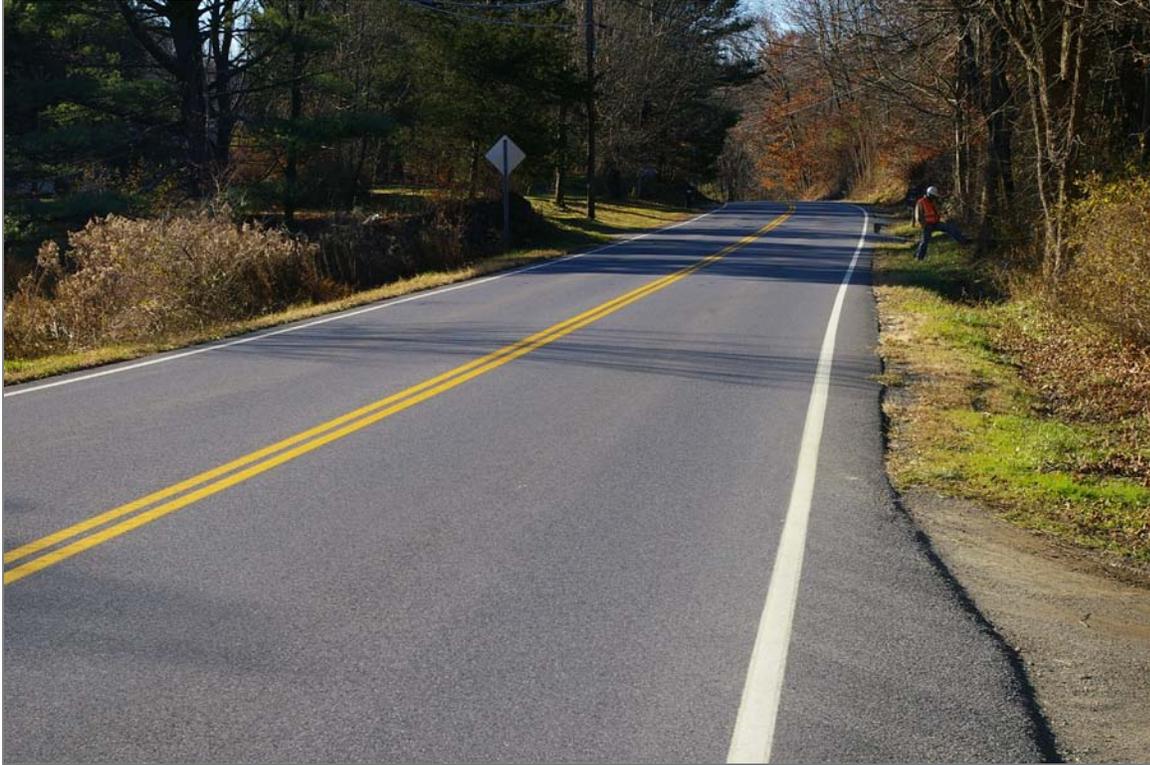
Observations: The regulatory speed limit is 55 mph. However, speeds appear to be too high for the corridor, especially for the curve north of Forest Drive. Unsafe speed was cited as a contributing factor in 13 of the 34 crashes from 2008-2012. Observed speeds, even though they may be lower than the un-posted 55 mph limit, pose a safety issue for vehicles entering the curve, most notably for vehicles travelling southbound on North Quaker Lane during wet or snowy conditions. This is evidenced by the 25 mph advisory speed plaque on North Quaker Lane southbound, 275 feet south of E. Fallkill Road, and a 30 mph advisory plaque travelling northbound, approx. 1,000 feet south of Forest Drive. The rapid transition from an un-posted 55 mph limit to an advisory 25 mph appears abrupt and may require an interim speed reduction beforehand to gradually slow vehicles down. An un-posted speed limit also makes enforcement difficult, negating an important tool to influence driver behavior. Speed data from the PDCTC's traffic count program indicated that 85 percent of vehicles were travelling at 47 mph, which supports the case for a 45 mph speed limit through the corridor.

Figure 6. North Quaker Lane looking south towards the curve between East Fallkill Road and Forest Drive.

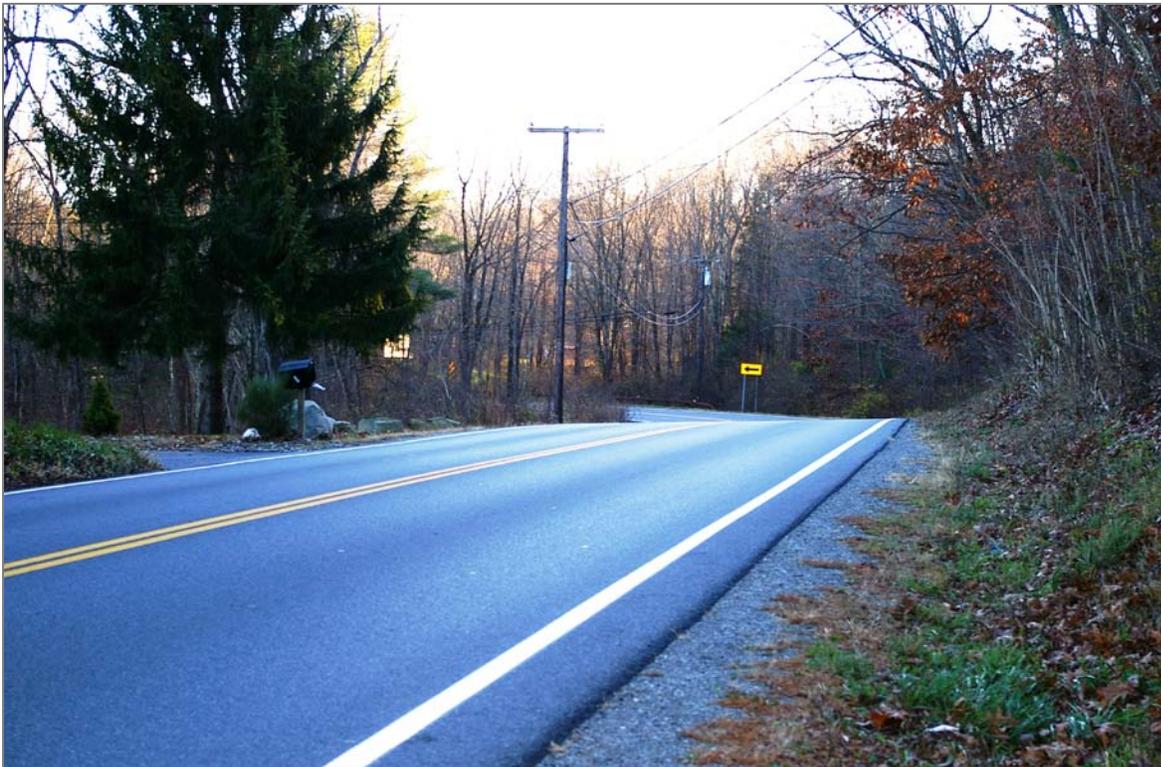
Figure 7. A second view of North Quaker Lane looking south towards the curve between East Fallkill Road and Forest Drive.

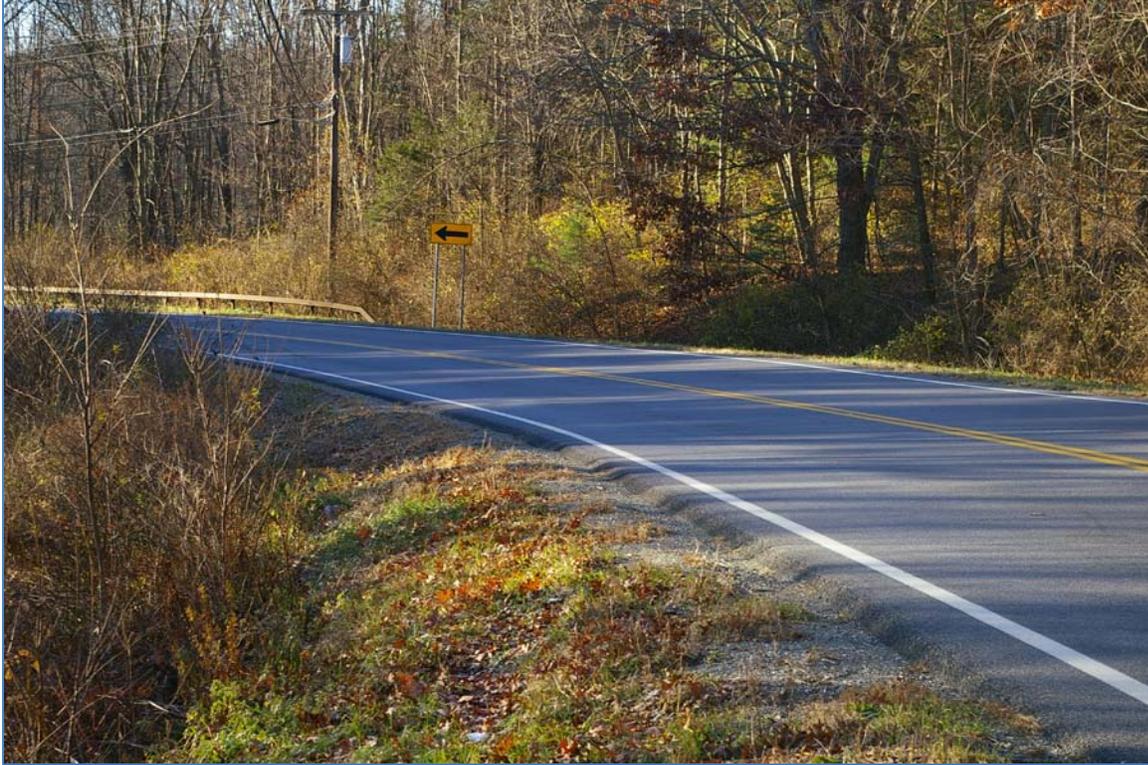
Figure 8. North Quaker Lane looking south towards the curve.

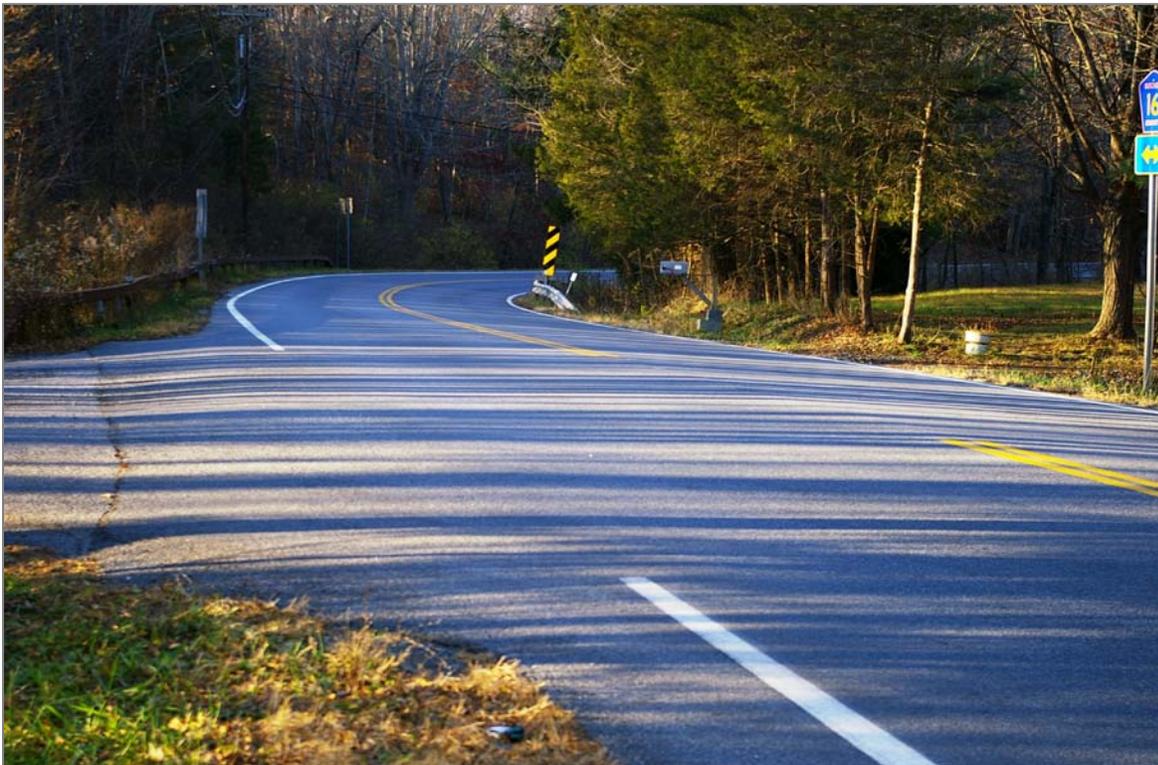
Figure 9. North Quaker Lane at Forest drive looking north towards the curve.

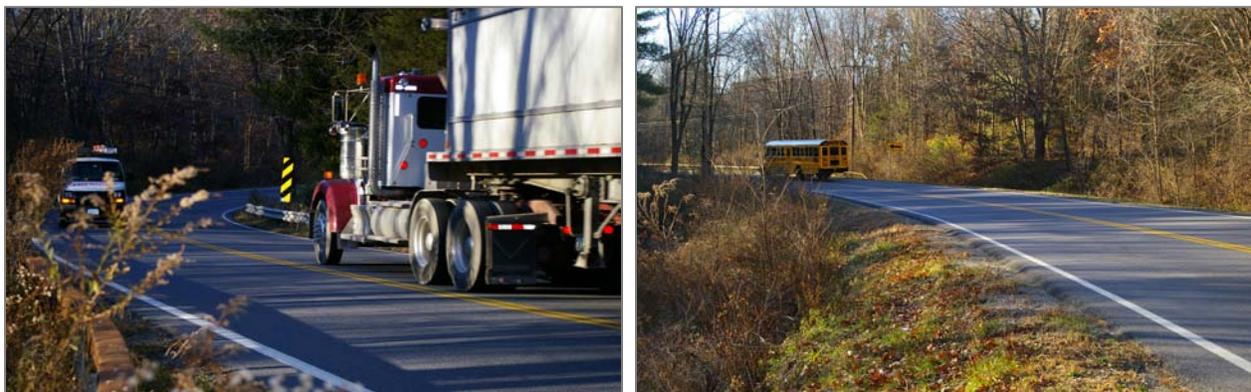
Observations: Based on field observations, numerous large, multi-axle trucks and buses travel through the corridor. School bus activity is especially high in the late afternoon, mainly turning right from Fallkill Road on to North Quaker Lane south. A number of large semi-trailers were observed using North Quaker Lane. In some cases, the SA team observed northbound semi-trailers crossing over the shoulder lane marking on the inside curve, which was a result of vehicle speed and narrow road geometry.

Risk Analysis: Though a rare occurrence, heavy vehicles crossing paths at the curve could pose a safety hazard, especially under wet road conditions.

Figure 10. Heavy vehicles use North Quaker Lane as an alternative to NYS Route 9G, while nearby schools generate noticeable bus activity.

Suggestion: Widen shoulders on North Quaker Lane to better accommodate larger vehicles, especially northbound on the right shoulder of the curve, though this might encourage higher speeds.
