**Road Safety Assessment (SA) Report
FINAL**

**BEEKMAN ROAD (CR 9) SAFETY ASSESSMENT
BEEKMAN-POUGHQUAG ROAD (CR 7) TO NYS ROUTE 55
TOWN OF BEEKMAN, NEW YORK**

**POUGHKEEPSIE-DUTCHESS COUNTY TRANSPORTATION COUNCIL
27 HIGH STREET, 2ND FLOOR
POUGHKEEPSIE, NY 12601**

**FINAL REPORT DATE: MARCH 2013
ASSESSMENT DATE: OCTOBER 24 - 26, 2012**

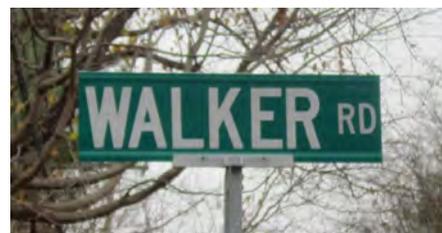
Observations: Street name signs are of an older style (all capital letters and no borders) and lack clear legibility and conspicuity on approach. The SA Team observed several different styles throughout the project limits.

Risk Analysis: Lack of clear navigational information increases the risk of last minute decision making and maneuvers, which in turn may increase the risk of a collision. This condition would affect unfamiliar motorists to a greater extent than local motorists.

Exhibit 13: Example of existing (top) and proposed (bottom) street name signs.

Suggestions: Upgrade existing street name signs. Street name signs should be larger and in accordance with the MUTCD. Larger panels would assist with intersection conspicuity, especially at night.
