# Beacon-Hopewell Rail Trail Study

## Existing Conditions Report

DUTCHESS COUNTY  
TRANSPORTATION COUNCIL

October  
2024

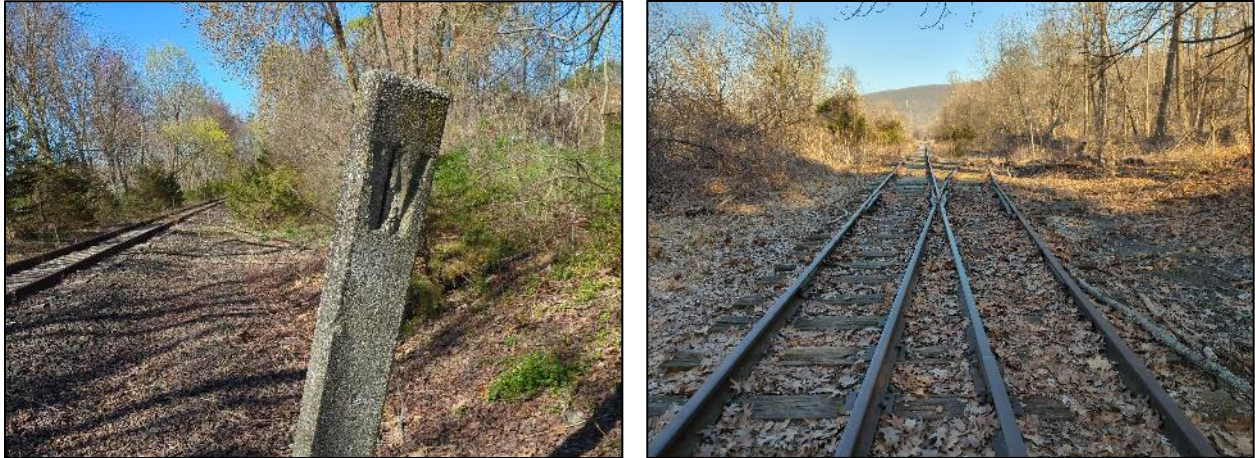
**Figure 2: “W” Post (left) and railroad switch (right).**

Other railroad infrastructure included six “W” posts (most likely whistle posts), two railroad switches, and two sections of double tracks (see Figure 2). The double track sections are located just west of Washington Ave in the Town of Fishkill and Jackson St on the Town/Village of Fishkill line, and the switches are just west of Washington Ave and near the sub-station, about one mile south of the Route 82 crossing. This infrastructure would not inhibit the construction of a trail. See the existing condition maps in Appendix A for the locations of the existing railroad infrastructure.

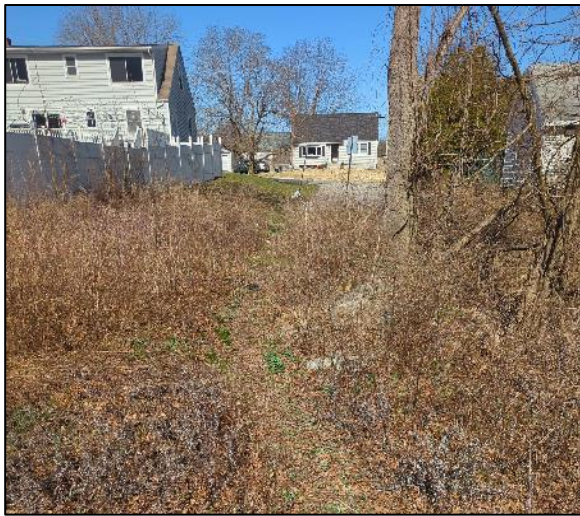
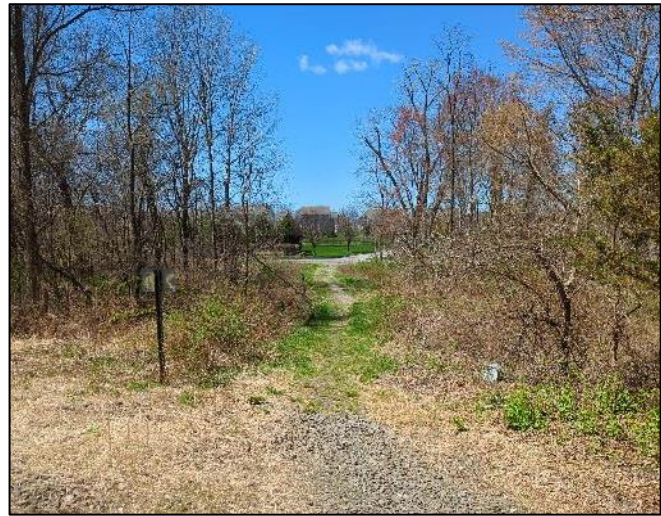
There are six dirt, grass, or gravel paths that lead from nearby residences and neighborhoods to the corridor (see Table 1). These paths are generally narrow in width (1-5 feet) and are only accessible by people walking or bicycling. These paths often cross private property and were likely formed by residents accessing the corridor (see Figure 9).

**Figure 9: Existing narrow dirt footpath from Van Steuben Rd (left) and a wider and more heavily used gravel/dirt footpath from Hopewell Glen to the ACME Unity Plaza (right).**

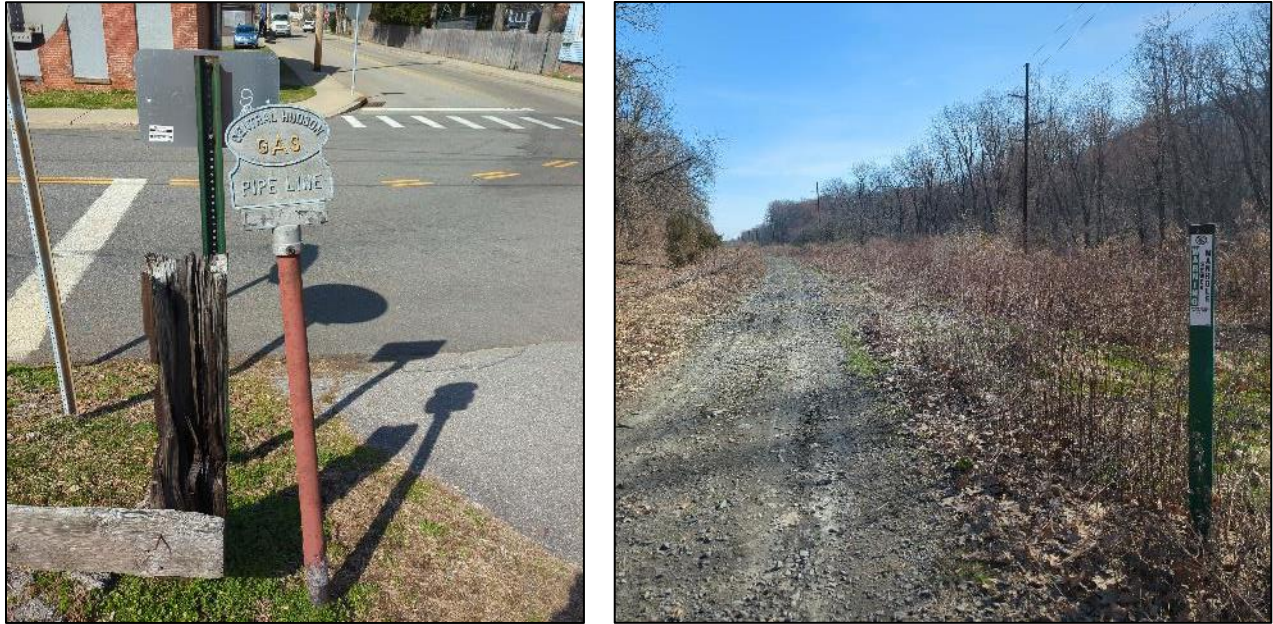
The existing railroad corridor was observed for visible utility infrastructure (such as gas, electric, telephone, cable TV, and water/sewer lines) within or crossing the corridor. In general, overhead electric distribution and communication lines were encountered at each of the major and minor roadway crossings (28 total). Underground gas and water utility markers were observed at four of the roadway crossings throughout the corridor (see Figure 10).

**Figure 10: An underground gas pipeline marker along Main St. in the City of Beacon (left) and overhead electric transmission lines and a sewer pipeline marker east of Washington Ave (right).**

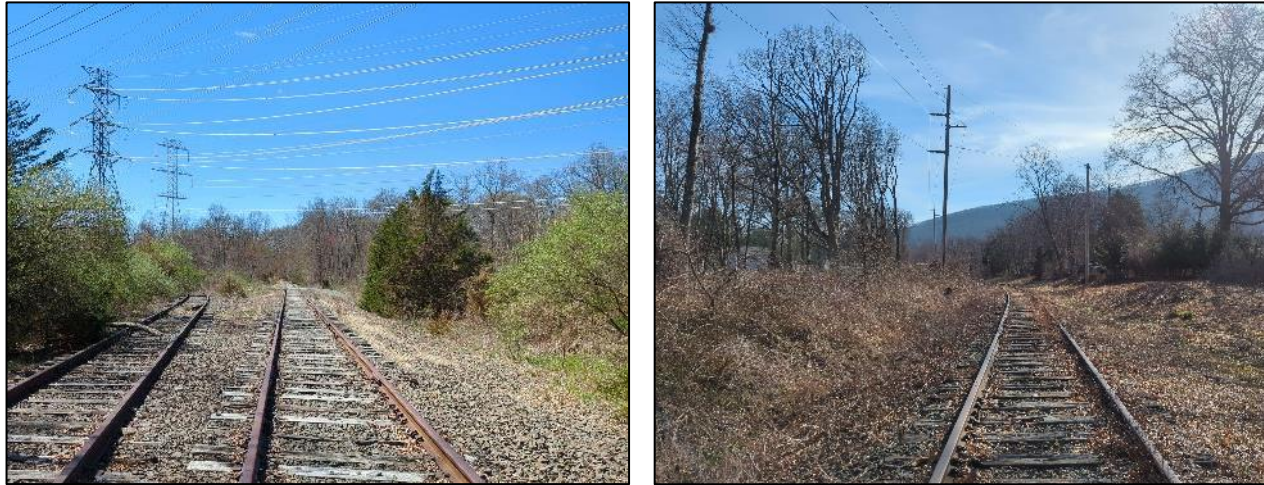
Additionally, there are perpendicular crossings of the electric distribution and transmission lines in the vicinity of the Washington Ave crossing in the Town of Fishkill, the US Route 9 crossing in the Village of Fishkill, and east of the Broadway crossing in the Town of East Fishkill. There are multiple lines that cross over the railroad corridor in the Town of East Fishkill just east of the Broadway

crossing and then enter the Central Hudson Gas & Electric (CHG&E) sub-station (see Figure 12).

**Figure 12: Overhead electric transmission lines near the CHG&E sub-station (left) and overhead electric transmission lines east of Washington Ave (right).**

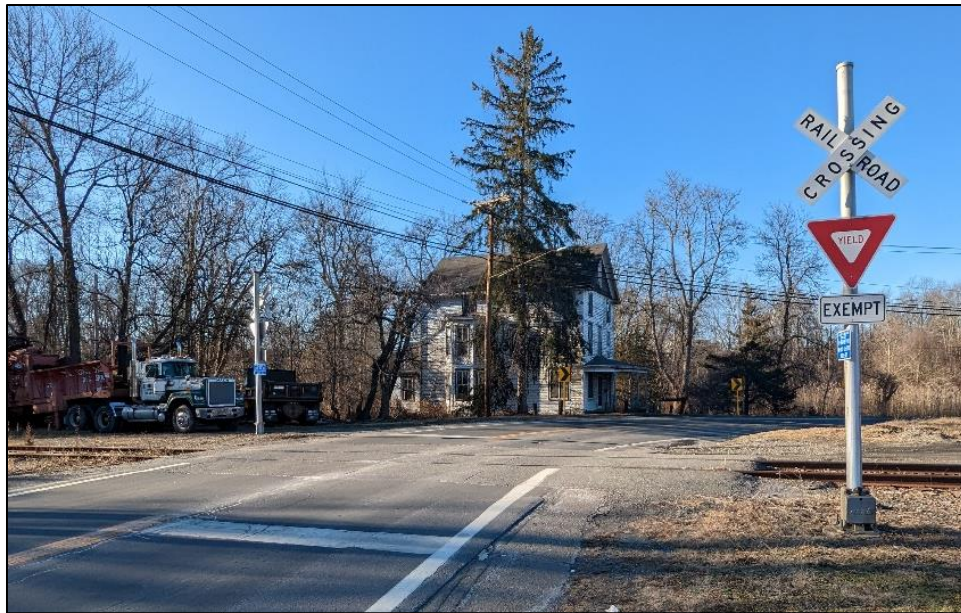
For this report, the at-grade roadway crossings are organized into two categories, Major and Minor, based on the Average Annual Daily Traffic (AADT) of the crossing. Major crossings have an AADT of more than 1,000 vehicles per day (vpd) on the road, and Minor Crossings have an AADT of fewer than 1,000 vpd. Existing railroad infrastructure at the crossings consists of steel rails running through the pavement and Railroad Crossing “X” signs (R15-1) with Yield (R1-2) and Exempt (R15-3) signs on the same posts. The crossings do not contain warning features such as flashing red lights, gates, RXR (Railroad Crossing) pavement markings, or RXR signs (W10-1), all of which would typically be found at an active railroad crossing (see Figure 14).

**Figure 14: Typical signage found at the roadway crossings.**

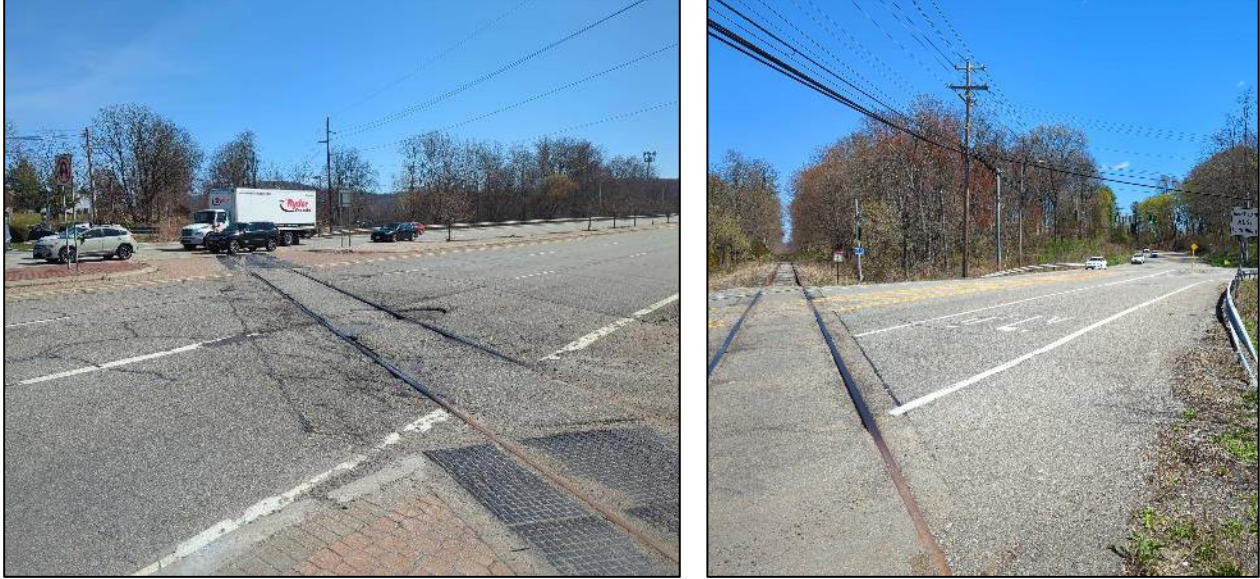
The most challenging location for a trail crossing is at NYS Route 9 in the Village of Fishkill. The high volumes, exceeding 38,000 vehicles a day, long crossing distance of 140 feet, and six lanes of vehicle traffic make any at-grade trail crossing a challenge. The nearby signalized intersection of Route 9 with Loudon Dr and Elm St experiences queue lengths that extend through the railroad crossing, as shown in Figure 15. Additionally, this intersection was classified by the study team as a high vehicle crash location, with more than 15 reported crashes per year between 2017 and 2020. A detailed analysis of options for a trail crossing at this and the other major road crossings will be included in a separate report.

**Figure 15: Railroad Crossings at US Route 9 (left) and NYS Route 82 (right).**

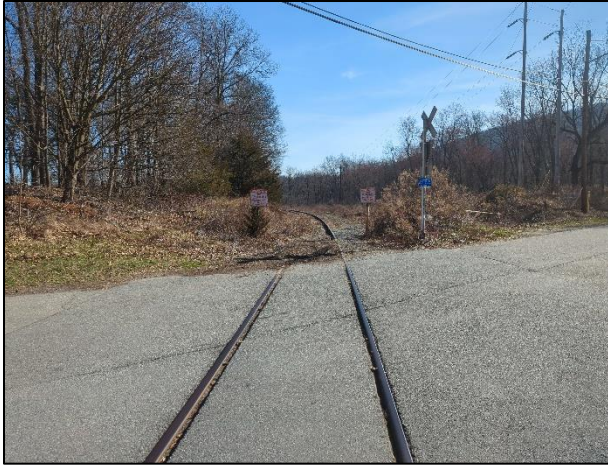
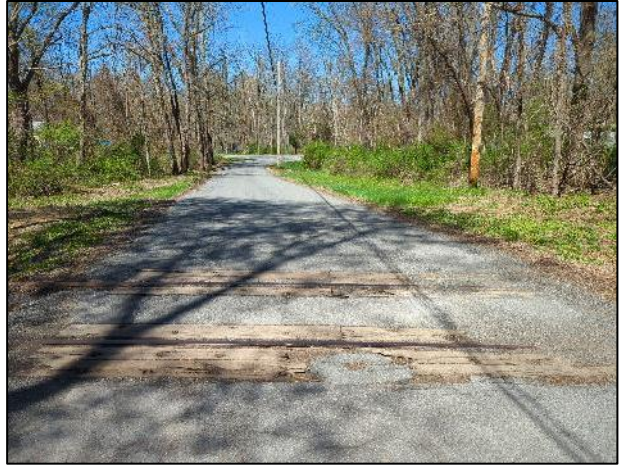
**Figure 16: Railroad Crossings at Petticoat Ln (left) and Lomala Ln (right).**

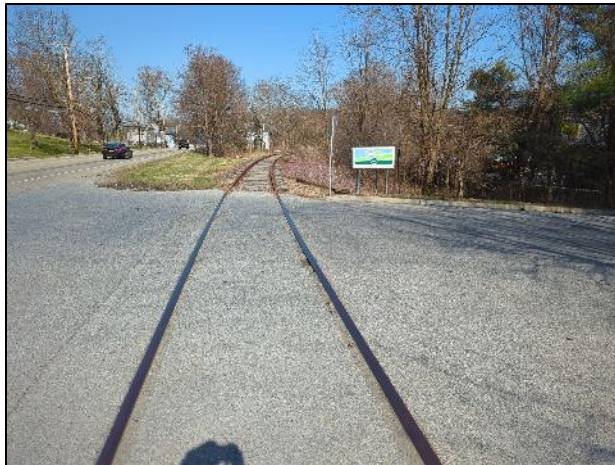
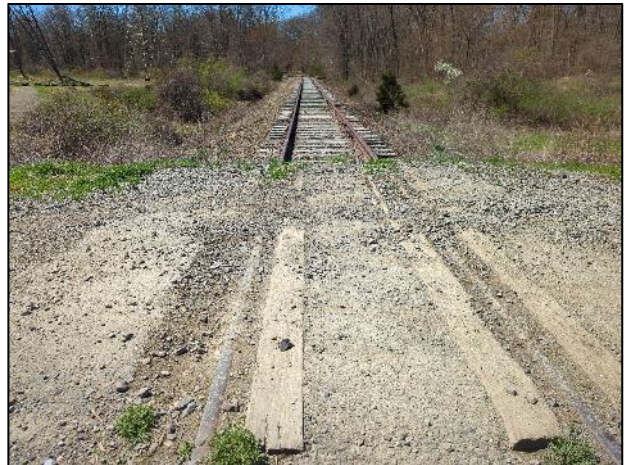
**Figure 17: Railroad Crossings at Commercial Driveway (left) and a gravel maintenance road (right).**
