TRANSPORTATION SAFETY ACTION PLAN

Location Report

DUTCHES COUNTY
TRANSPORTATION COUNCIL

CAMBRIDGE
SYSTEMATICS

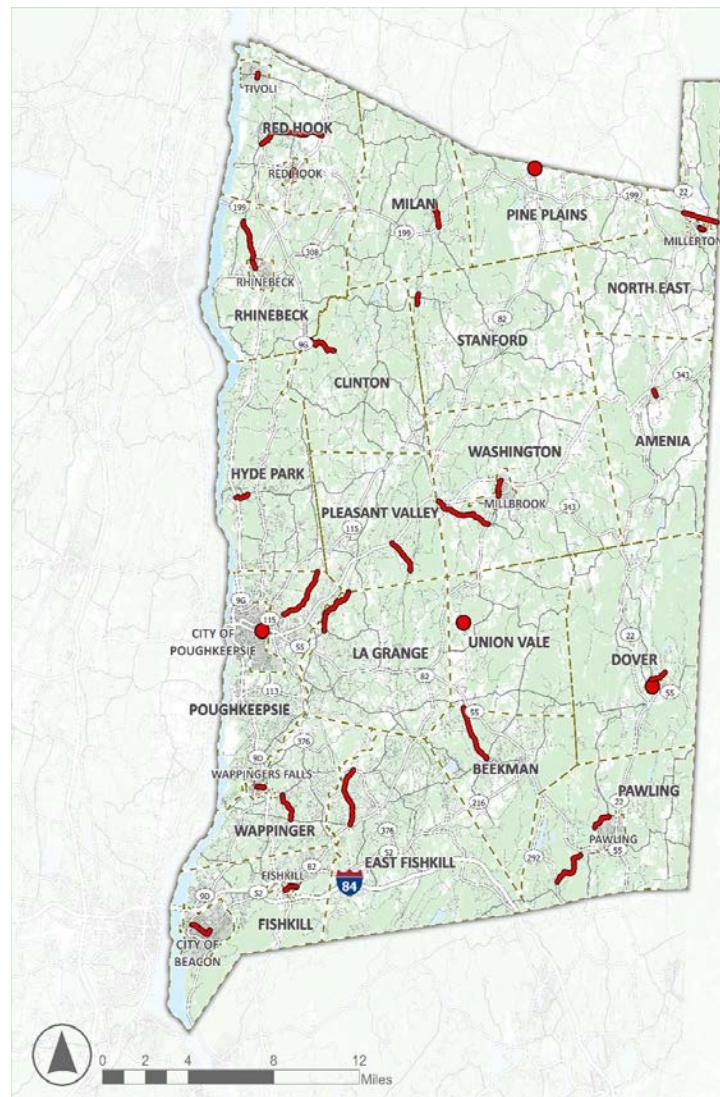
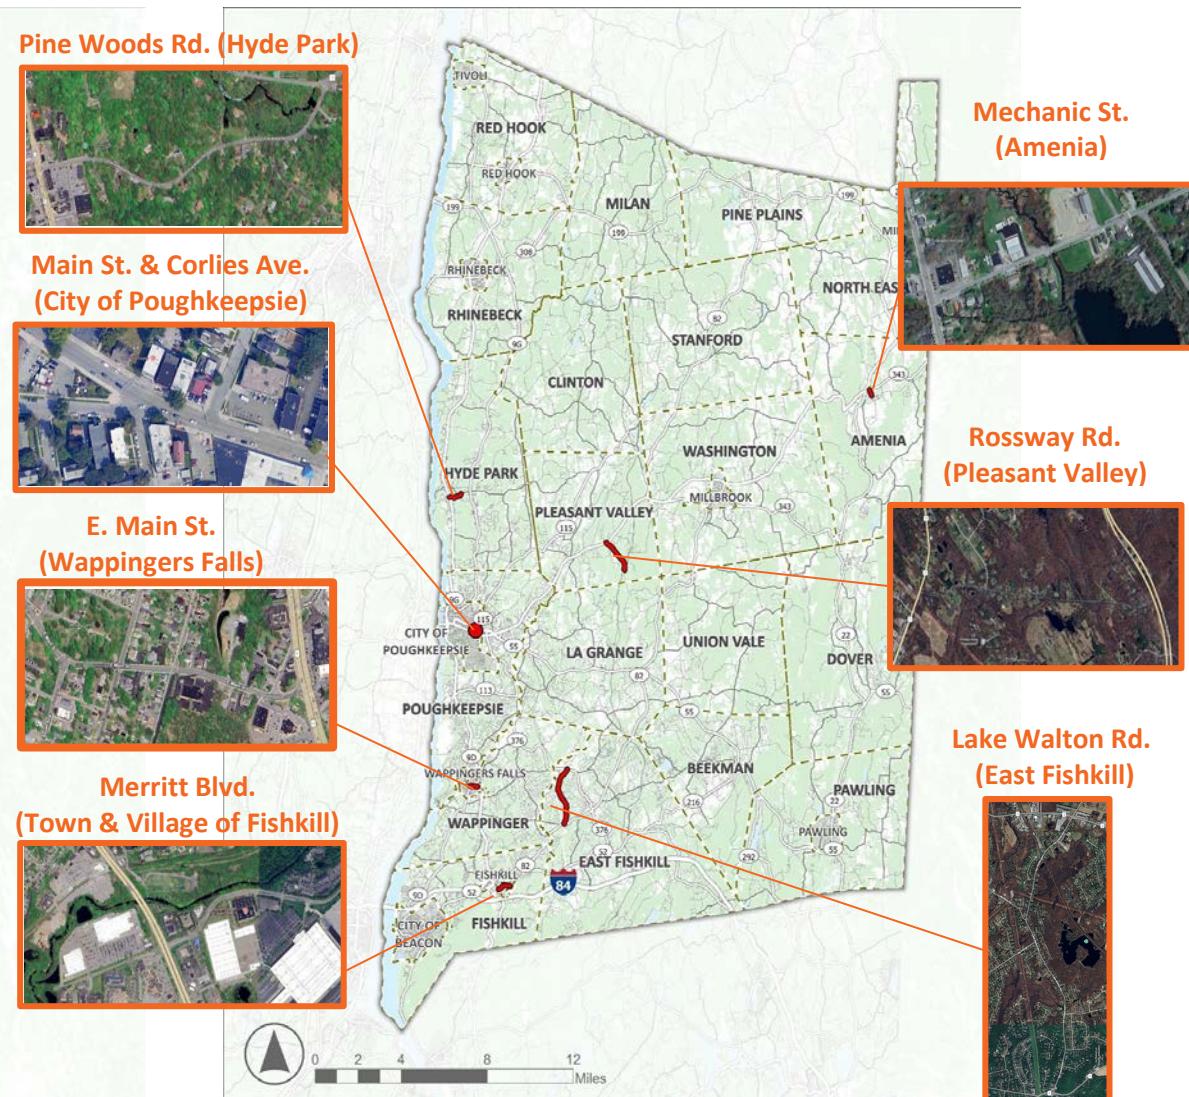
FIGURE 2.1 DESKTOP AND FIELD INVESTIGATION SITES

This report presents the results of these desktop and field investigations, which are mapped in Figure 2.1.

Desktop Investigation Locations

Field Investigation Locations

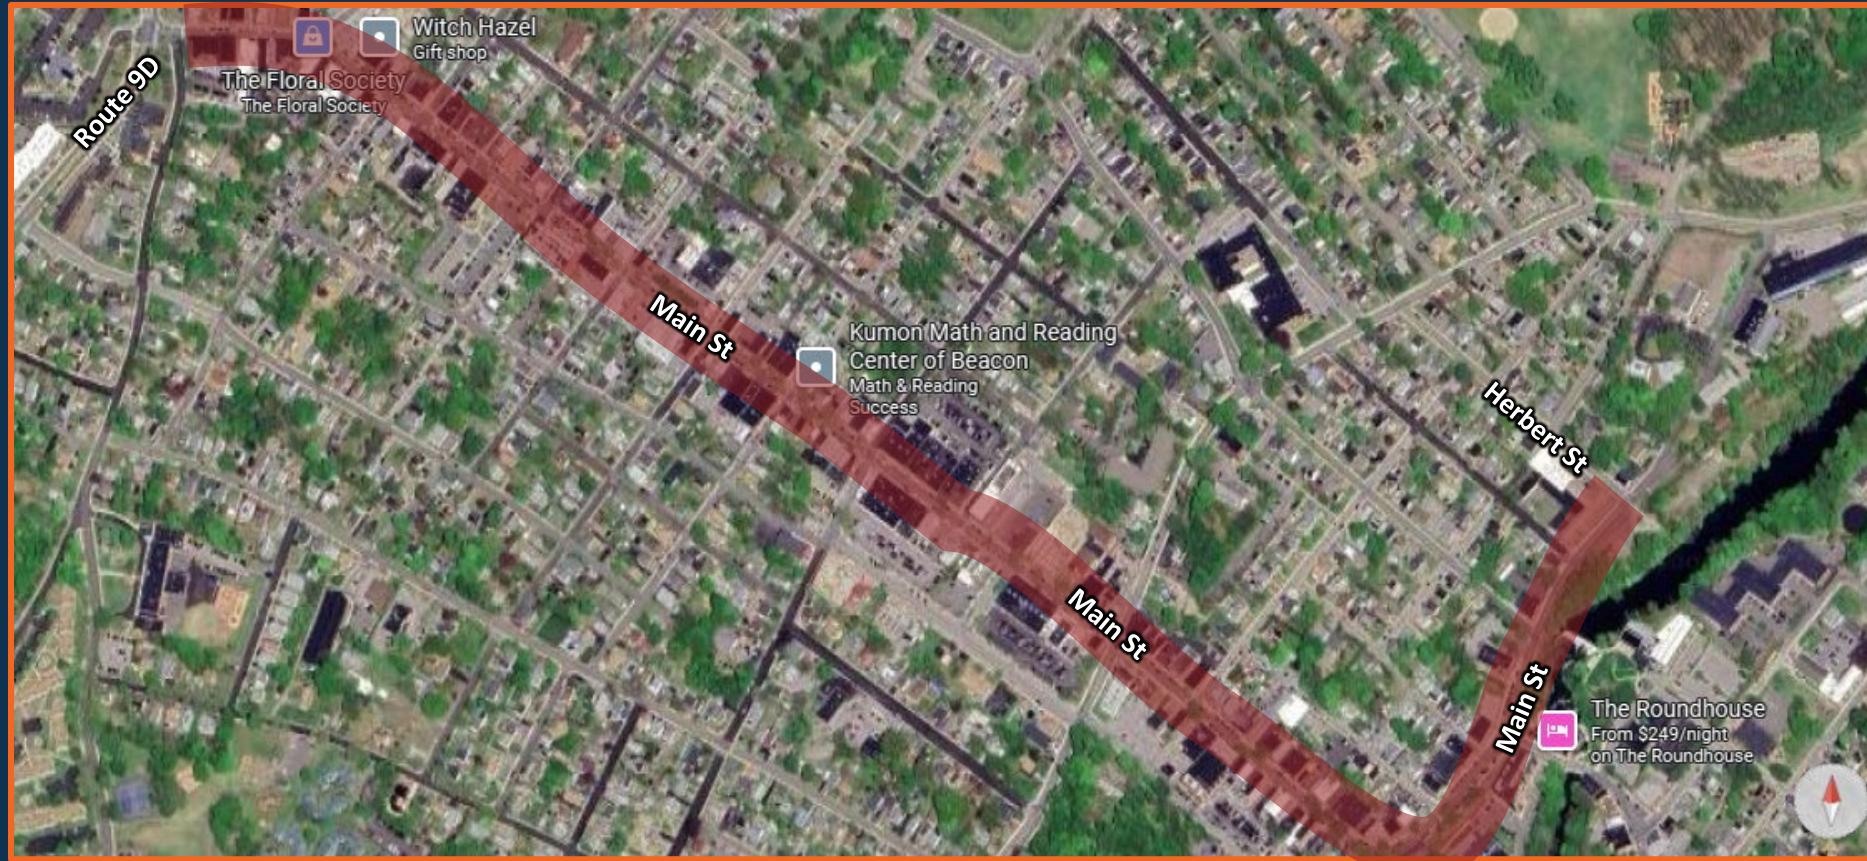
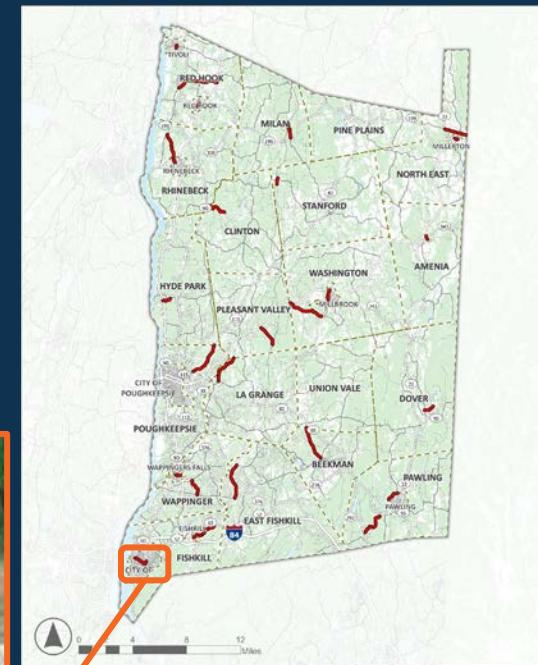
Main St between Route 9D and Herbert St

Location Information (Traffic data obtained from Dutchess County Traffic Data)	
Municipality	City of Beacon
Functional Classification	Major Collector
Area Type	Urban
Road Owner	City of Beacon
Annual Average Daily Traffic (2022)	5,191
Posted Speed Limit	30 MPH
85 th Percentile Speed (2022)	22 MPH
Average Heavy Vehicle Percentage (2022)	1.9%

210* Crashes (2019-2023) – 5% on State Facilities	
Fatal Crashes	1
Serious Injury Crashes	9
Moderate Injury Crashes	12
Minor Injury Crashes	9
Property Damage Only Crashes	179

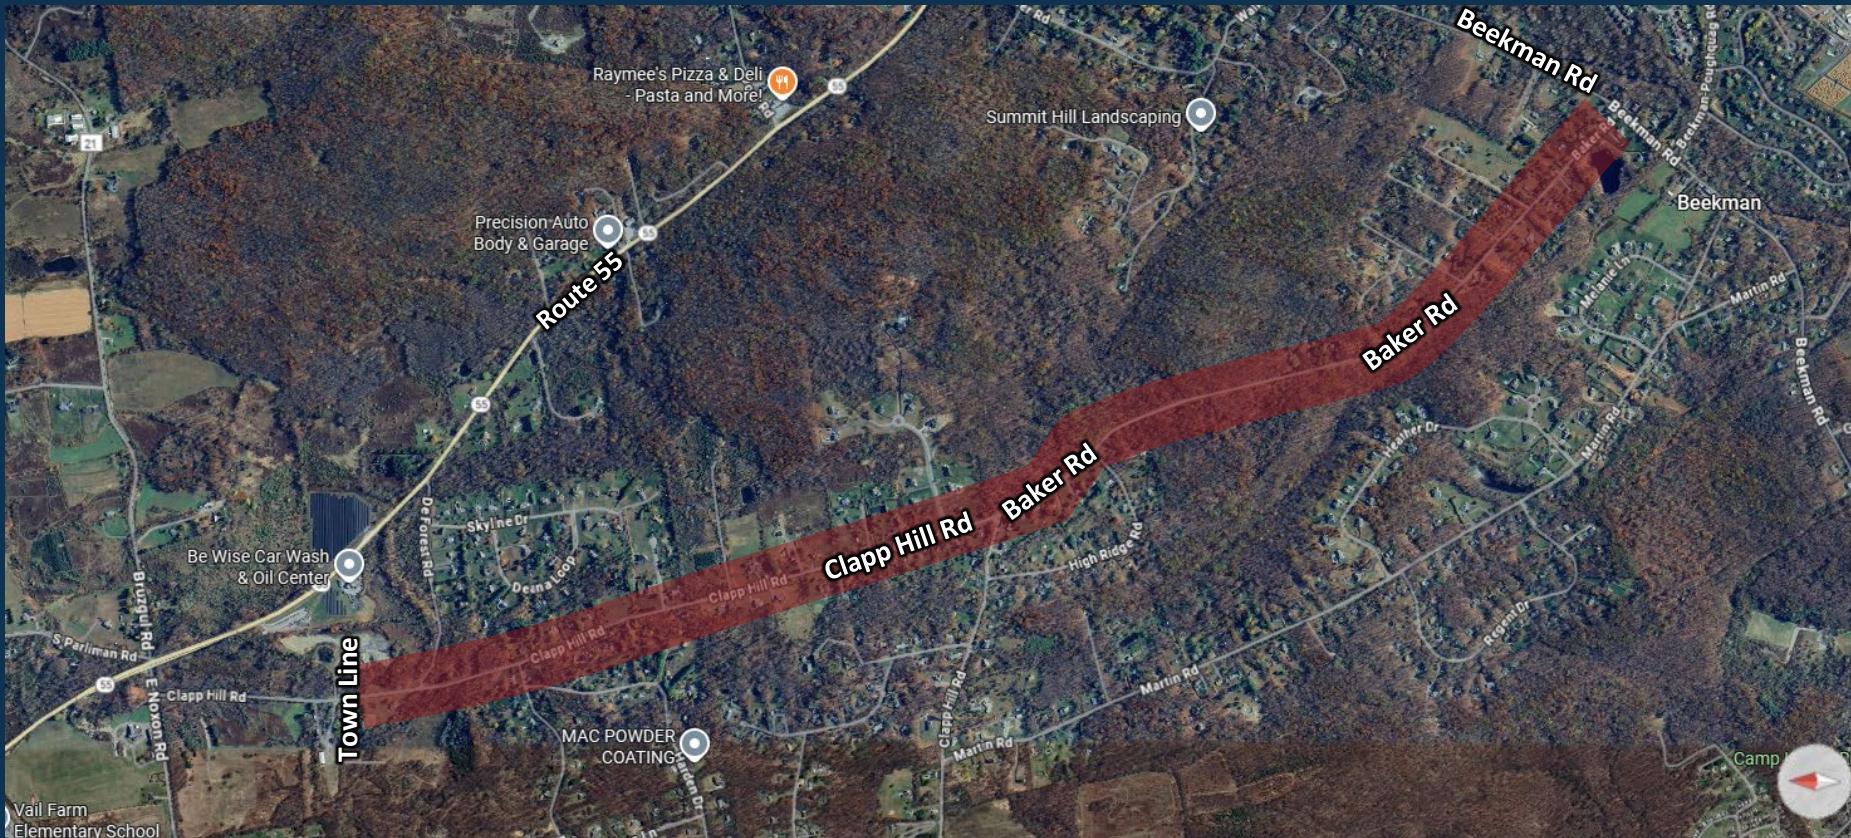
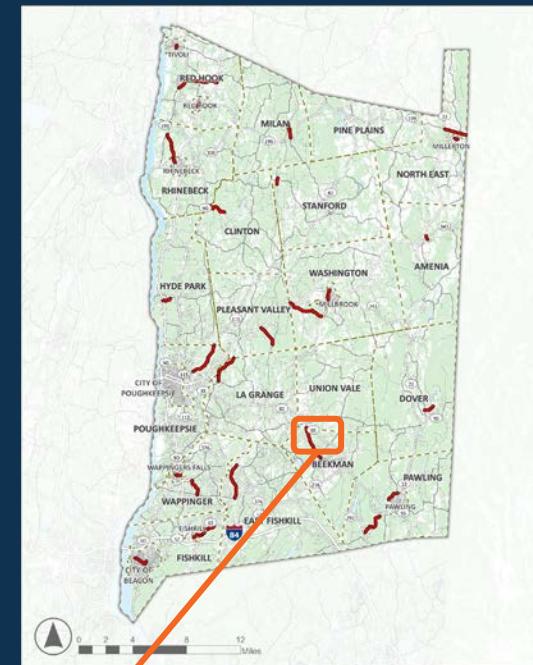
Baker Rd between Beekman Rd (CR 9) and the Town Line

Location Information (Traffic count data not available at this site)	
Municipality	Town of Beekman
Functional Classification	Local
Area Type	Urban
Road Owner	Town of Beekman
Annual Average Daily Traffic (2022)	NA
Posted Speed Limit	40 MPH
85 th Percentile Speed (2022)	NA
Average Heavy Vehicle Percentage (2022)	NA

22* Crashes (2019-2023)	
Fatal Crashes	0
Serious Injury Crashes	2
Moderate Injury Crashes	2
Minor Injury Crashes	1
Property Damage Only Crashes	17

This is a two-way, two-lane undivided segment in a suburban/semi-rural area. There are no sidewalks or street lighting along the road. Some portions of the pavement show signs of cracking. However, other portions show signs of recent repaving.

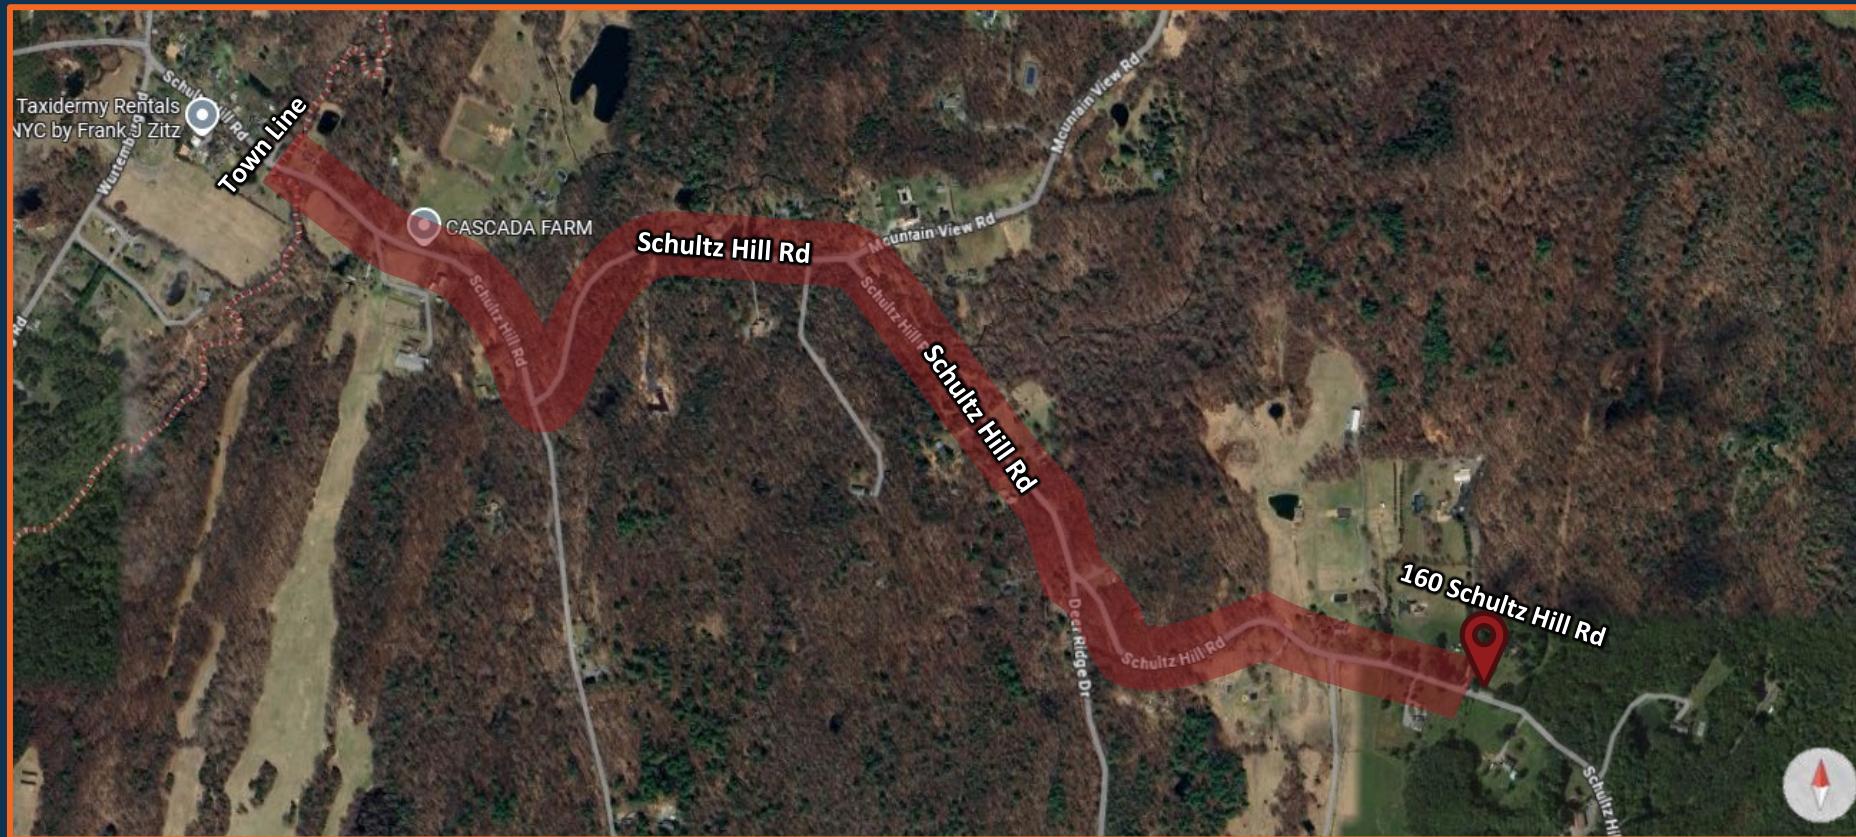
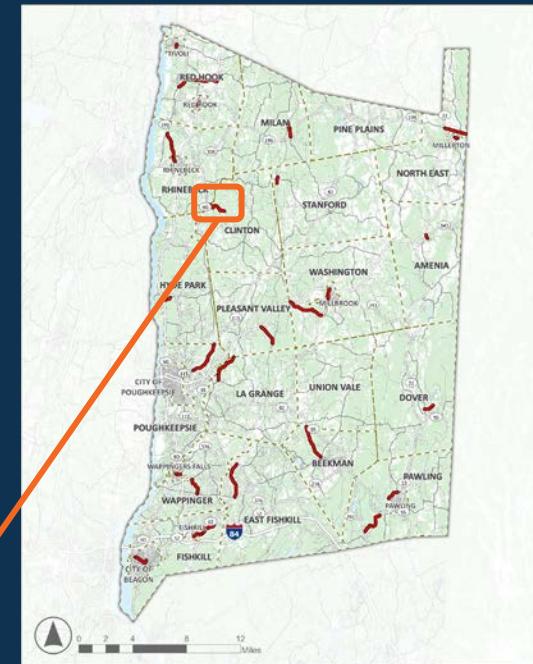
Schultz Hill Rd between the Town Line and 160 Schultz Hill Rd

Location Information (Traffic count data not available at this site)	
Municipality	Town of Clinton
Functional Classification	Local
Area Type	Rural
Road Owner	Town of Clinton
Annual Average Daily Traffic (2022)	NA
Posted Speed Limit	30 MPH
85 th Percentile Speed (2022)	NA
Average Heavy Vehicle Percentage (2022)	NA

This is a two-way, two-lane undivided segment in a rural area. There are no sidewalks or street lighting. The road has significant curves and elevation changes. While curves are supplemented with warning signs and reduced speed advisories, the absence of barriers or enhanced delineation may increase the risk of run-off-road crashes, particularly at nighttime or under adverse weather conditions.

8 Crashes* (2019-2023)	
Fatal Crashes	0
Serious Injury Crashes	1
Moderate Injury Crashes	0
Minor Injury Crashes	1
Property Damage Only Crashes	6

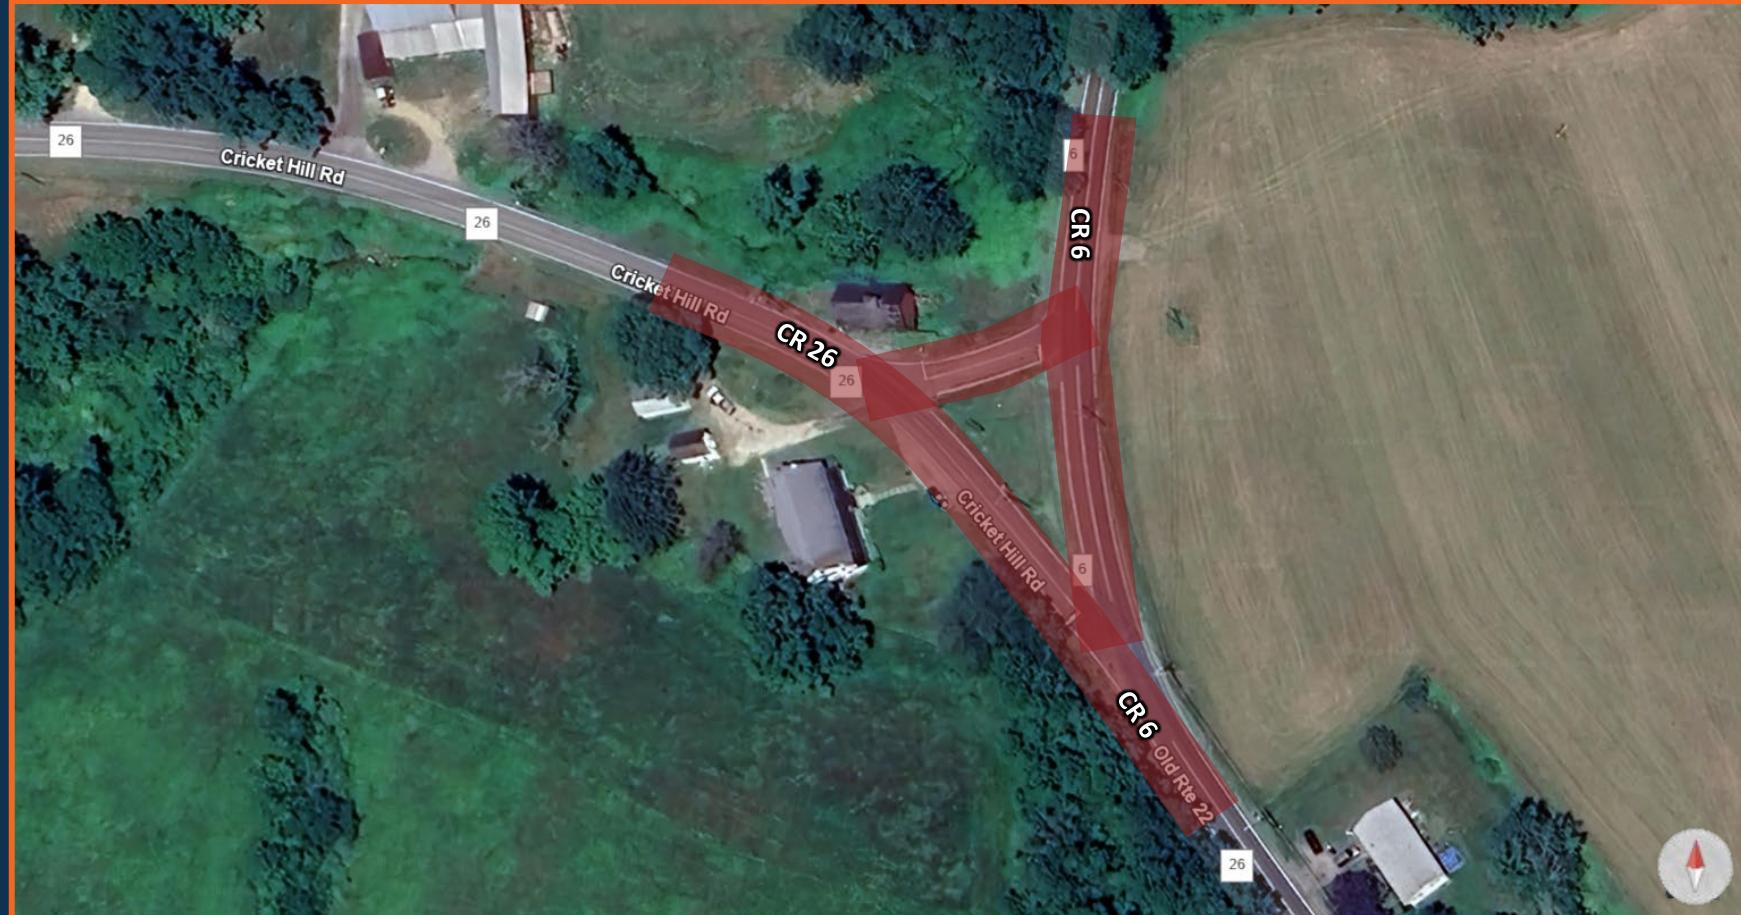
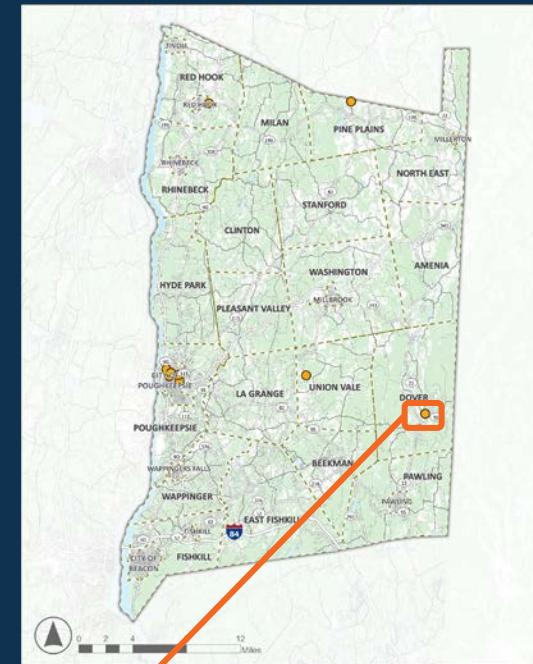
Cricket Hill Rd (CR 26) & Old Route 22 (CR 6) Intersection

Location Information (Traffic data obtained from Dutchess County Traffic Data)	
Municipality	Town of Dover
Functional Classification	Local
Area Type	Rural
Road Owner	Dutchess County
Annual Average Daily Traffic (2023)	CR 26: 1,417 CR 6: 1,752
Posted Speed Limit	40 MPH
85th Percentile Speed (2023)	54 MPH
Average Heavy Vehicle Percentage (2023)	CR 26: 7.3% CR 6: 8%

The east-west segment is on a slope, which may create sight distance limitations, particularly for vehicles turning left from Cricket Hill Rd onto Old Route 22. Street lighting is provided only on Old Route 22, which may reduce the visibility of stop signs and turning vehicles on Cricket Hill Rd, especially under nighttime and low-visibility conditions.

Fatal Crashes	0	Minor Injury Crashes	0
Serious Injury Crashes	0	Property Damage Only Crashes	6
Moderate Injury Crashes	1

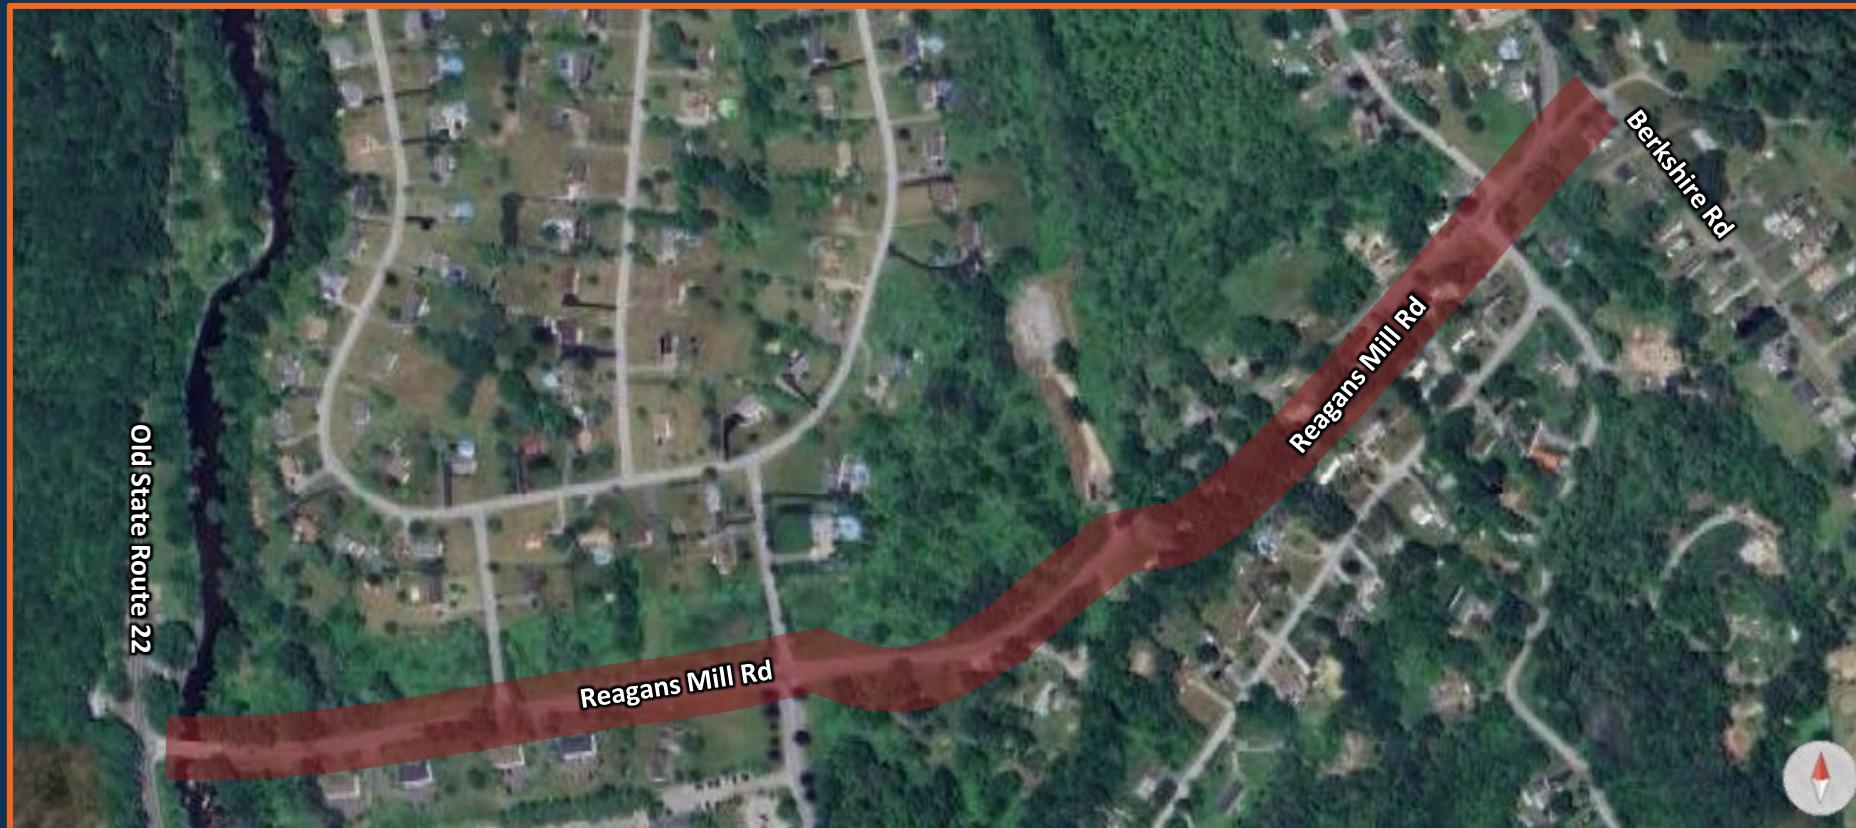
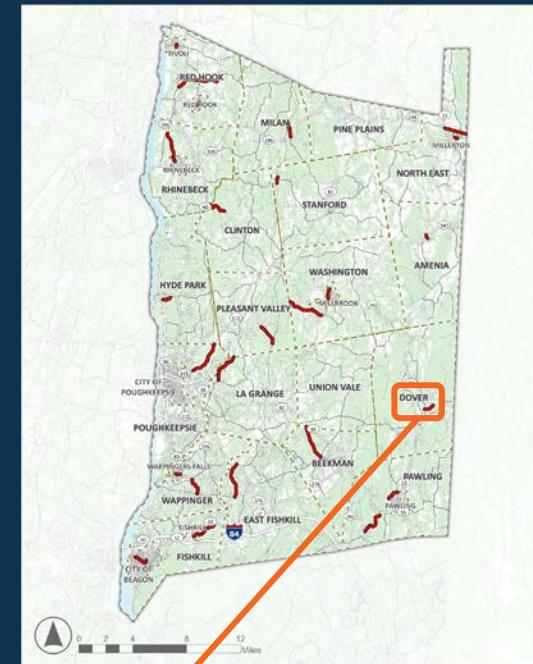
Reagans Mill Rd between Old State Route 22 (CR 6) and Berkshire Rd

Location Information (Traffic data obtained from Dutchess County Traffic Data)	
Municipality	Town of Dover
Functional Classification	Local
Area Type	Rural
Road Owner	Town of Dover
Annual Average Daily Traffic (2022)	3,176
Posted Speed Limit	40 MPH
85 th Percentile Speed (2022)	44 MPH
Average Heavy Vehicle Percentage (2022)	5.2%

8 Crashes* (2019-2023)	
Fatal Crashes	0
Serious Injury Crashes	1
Moderate Injury Crashes	1
Minor Injury Crashes	0
Property Damage Only Crashes	6

All intersections along Reagans Mill Rd are side-street stop-controlled. However, only the intersection at Old State Route 22 has a stop bar. The absence of stop bars at the other intersections may reduce driver compliance with stop signs. The segment between White Farm Rd and Morgan Dr has a slight curve with a guiderail, but advance warning signs may improve driver awareness. The triangular intersection with Berkshire Rd is unusual and may cause driver confusion.

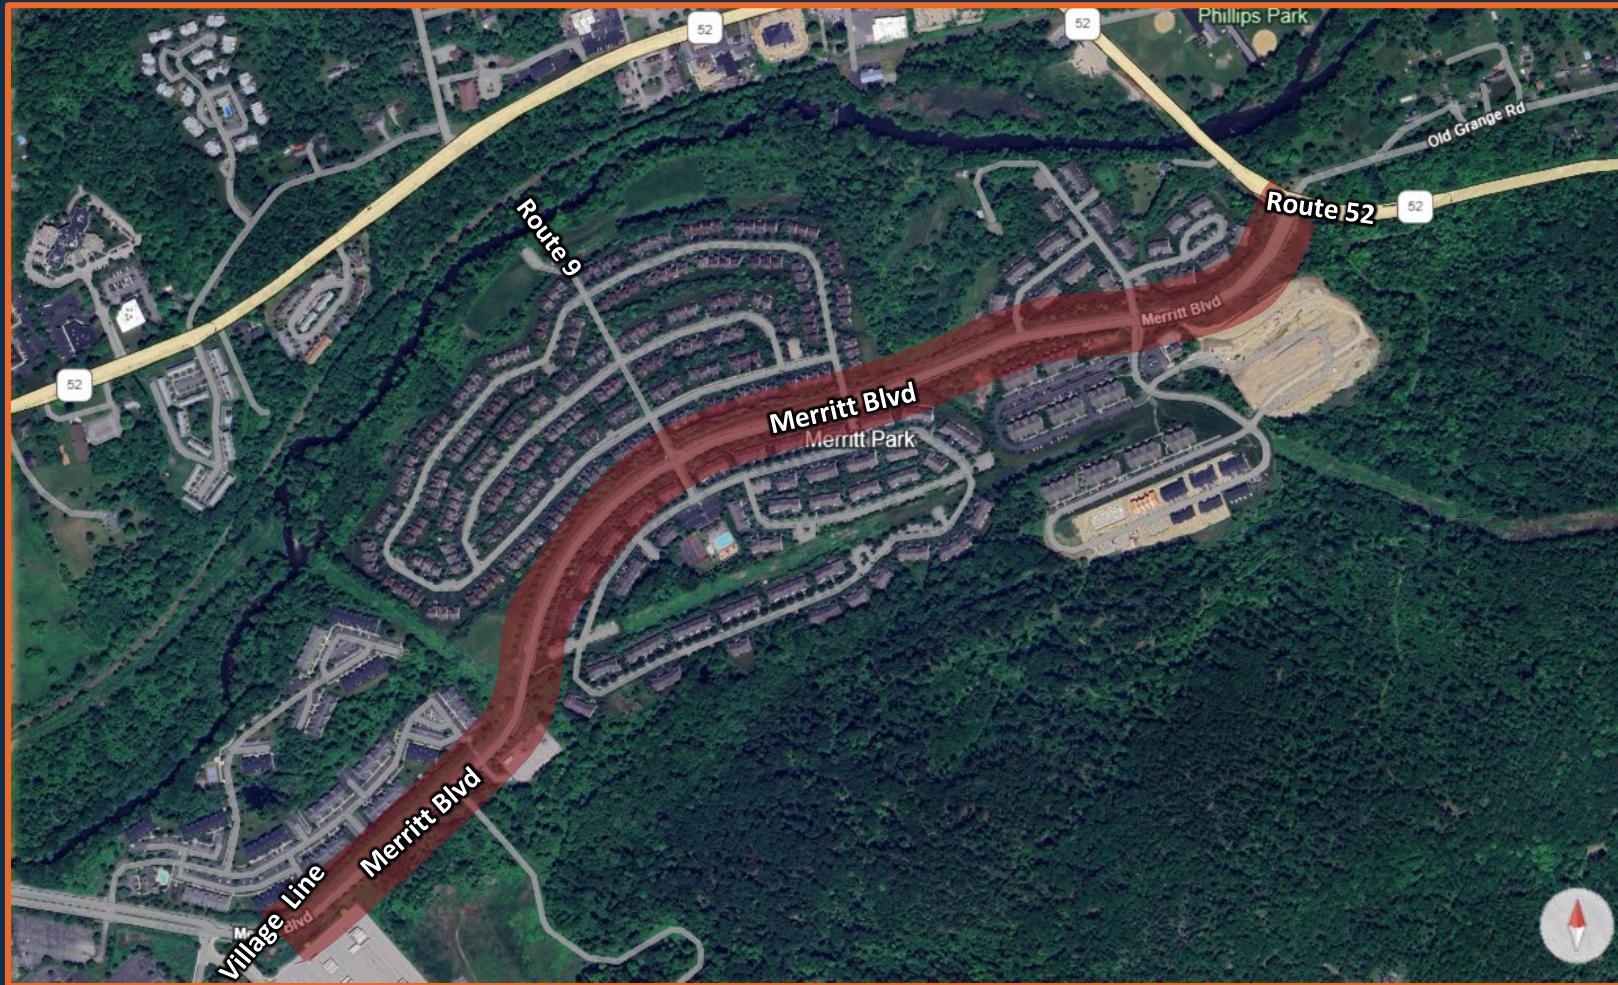
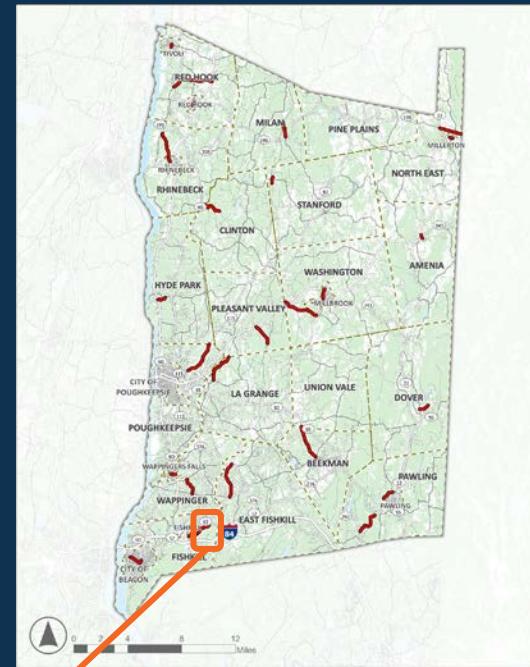
Merritt Blvd between the Village Line and Route 52

Location Information (Traffic data obtained from Dutchess County Traffic Data)	
Municipality	Town of Fishkill
Functional Classification	Major Collector
Area Type	Urban
Road Owner	Town of Fishkill
Annual Average Daily Traffic (2022)	8,525
Posted Speed Limit	30 MPH
85 th Percentile Speed (2022)	43 MPH
Average Heavy Vehicle Percentage (2022)	2.1%

Fatal Crashes	1
Serious Injury Crashes	1
Moderate Injury Crashes	2
Minor Injury Crashes	4
Property Damage Only Crashes	19

Along the segment, double-yellow centerlines, white edge lines, and delineator posts are present. Curve warning signs are installed in advance of curves, with guardrails at the curves. The Speed limit signs with radar speed feedback are also present. It should be noted that the beginning section of the guardrail on the east side of the curve west of Vanderbilt Way appears to have been struck and should be restored.

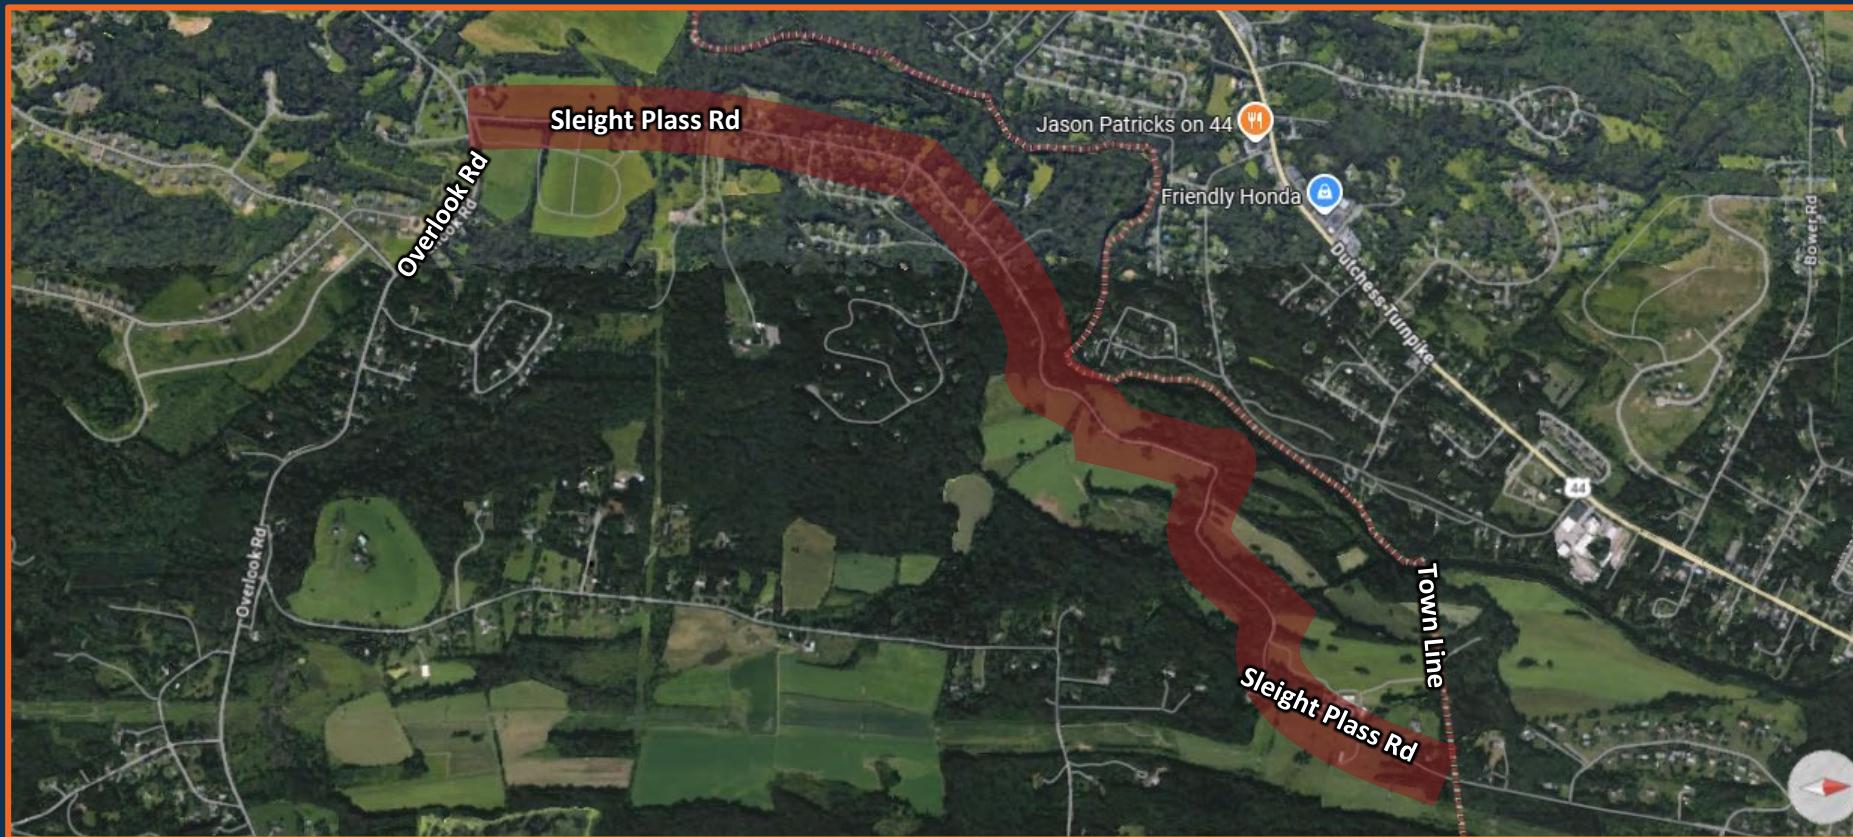
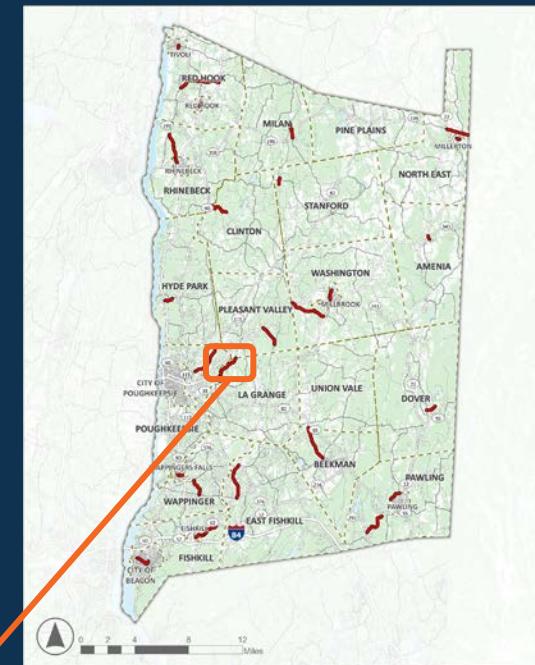
Sleight Plass Rd between Overlook Rd (CR 46) and the Town Line

Location Information (Traffic count data not available at this site)	
Municipality	Town of LaGrange
Functional Classification	Local
Area Type	Urban
Road Owner	Town of LaGrange
Annual Average Daily Traffic (2022)	NA
Posted Speed Limit	35 MPH
85 th Percentile Speed (2022)	NA
Average Heavy Vehicle Percentage (2022)	NA

22 Crashes* (2019-2023)	
Fatal Crashes	1
Serious Injury Crashes	0
Moderate Injury Crashes	2
Minor Injury Crashes	4
Property Damage Only Crashes	15

All intersections along Sleight Plass Rd are stop-controlled (most are side-street stops; Acorn Dr is an all-way stop). There is also a series of driveways along the corridor, which may lead to conflicts with through traffic. The northern segment has a series of substantial horizontal and vertical curves. Overall, the pavement appears to be in good condition.

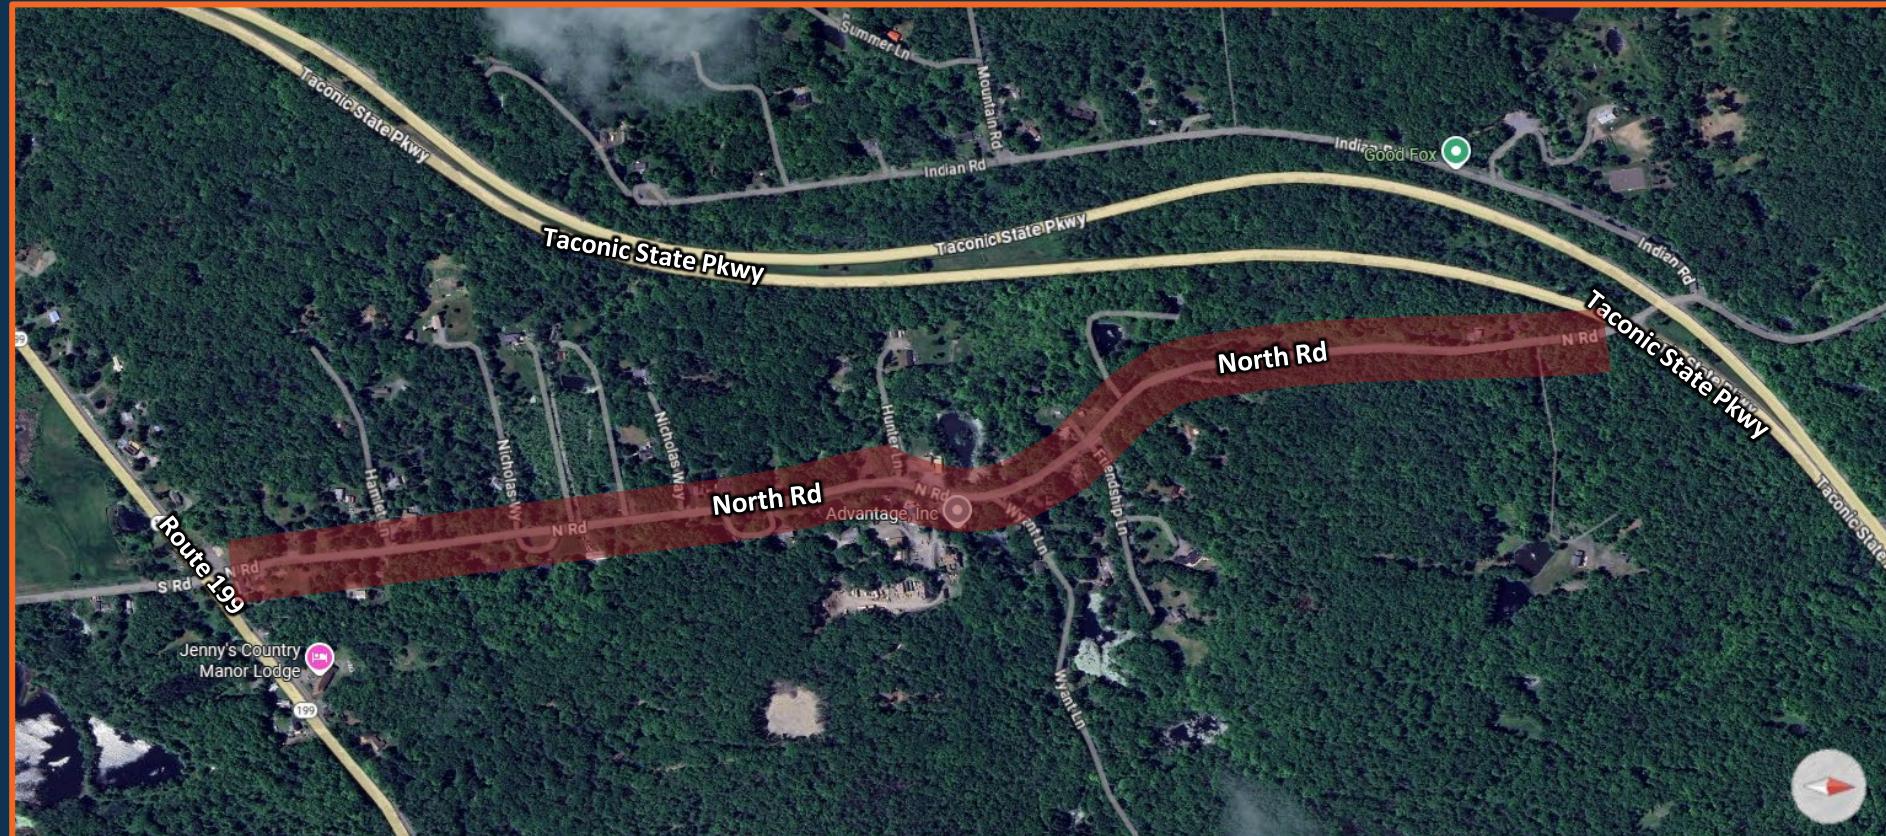
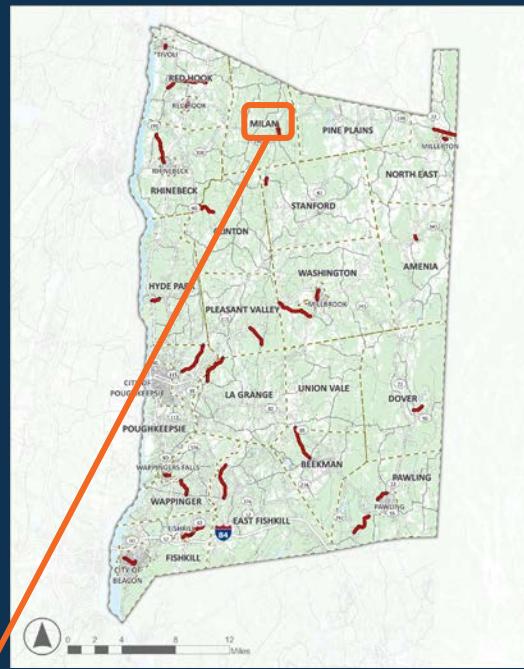
North Rd between Route 199 and the Taconic State Pkwy

Location Information (Traffic count data not available at this site)	
Municipality	Town of Milan
Functional Classification	Local
Area Type	Rural
Road Owner	Town of Milan
Annual Average Daily Traffic (2022)	NA
Posted Speed Limit	35 MPH
85 th Percentile Speed (2022)	NA
Average Heavy Vehicle Percentage (2022)	NA

4 Crashes* (2019-2023) – 25% on State Facilities	
Fatal Crashes	0
Serious Injury Crashes	1
Moderate Injury Crashes	1
Minor Injury Crashes	0
Property Damage Only Crashes	2

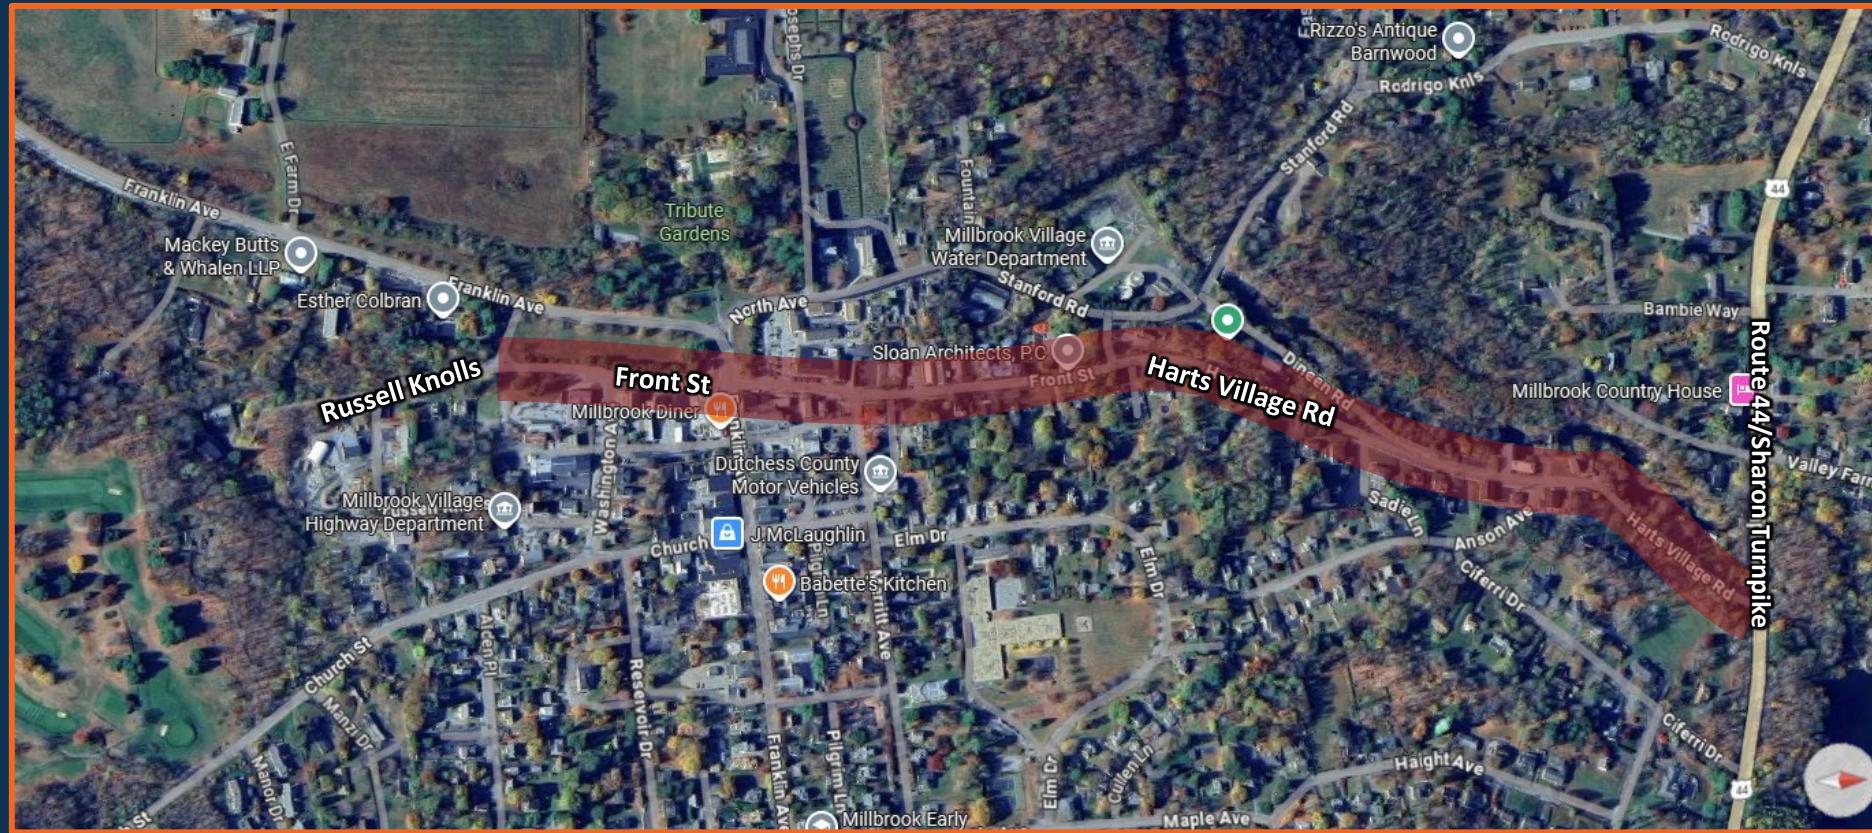
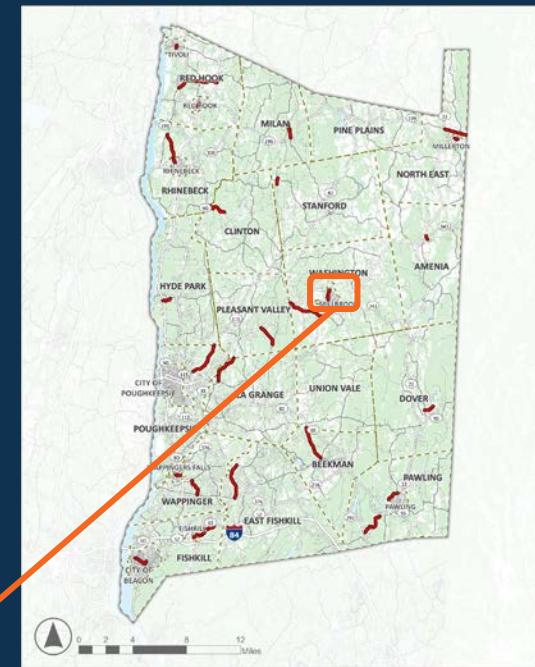
Front St/Harts Village Rd between Russell Knolls and Route 44

Location Information (Traffic count data not available at this site)	
Municipality	Village of Millbrook
Functional Classification	Local
Area Type	Rural
Road Owner	Village of Millbrook
Annual Average Daily Traffic	NA
Posted Speed Limit	25 MPH
85 th Percentile Speed	NA
Average Heavy Vehicle Percentage	NA

11 Crashes* (2019-2023)	
Fatal Crashes	0
Serious Injury Crashes	0
Moderate Injury Crashes	1
Minor Injury Crashes	0
Property Damage Only Crashes	10

The street has no centerline or edge lines. The pavement quality is fair; there are instances of cracking, indicating a future need for road maintenance. Streetlights are provided and there is on-street parking near the Franklin Ave intersection.
