TRANSPORTATION SAFETY ACTION PLAN

Location Report

DUTCHES COUNTY
TRANSPORTATION COUNCIL

CAMBRIDGE
SYSTEMATICS

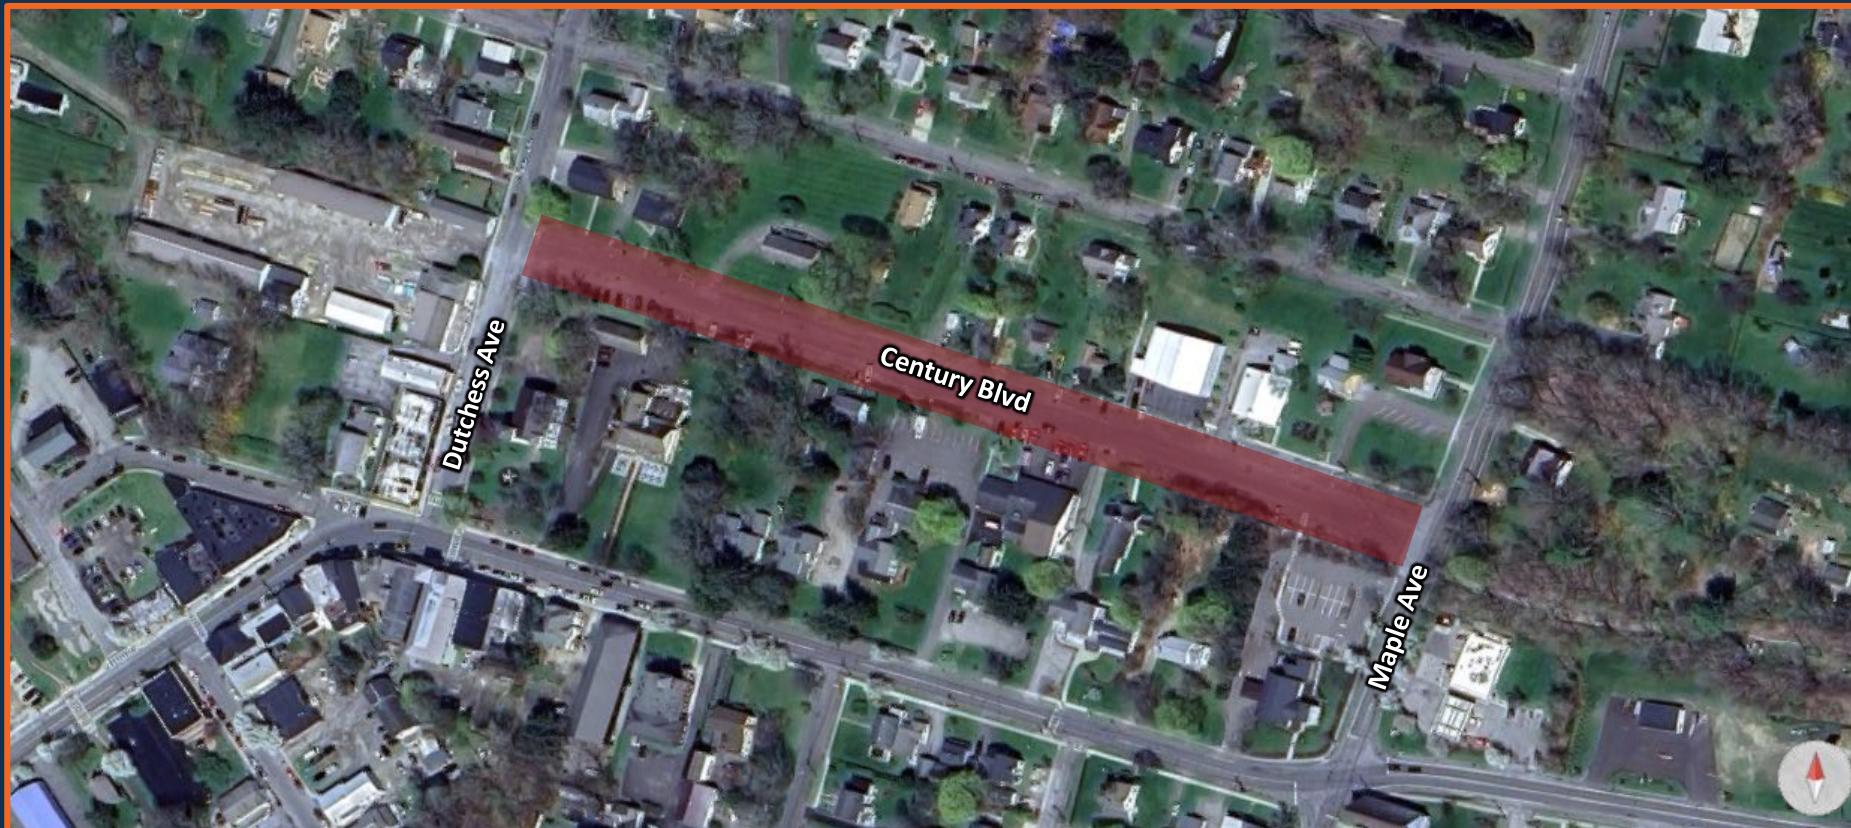
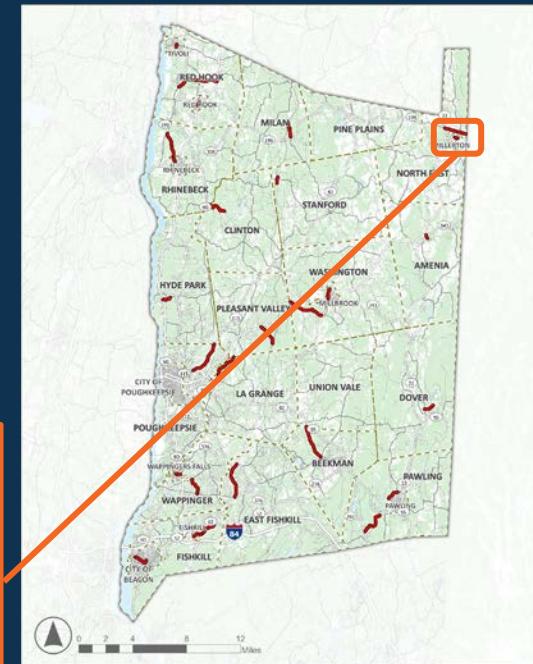
Century Blvd between Dutchess Ave and Maple Ave (CR 62)

Location Information (Traffic count data not available at this site)	
Municipality	Village of Millerton
Functional Classification	Local
Area Type	Rural
Road Owner	Village of Millerton
Annual Average Daily Traffic	NA
Posted Speed Limit	NA
85 th Percentile Speed	NA
Average Heavy Vehicle Percentage	NA
6 Crashes* (2019-2023)	
Fatal Crashes	0
Serious Injury Crashes	0
Moderate Injury Crashes	1
Minor Injury Crashes	1
Property Damage Only Crashes	4

The road has no centerline and no street lighting. The pavement condition appears fair.

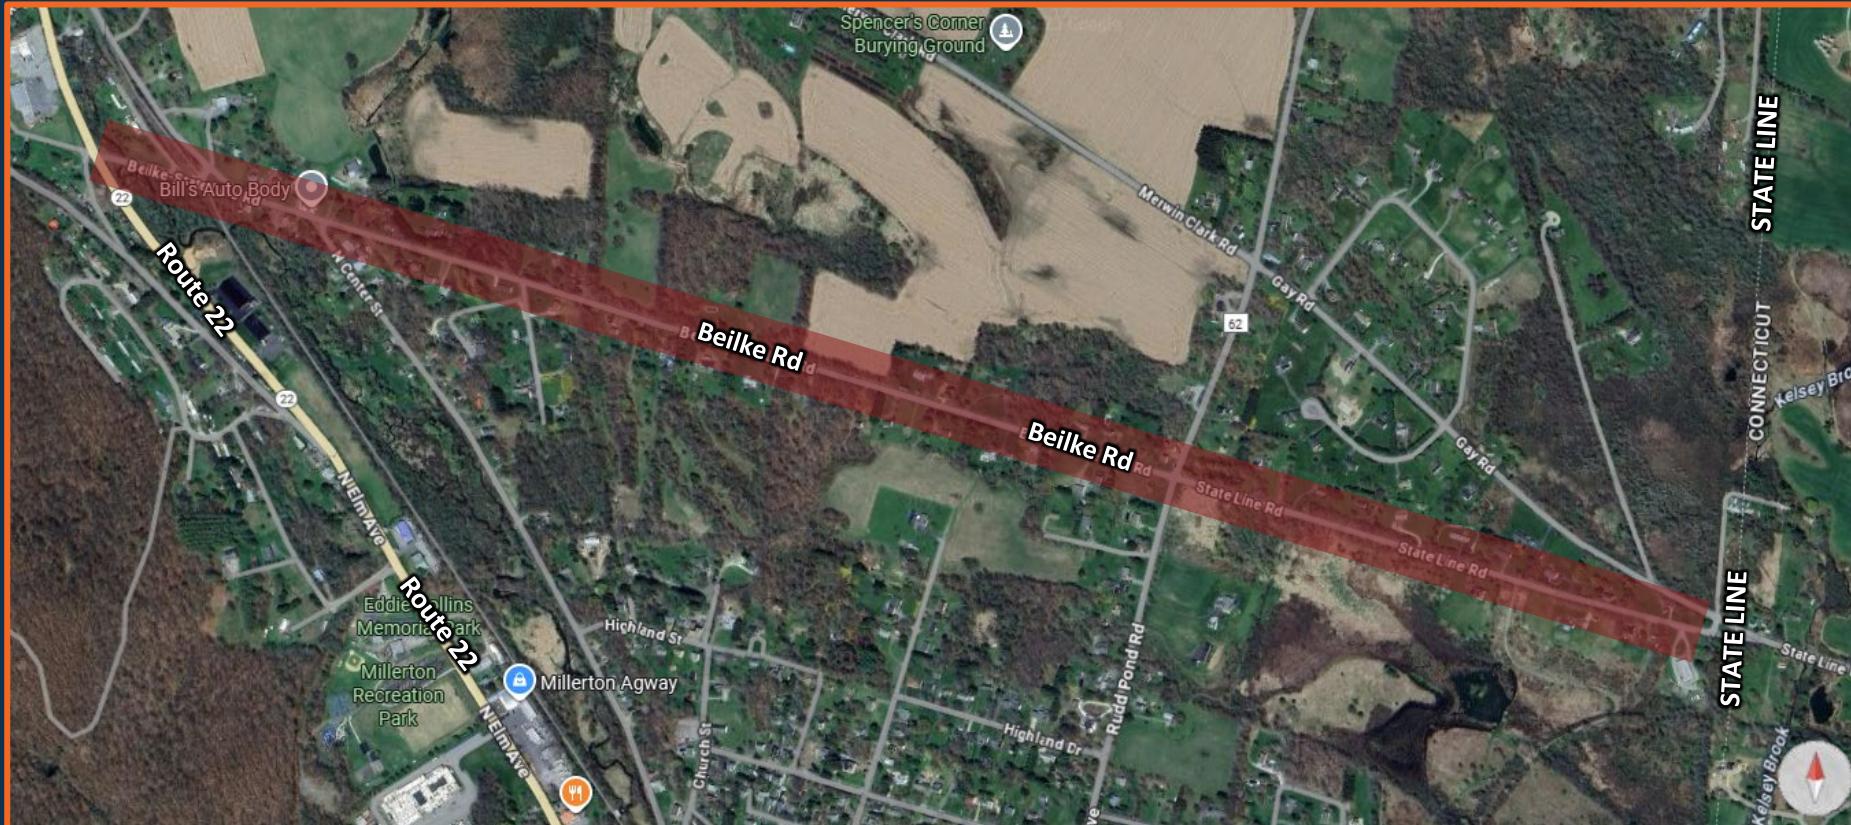
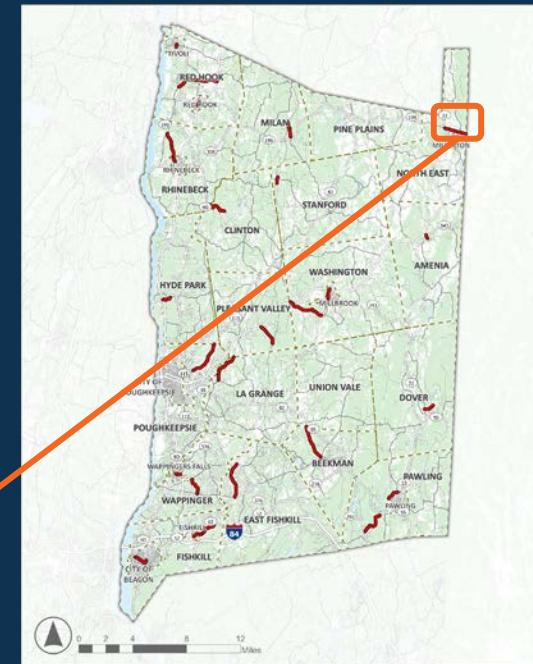
Beilke Rd/State Line Rd between Route 22 and the Town Line

Location Information (Traffic data obtained from Dutchess County Traffic Data)	
Municipality	Town of North East
Functional Classification	Minor Collector
Area Type	Rural
Road Owner	Town of North East
Annual Average Daily Traffic (2022)	963
Posted Speed Limit	40 MPH
85 th Percentile Speed (2022)	47 MPH
Average Heavy Vehicle Percentage (2022)	3.9%

Fatal Crashes	0
Serious Injury Crashes	0
Moderate Injury Crashes	3
Minor Injury Crashes	2
Property Damage Only Crashes	6

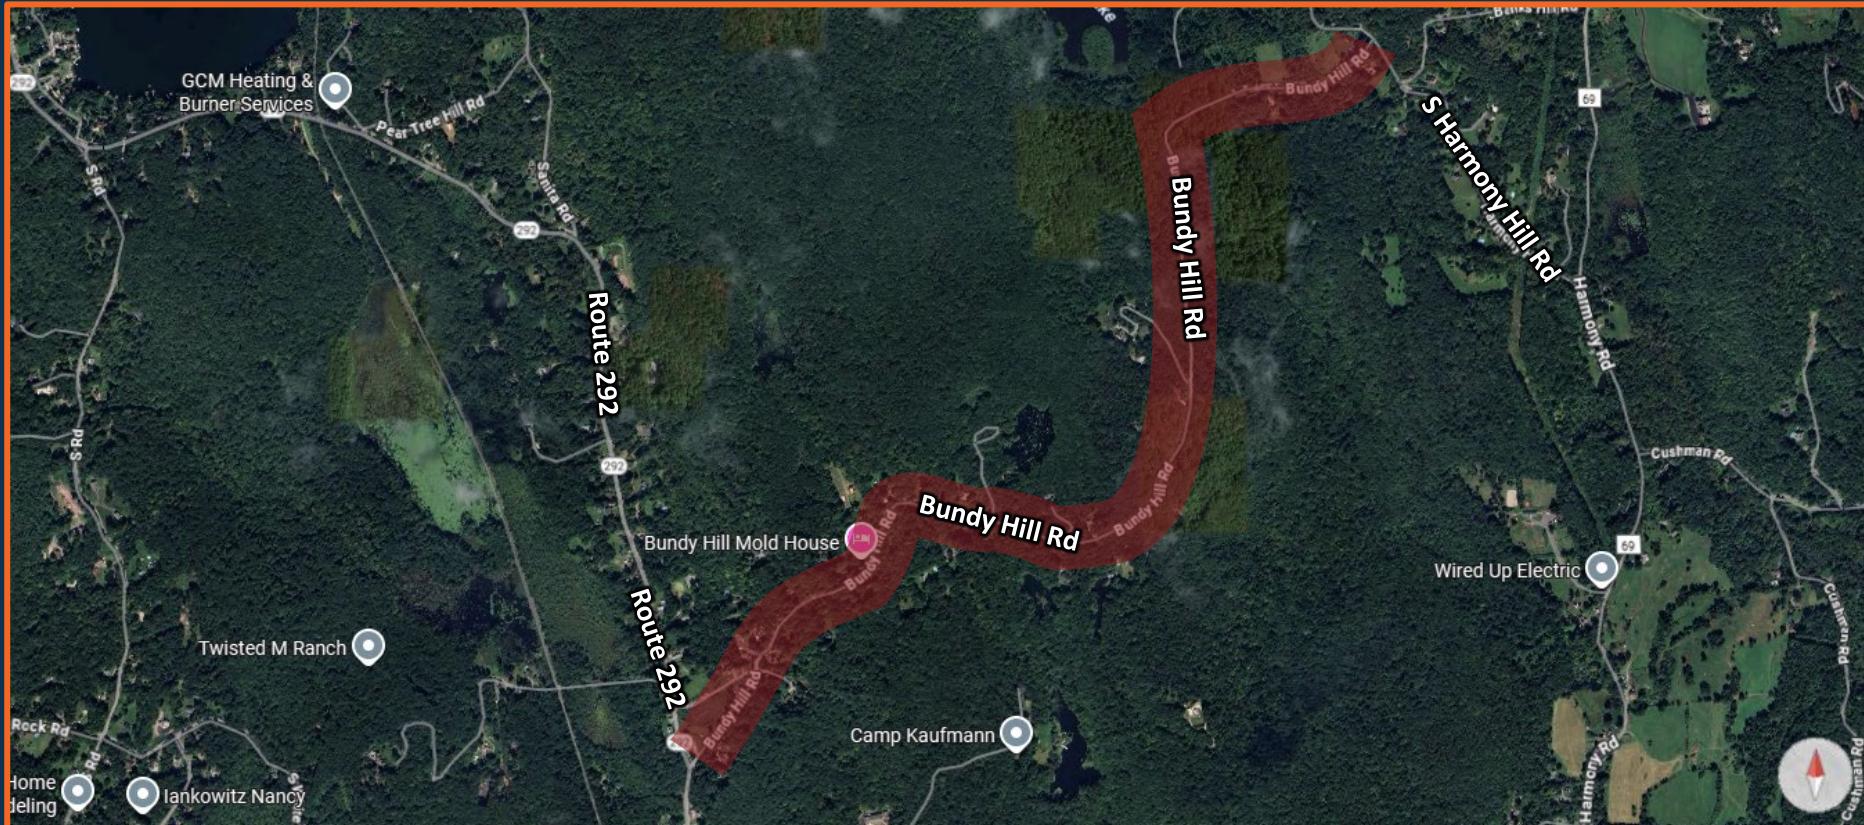
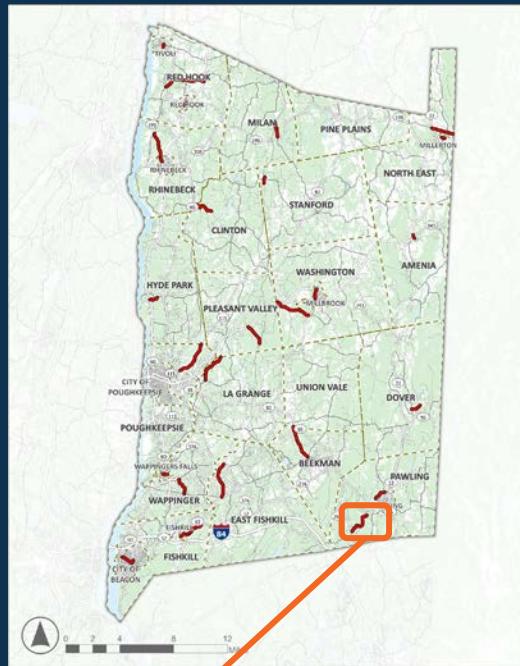
Bundy Hill Rd between Route 292 and S. Harmony Hill Rd

Location Information (Traffic count data not available at this site)	
Municipality	Town of Pawling
Functional Classification	Local
Area Type	Rural
Road Owner	Town of Pawling
Annual Average Daily Traffic (2022)	NA
Posted Speed Limit	30 MPH
85 th Percentile Speed (2022)	NA
Average Heavy Vehicle Percentage (2022)	NA

Fatal Crashes	0
Serious Injury Crashes	2
Moderate Injury Crashes	1
Minor Injury Crashes	1
Property Damage Only Crashes	17

There are no sidewalks and no street lighting. At some horizontal curves, there are chevrons and warning signs with advisory speeds. The road is cracked in some locations, indicating a future need for road maintenance.

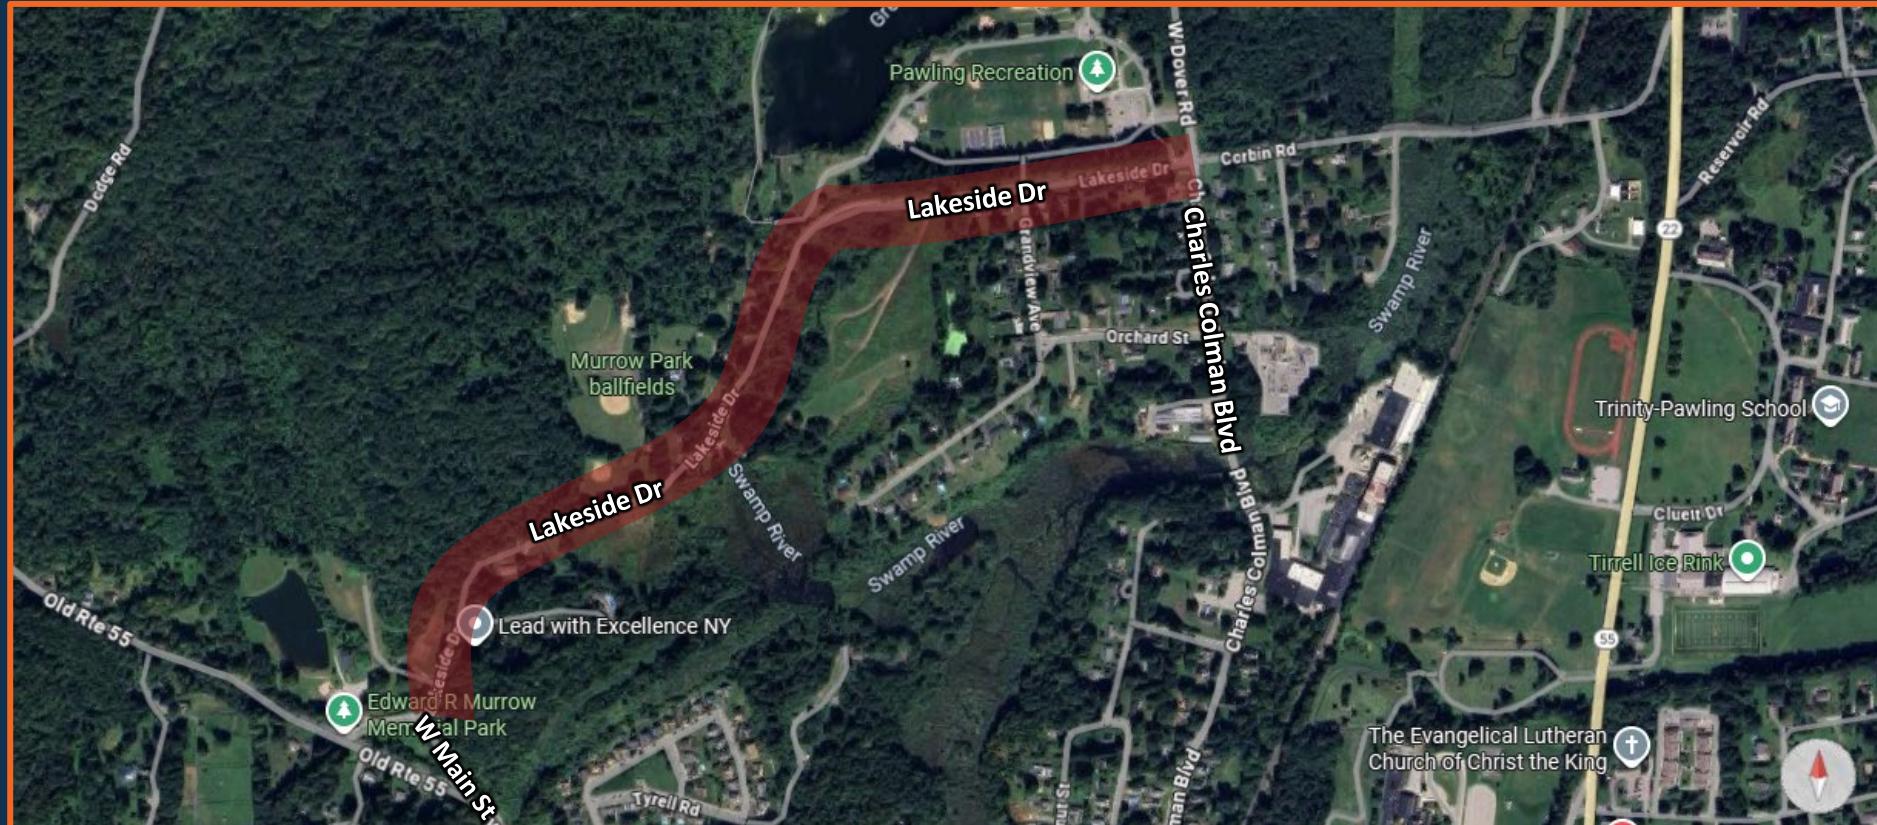
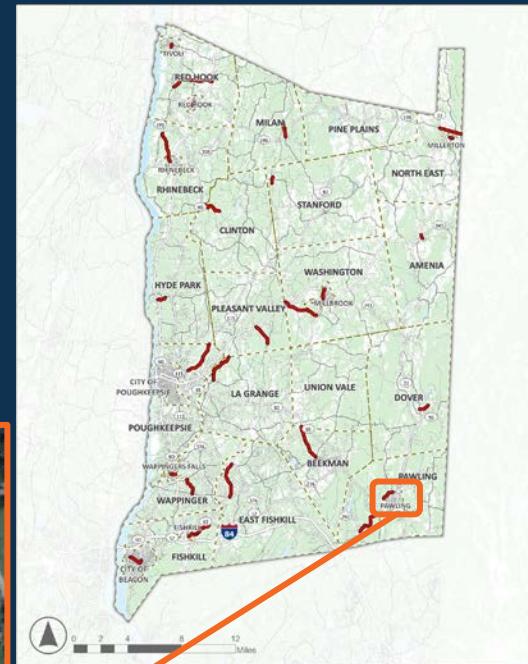
Lakeside Dr between W. Main St and Charles Colman Blvd

Location Information (Traffic count data not available at this site)	
Municipality	Village of Pawling
Functional Classification	Local
Area Type	Rural
Road Owner	Village of Pawling
Annual Average Daily Traffic	NA
Posted Speed Limit	30 MPH
85th Percentile Speed	NA
Average Heavy Vehicle Percentage	NA

9 Crashes* (2019-2023)	
Fatal Crashes	0
Serious Injury Crashes	0
Moderate Injury Crashes	0
Minor Injury Crashes	1
Property Damage Only Crashes	8

Lakeside Dr has cracked pavement, indicating a need for road maintenance.

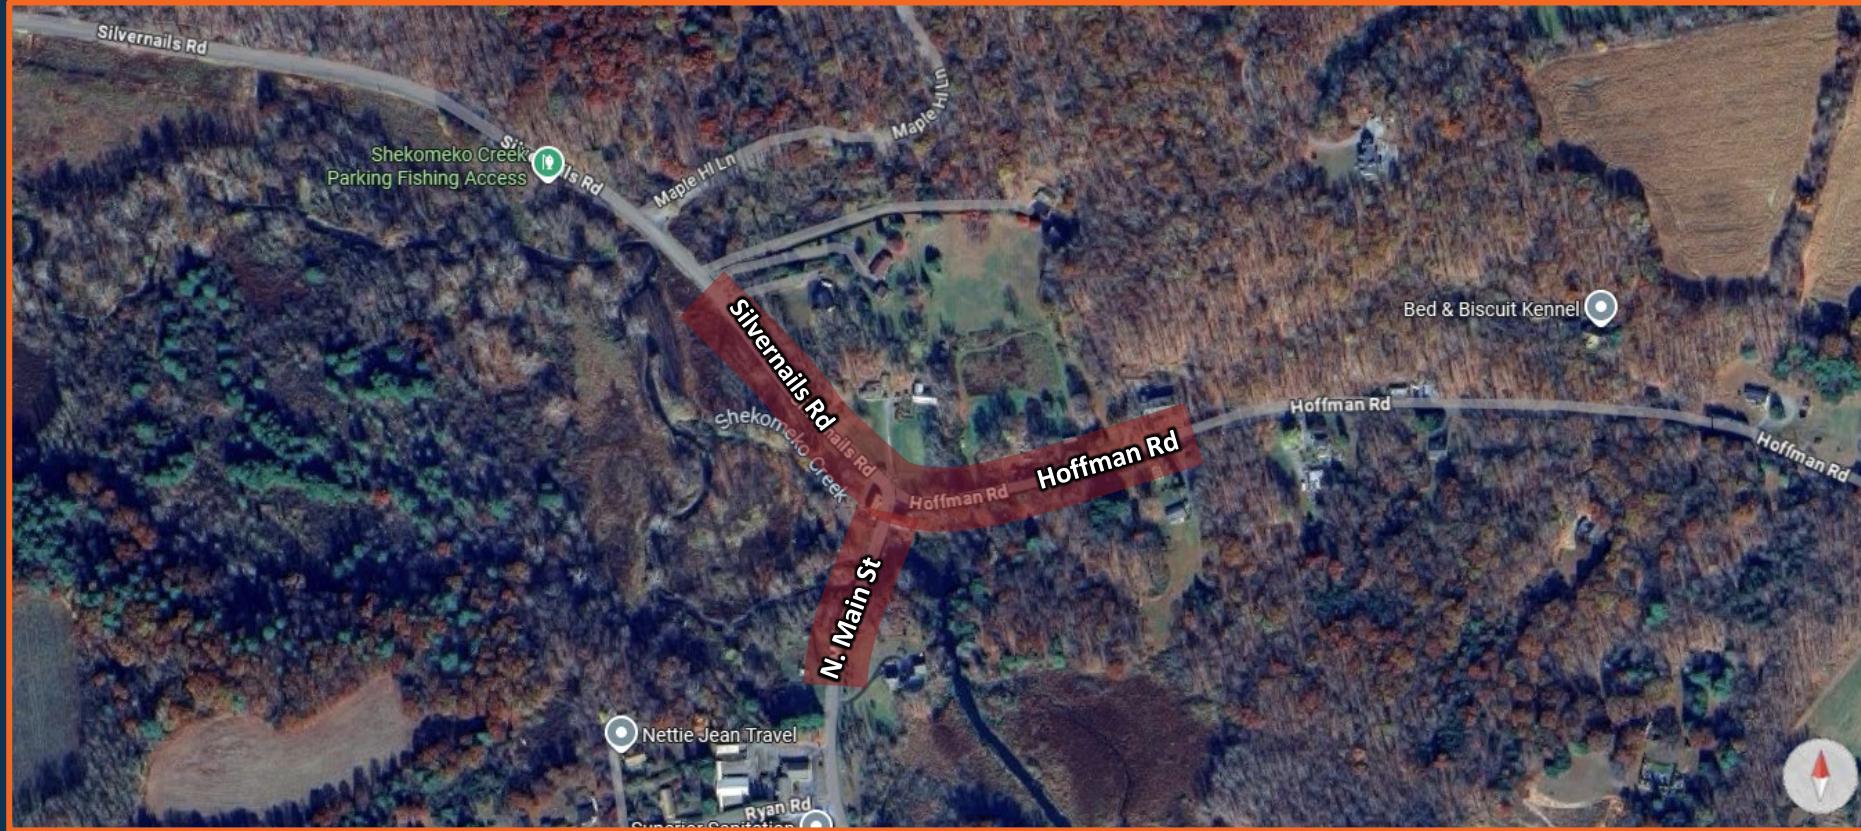
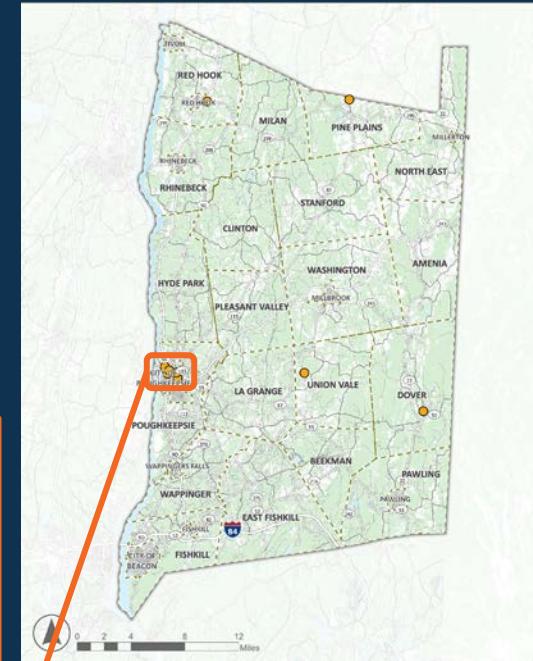
N. Main St, Hoffman Rd, & Silvernails Rd Intersection

Location Information (Traffic count data not available at this site)	
Municipality	Town of Pine Plains
Functional Classification	Local
Area Type	Rural
Road Owner	Town of Pine Plains
Annual Average Daily Traffic (2022)	NA
Posted Speed Limit	30 MPH
85 th Percentile Speed (2022)	NA
Average Heavy Vehicle Percentage (2022)	NA

1 Crash* (2019-2023)	
Fatal Crashes	0
Serious Injury Crashes	0
Moderate Injury Crashes	0
Minor Injury Crashes	0
Property Damage Only Crashes	1

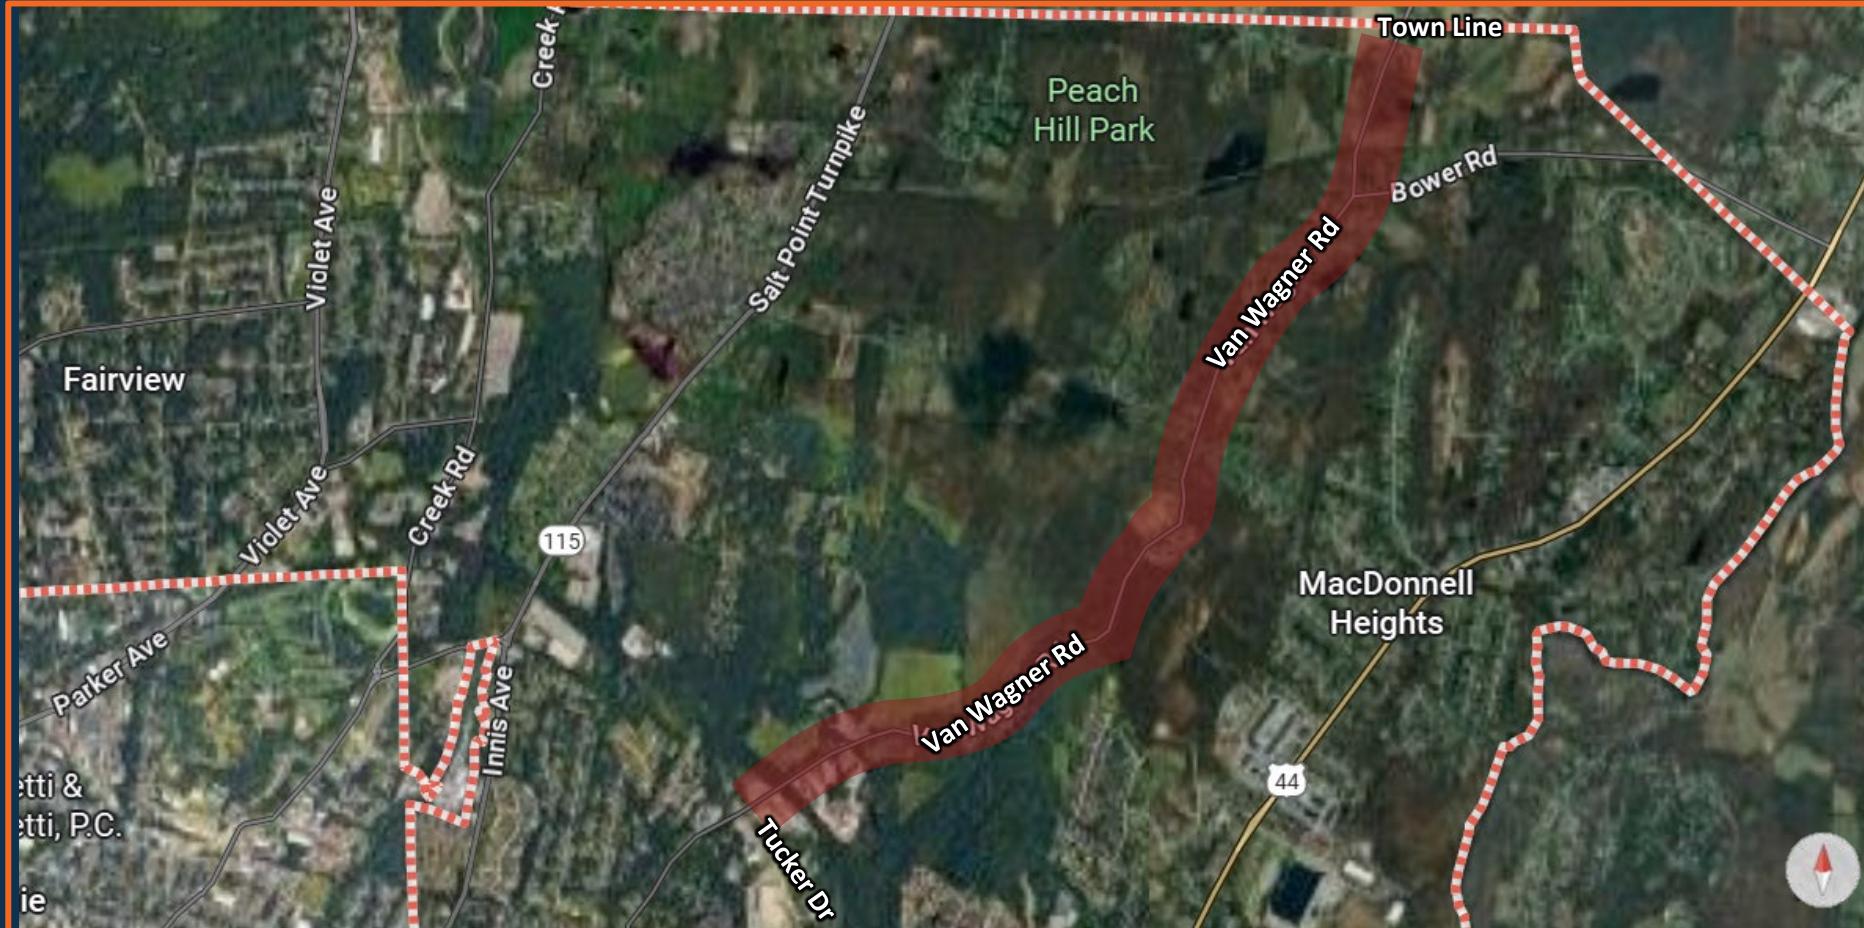
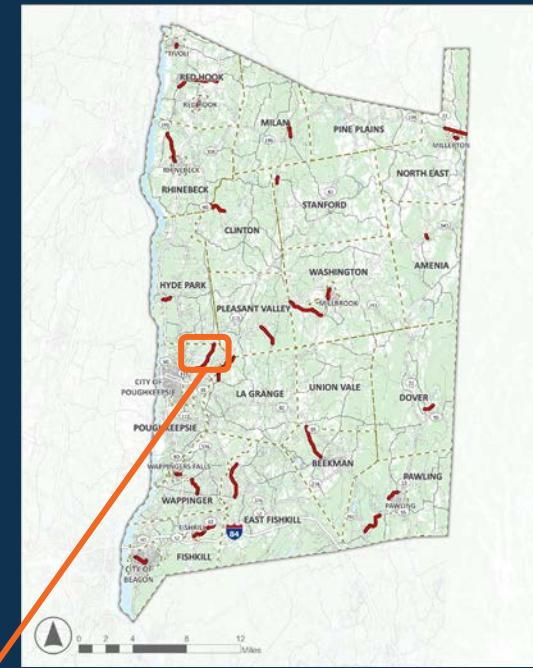
Van Wagner Rd between Tucker Dr and the Town Line

Location Information (Traffic data obtained from Dutchess County Traffic Data)	
Municipality	Town of Poughkeepsie
Functional Classification	Major Collector
Area Type	Urban
Road Owner	Town of Poughkeepsie
Annual Average Daily Traffic (2022)	2,506
Posted Speed Limit	30 MPH
85 th Percentile Speed (2022)	42 MPH
Average Heavy Vehicle Percentage (2022)	6.7%
60 Crashes* (2019-2023)	
Fatal Crashes	0
Serious Injury Crashes	1
Moderate Injury Crashes	5
Minor Injury Crashes	13
Property Damage Only Crashes	41

Shoulder space is minimal. The road has multiple curves, with guiderail installed at some locations. The road is relatively smooth, with some instances of cracks and bumps.

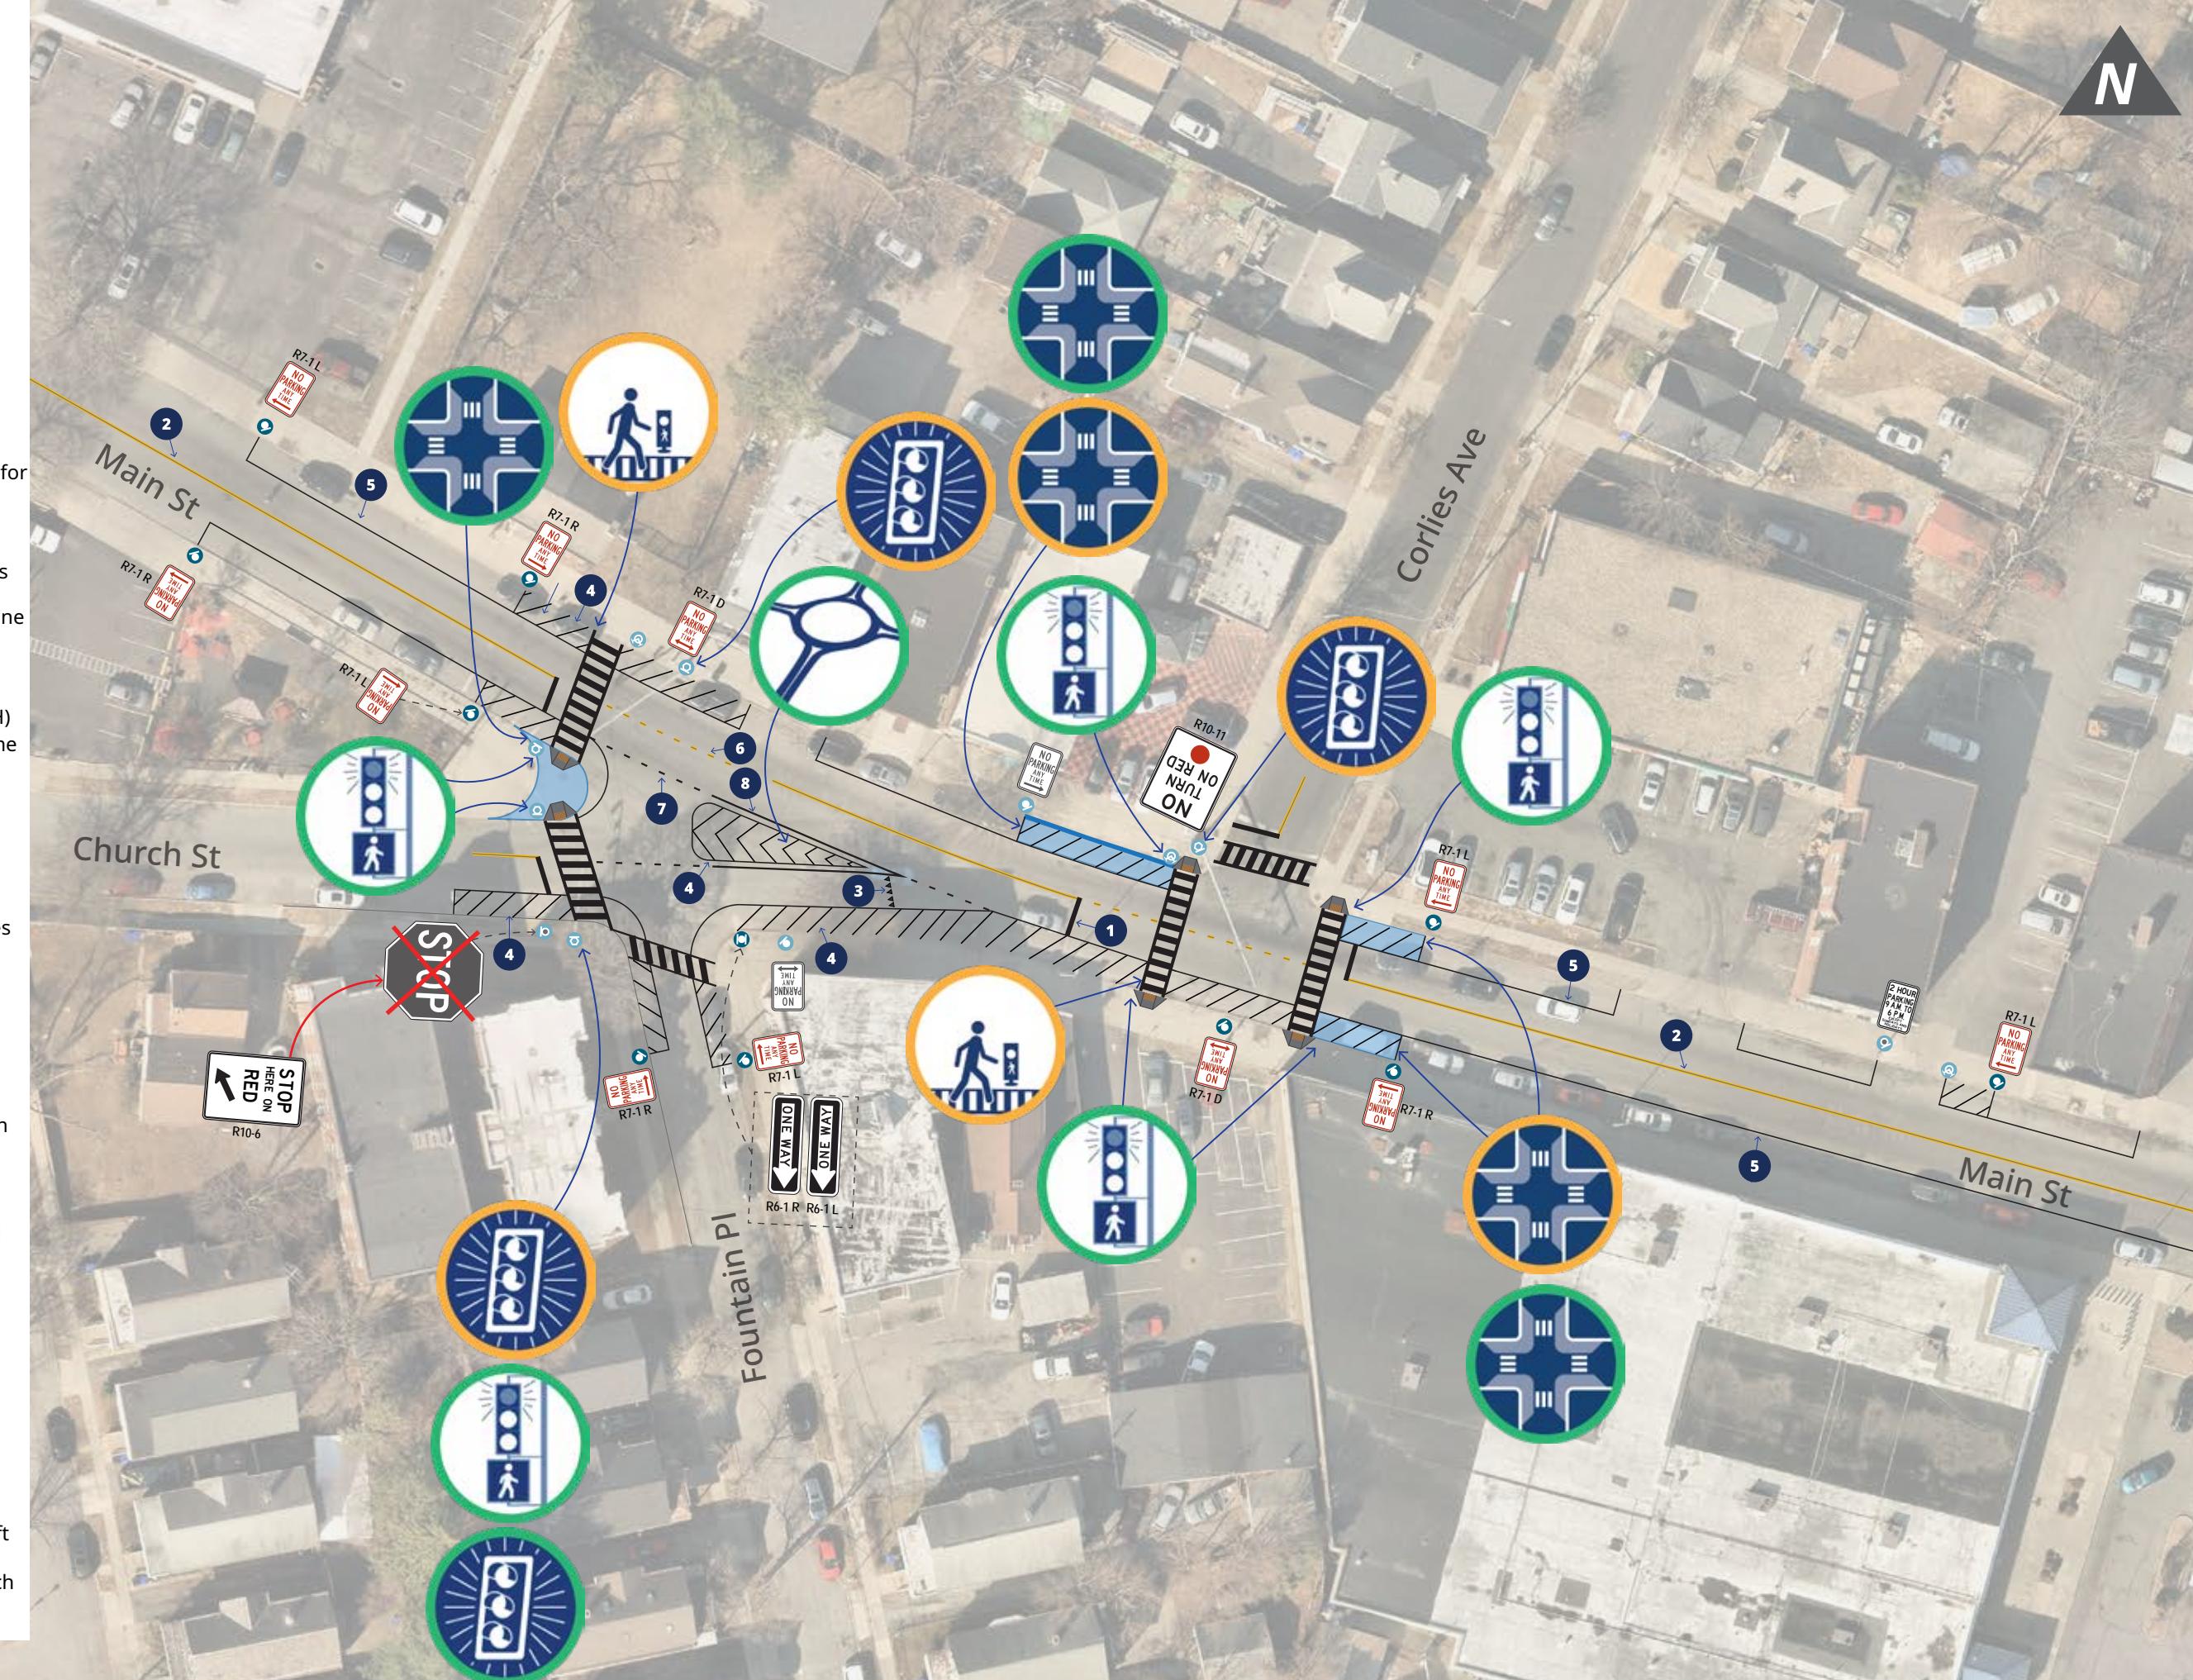
**Traffic Signal Improvement:** Update the Church Street flashing red light so that it is combined with the existing signal at Main/Church Street

The main goal at this site is to rationalize this complex intersection – an area in the City of Poughkeepsie where roads meet in confusing ways and there are often conflicts between vehicles and with people walking and bicycling.

- In the long term, the curb extensions could be made permanent with concrete. The gore area could also be made permanent with concrete, or the site could be considered for a roundabout. If a roundabout is not feasible, the Church St. signal could be updated and combined with the Main St. signal to better regulate traffic.

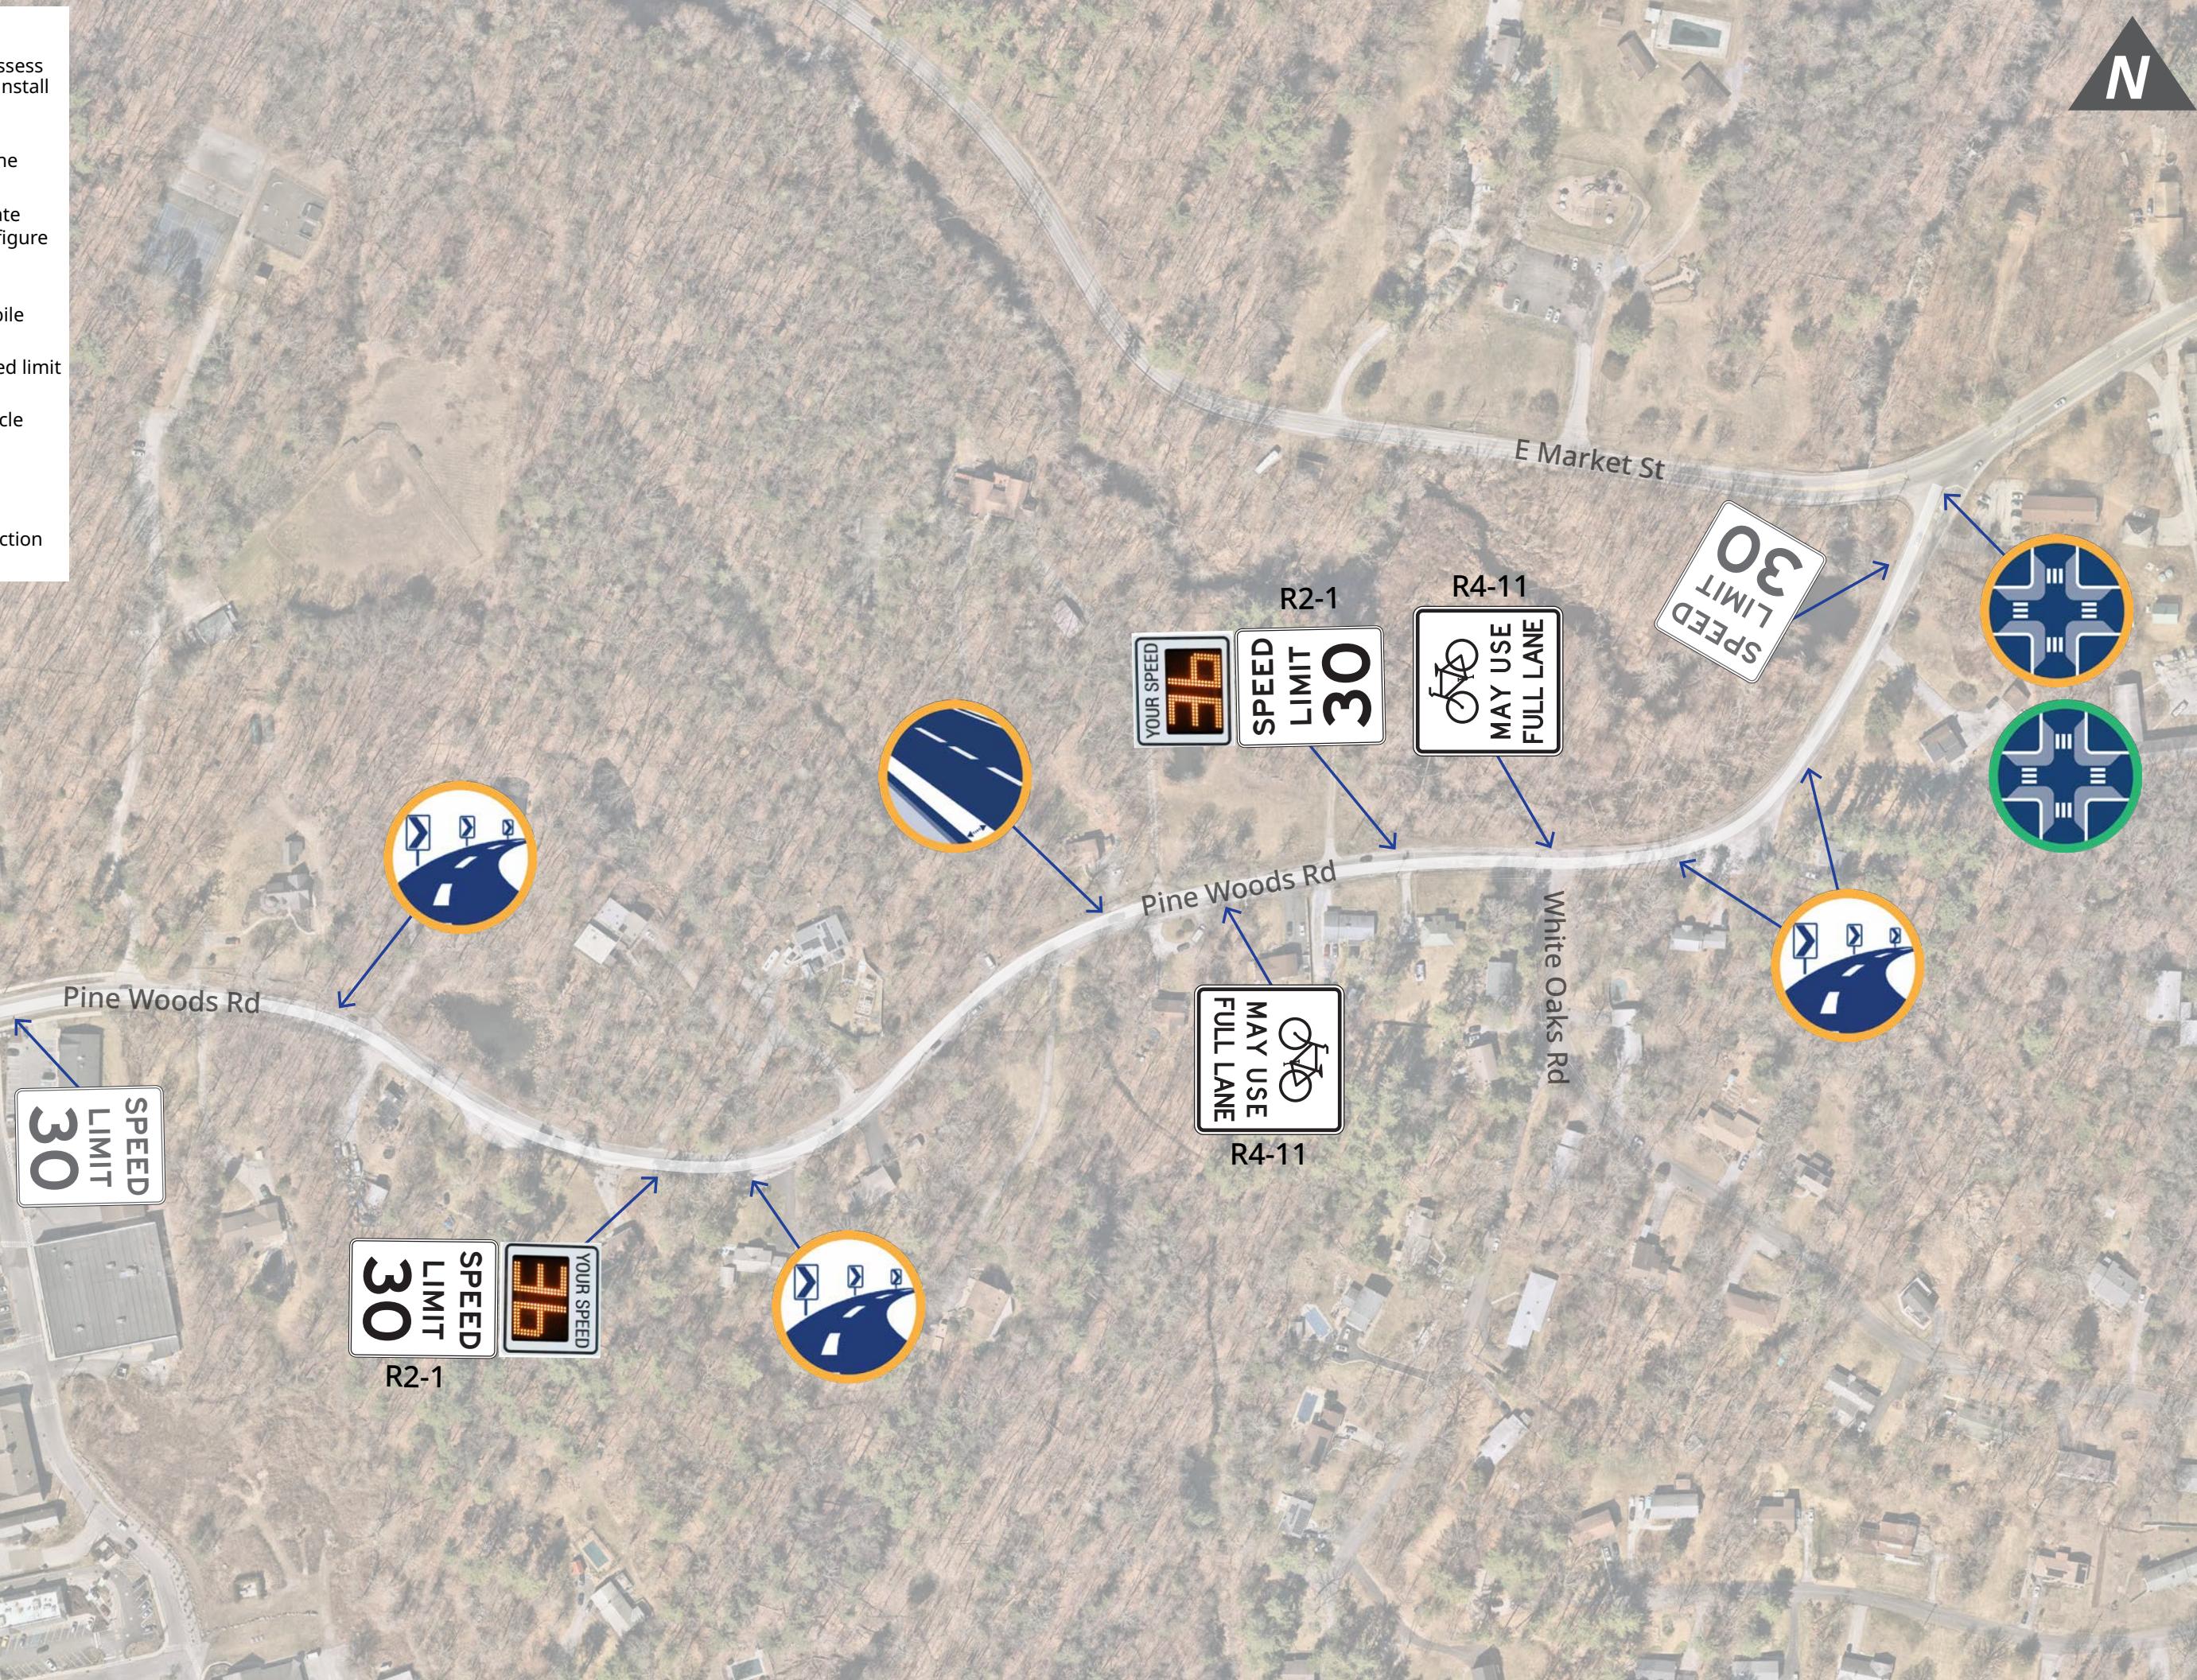
- Intersection Improvements:** Reconfigure intersection to T-intersection

This is a long rural segment with safety concerns along the corridor and at the intersection with E. Market St.

- The proposed improvements include speed limit signs, mobile speed feedback signs, and signage that bicyclists may use the full travel lane.
- The roadway curves could be assessed for advisory speed signs and chevron signs to warn drivers.
- A striped centerline and edge line markings would help drivers stay in their lanes.
- The intersection of Pine Woods Rd. and E. Market St. could be reconfigured with striping into a T-intersection to reduce conflicts with turning vehicles. In the long term, it could be reconfigured using concrete.
