TRANSPORTATION SAFETY ACTION PLAN

Location Report

DUTCHES COUNTY
TRANSPORTATION COUNCIL

CAMBRIDGE
SYSTEMATICS

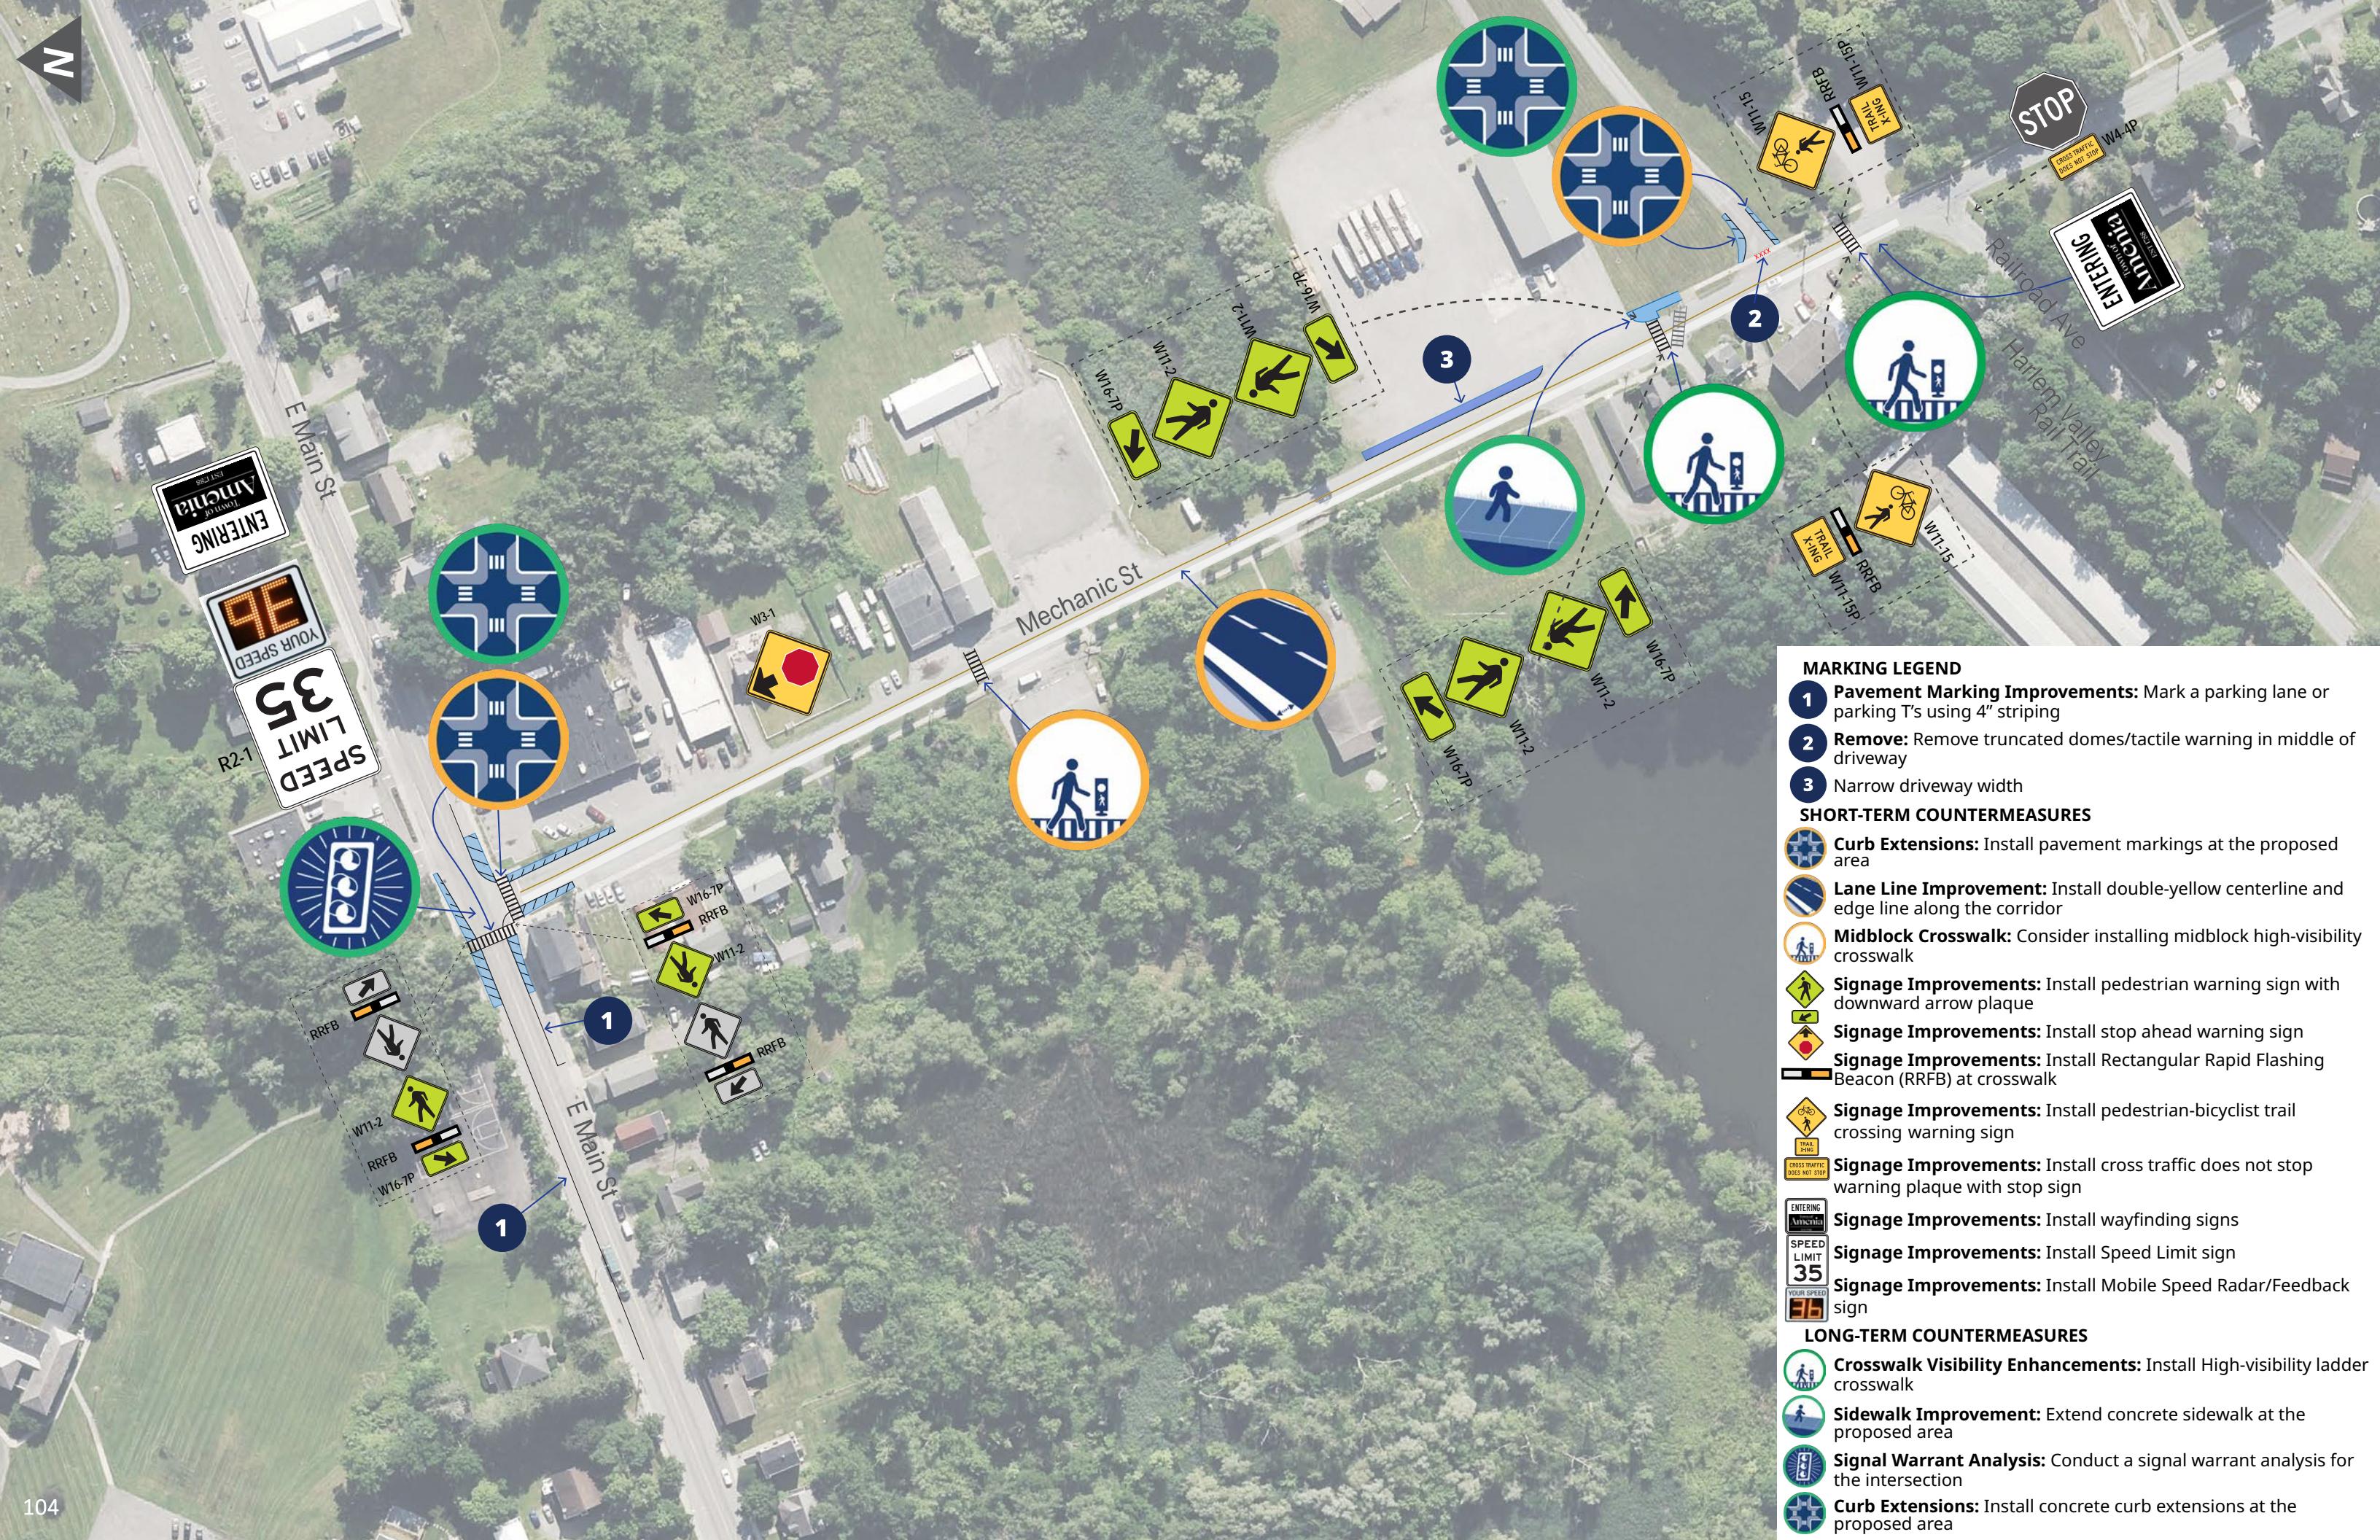
MARKING | LEGEND

1 **Pavement Marking Improvements:** Mark a parking lane or parking T's using 4" striping

- Proposed improvements include a centerline and edge line markings, high-visibility crosswalks, signs to warn drivers of pedestrian and bicyclists, and narrowing large open driveways.
- At the trail crossing, an improved crosswalk with warning signs and RRFBs would encourage drivers to yield.
- At the intersection with E. Main St., curb extensions (striped and eventually installed in concrete) would increase visibility for people crossing. RRFBs would improve yielding at the E. Main St. crossing.
- Marking a parking lane or parking T's on west side of the intersection would visually narrow the street and increase the effective use of the on-street parking.
- The E. Main St. intersection could also be investigated for a traffic signal.

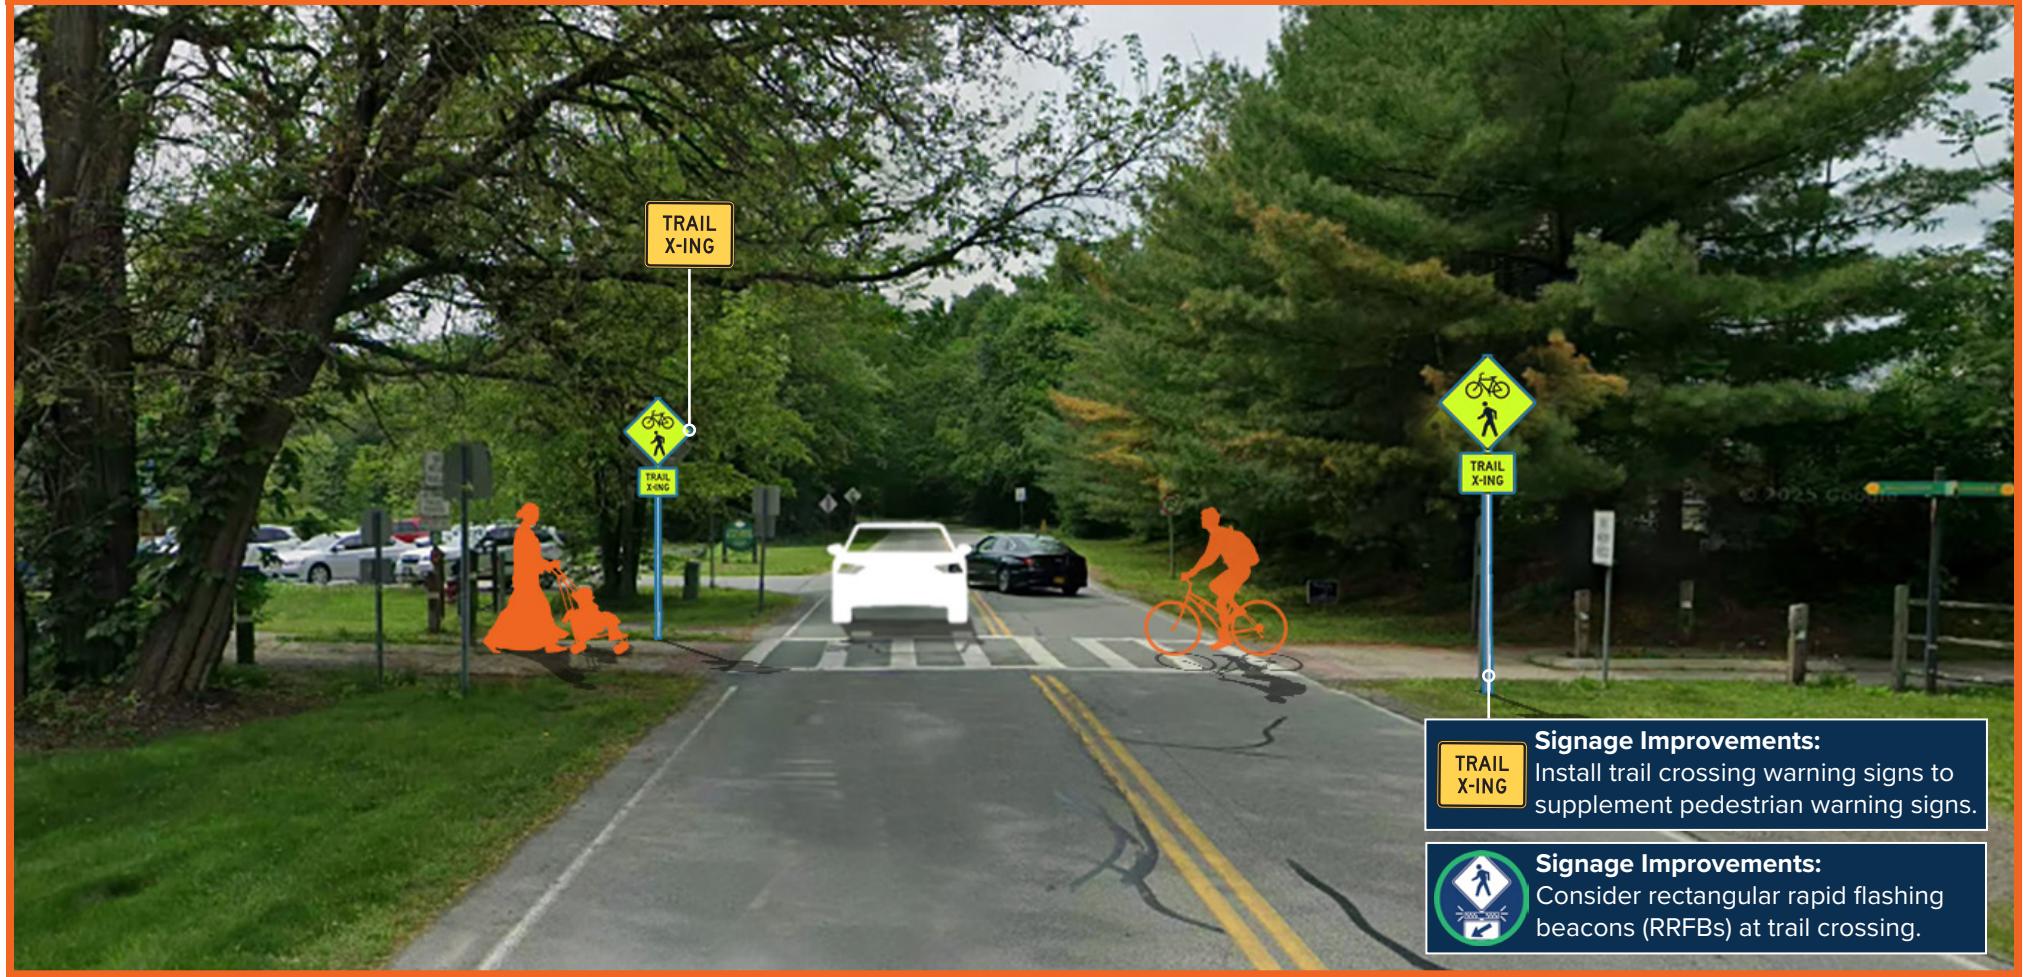
East Fishkill: Lake Walton Rd & WRS Dutchess Rail Trail | Proposed Improvements

- To address speeding, proposed improvements include mobile speed feedback signs along the corridor.
- The Monfort Rd. intersection could be narrowed using striping (and possibly concrete in the long term).
- Improved signage would warn approaching drivers of the rail trail crossing. In the long-term, RRFBs would facilitate safer crossings.

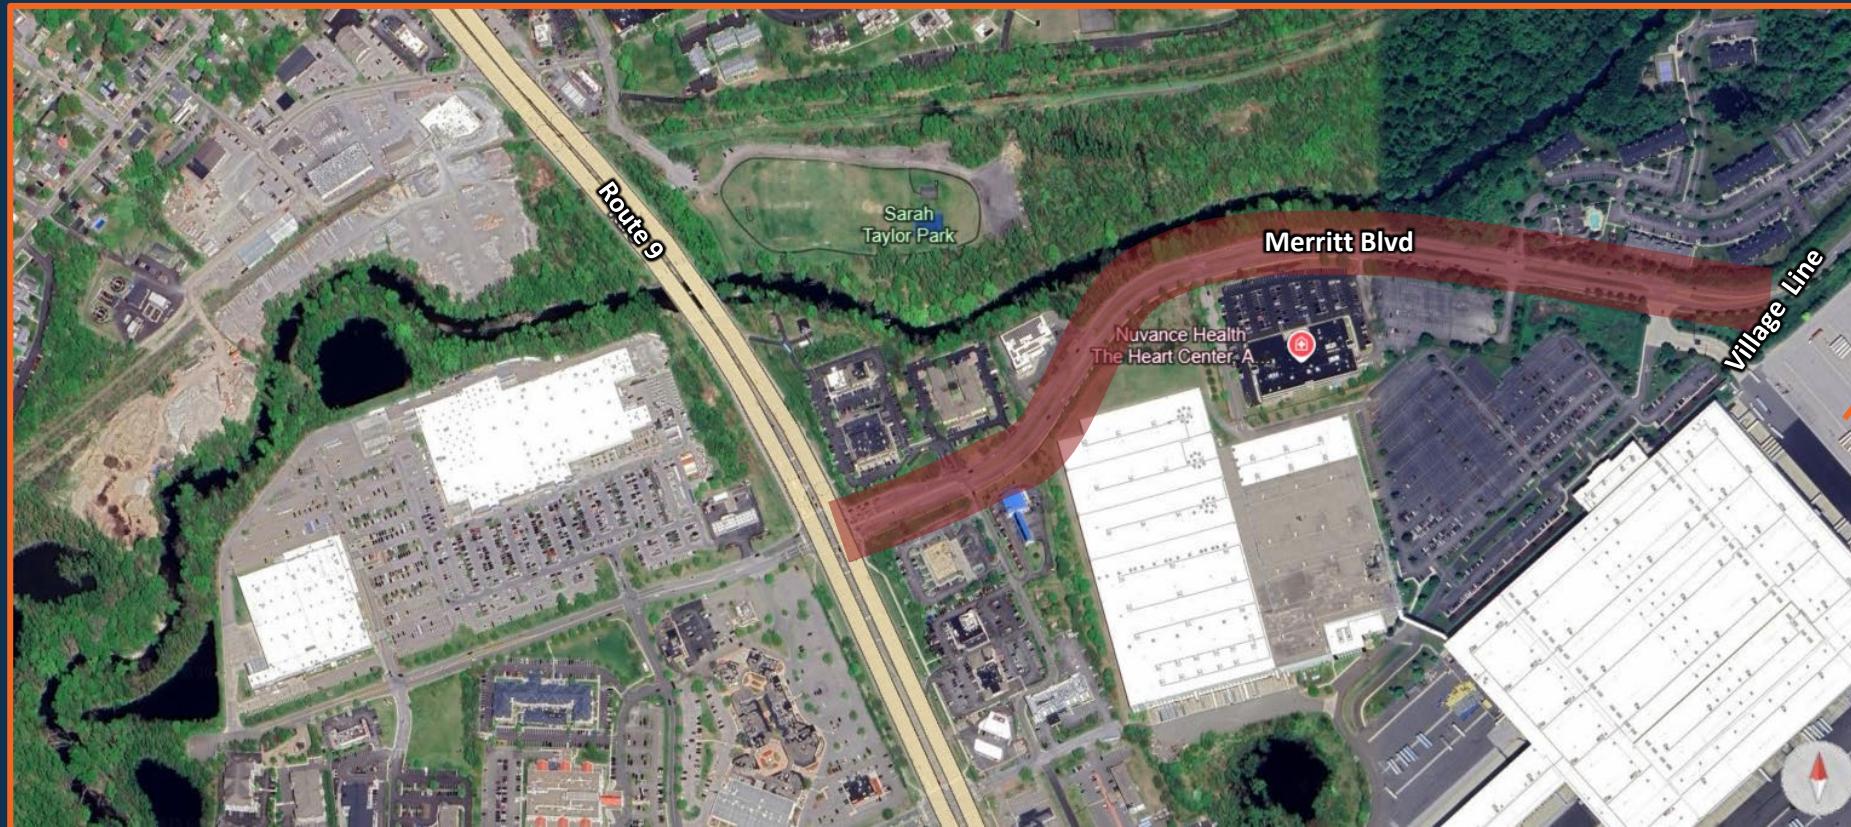
Field Location 6: Merritt Blvd between Route 9 and the Village Line

Merritt Blvd between Route 9 and the Village Line

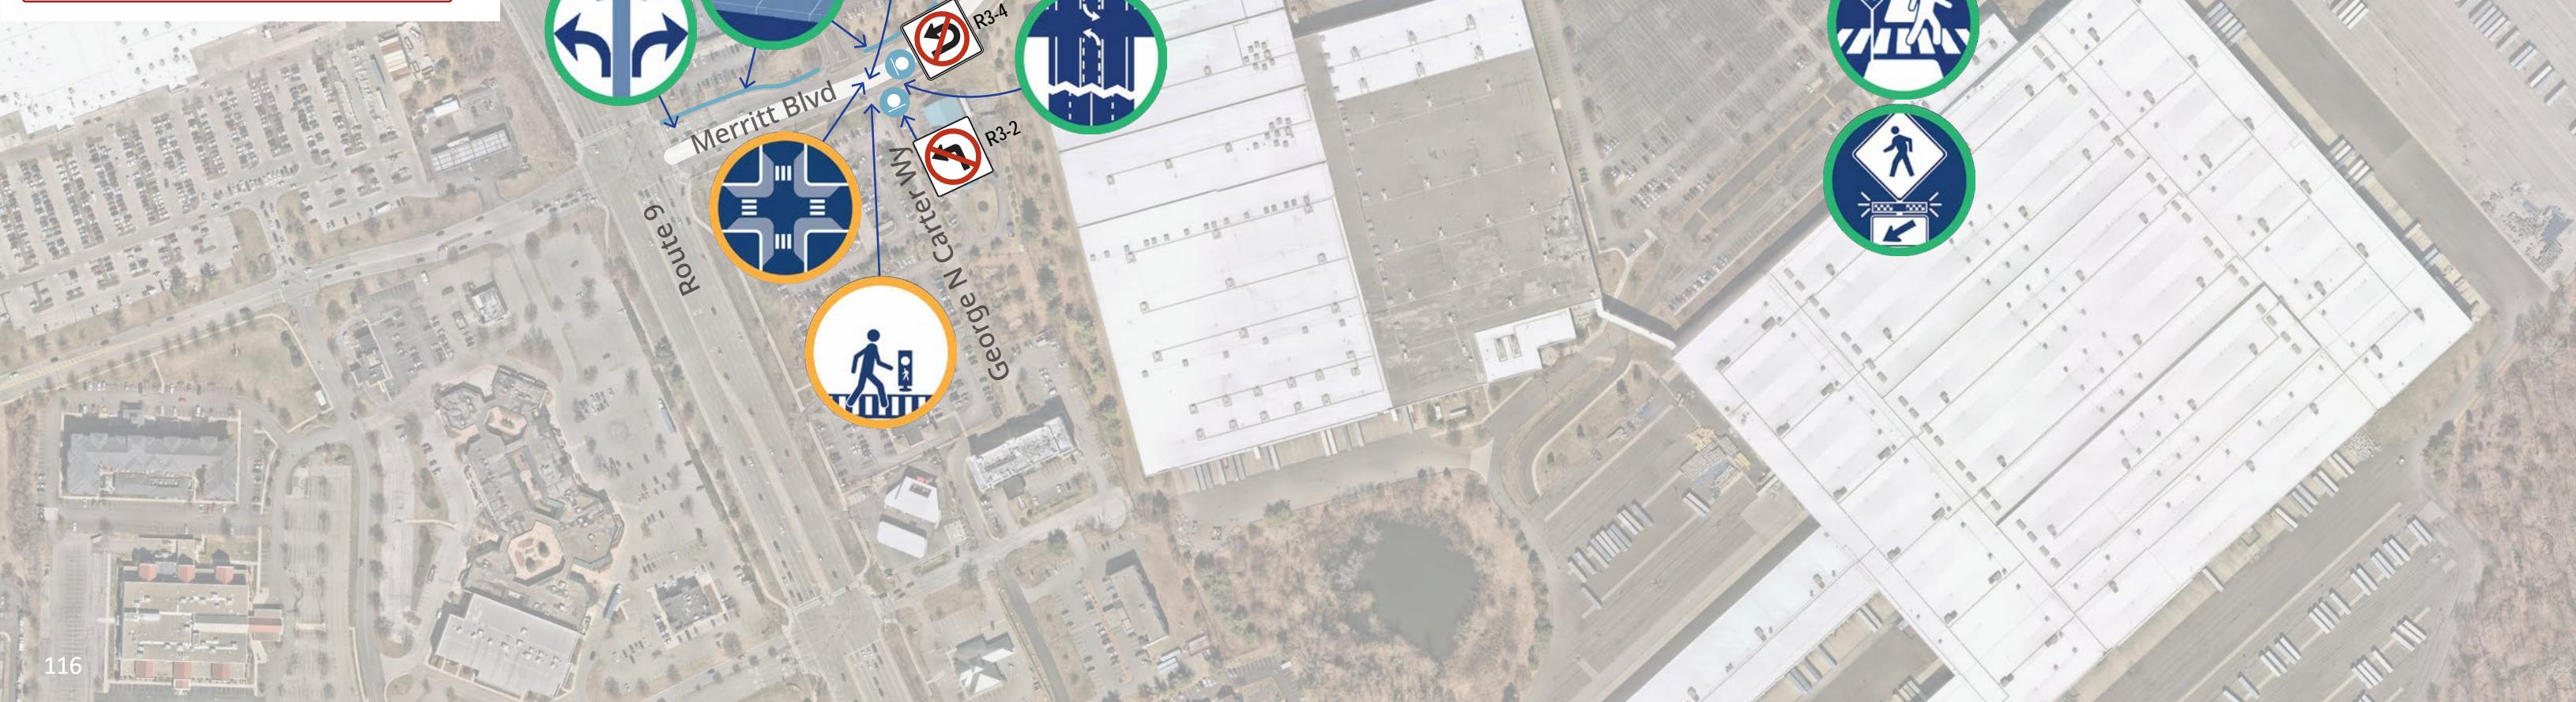
- Existing u-beam post
- U-beam post to be installed

Proposed signs need to maintain 2' horizontal clearance from curb and 7' vertical clearance

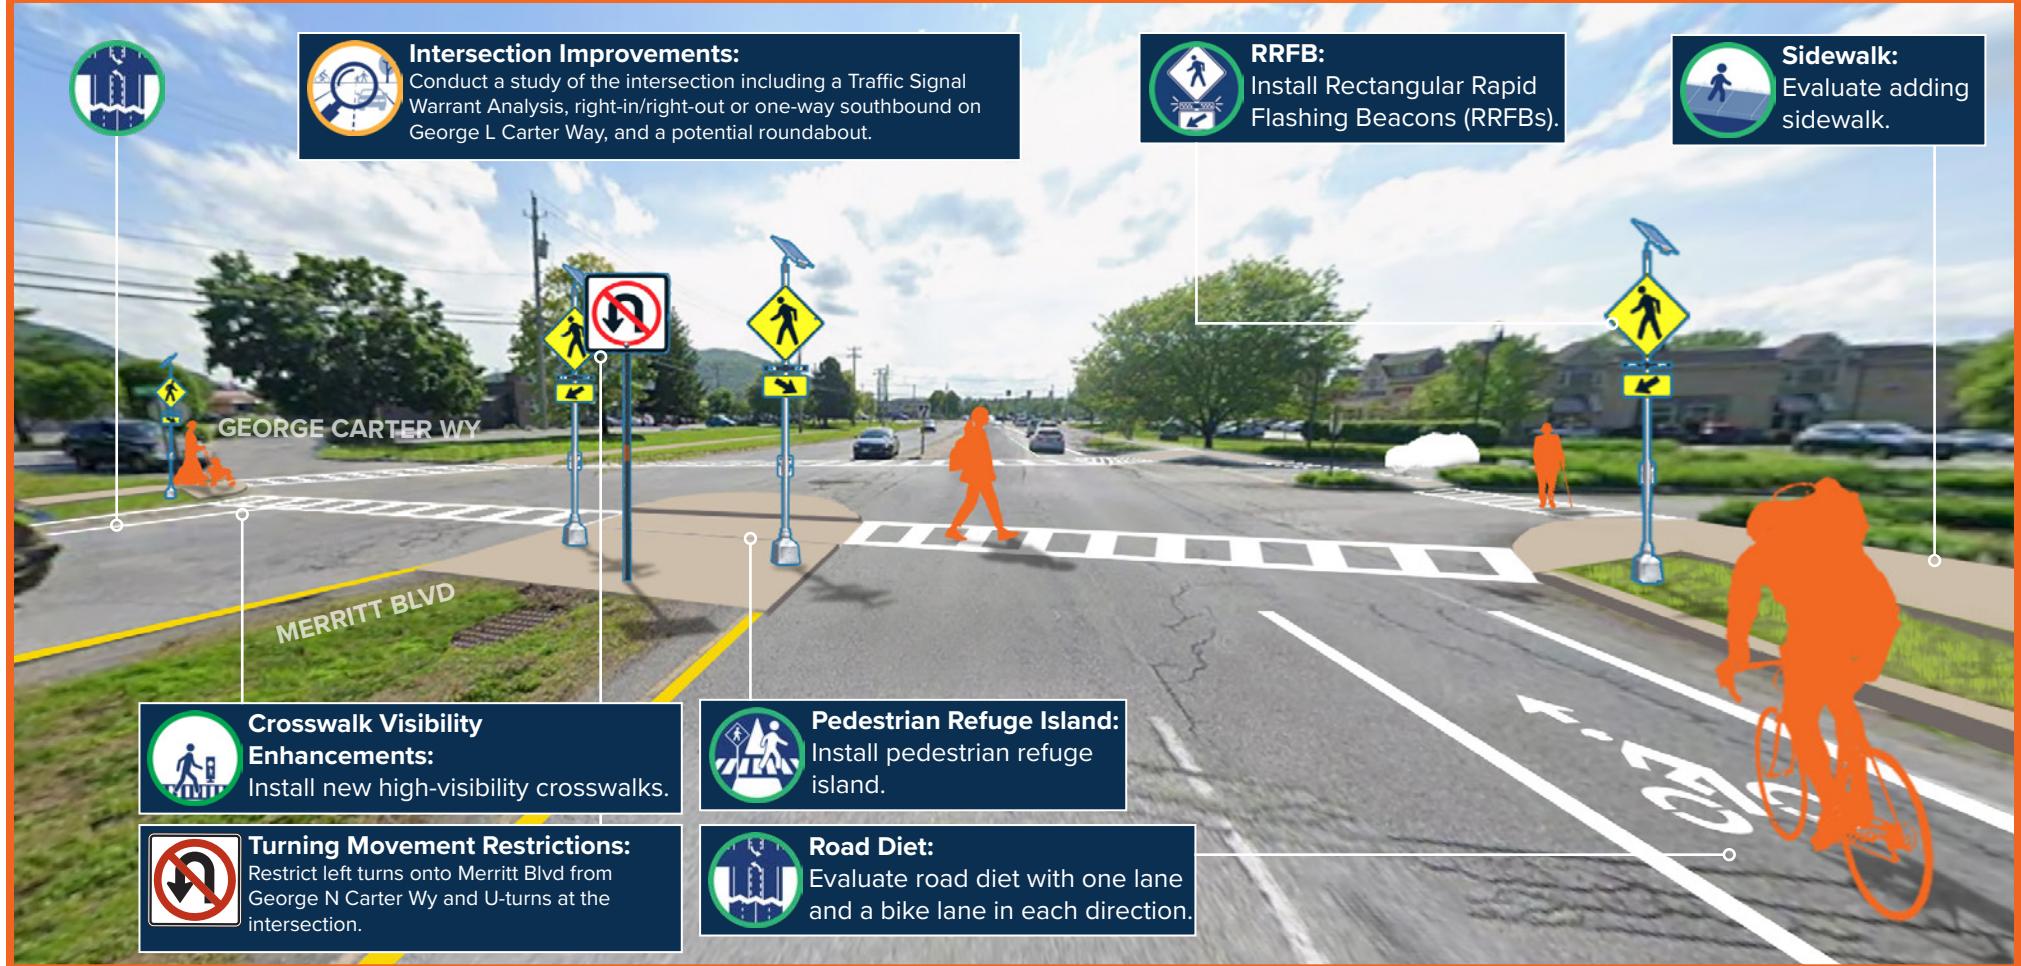
Village of Fishkill: Merritt Blvd & George N Carter Way | Proposed Improvements

This segment leads from a busy shopping area on Route 9, past major warehouse/distribution centers, and into a residential area. Throughout the corridor, vehicle and truck traffic pose risks to pedestrians.

- Proposed improvements include high-visibility crosswalk markings and pedestrian warning signs at crosswalks.
- The intersection with George Carter Way would benefit from turning restrictions and an intersection study to assess a potential traffic signal, roundabout, and other options.
- The George Carter Way intersection could also include a crosswalk across Merritt Blvd. with a median refuge island and RRFBs.
- In the long term, sidewalks on the north side of the corridor would improve pedestrian access and safety. The segment would also benefit from a road diet to reduce vehicle conflicts and allow the introduction of bicycle lanes.

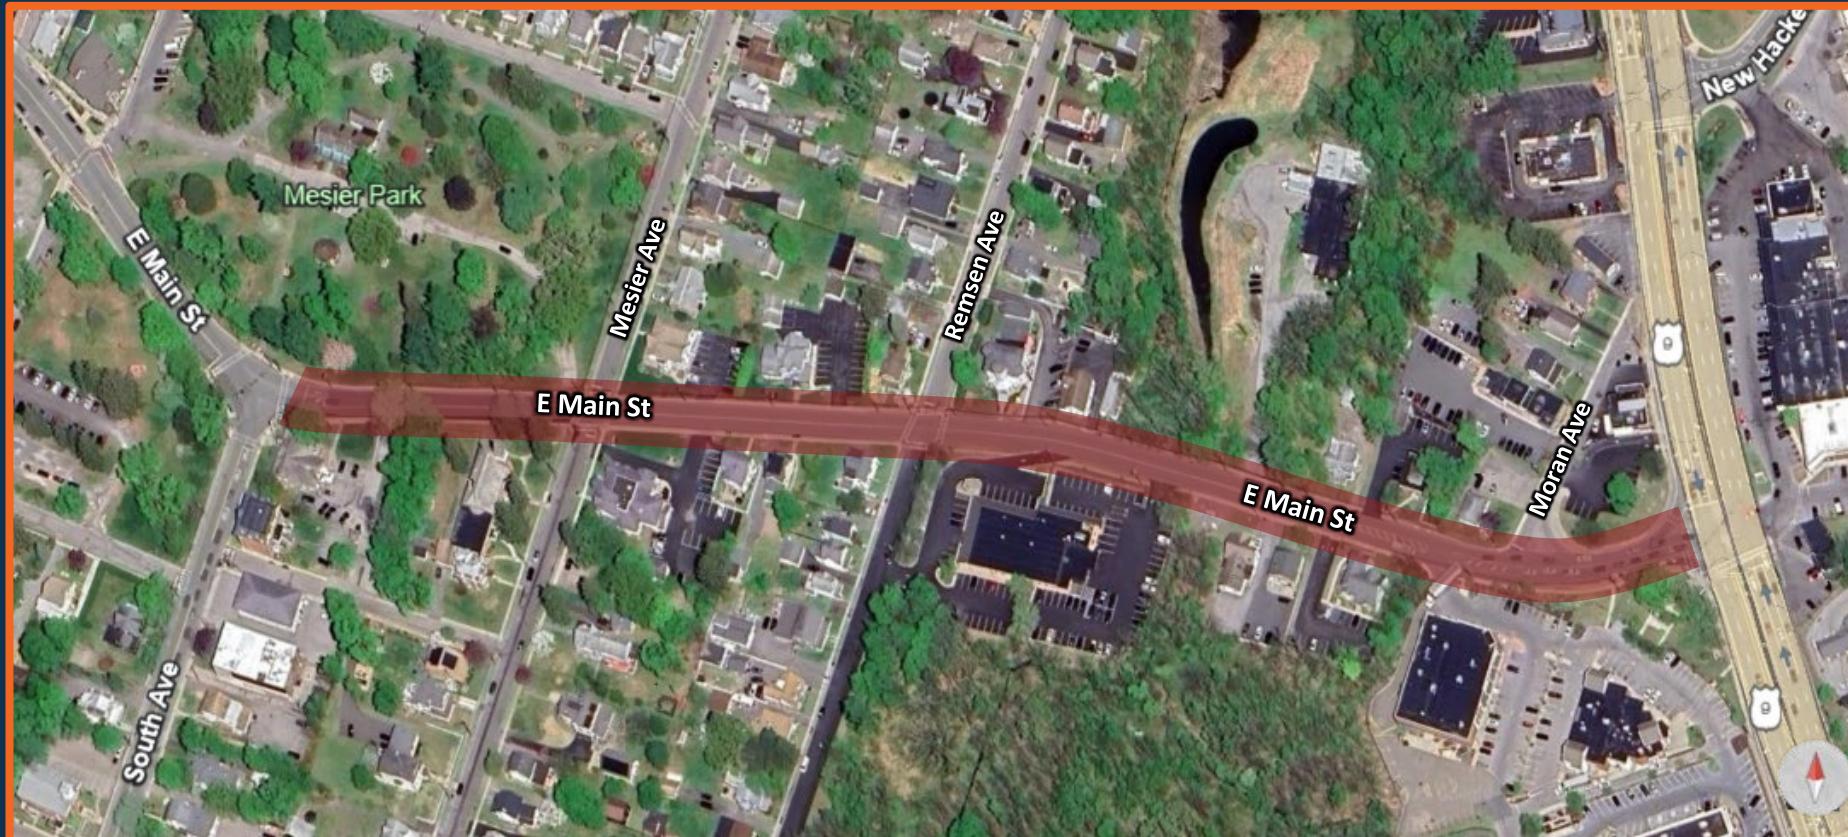
Field Location 7: E Main St between South Ave & Route 9

E Main St between South Ave & Route 9

Location Information (Traffic data obtained from Dutchess County Traffic Data)	
Municipality	Village of Wappingers Falls
Functional Classification	Minor Arterial
Area Type	Urban
Road Owner	Village of Wappingers Falls
Annual Average Daily Traffic (2022)	8,810
Posted Speed Limit	25 MPH
85th Percentile Speed (2022)	35 MPH
Average Heavy Vehicle Percentage (2022)	2.4%

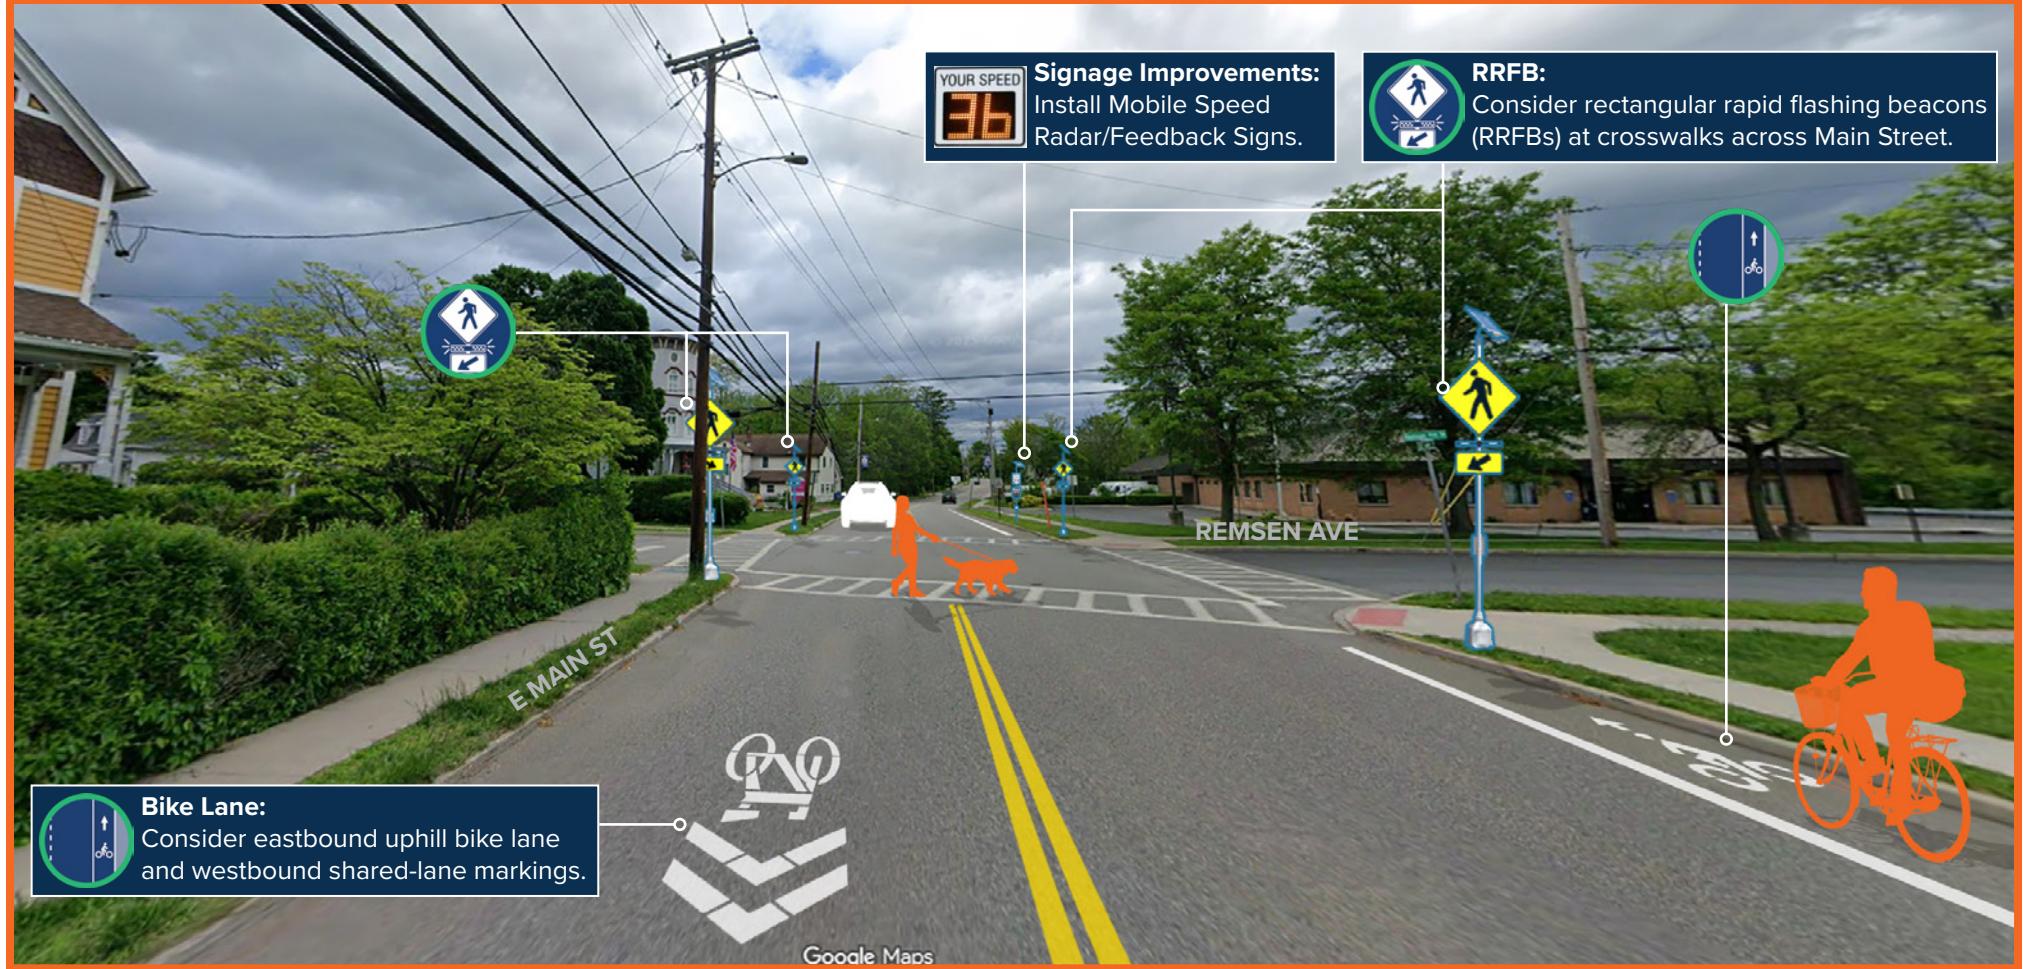
Wappingers Falls: E Main St & Remsen Ave | Proposed Improvements

This segment stretches from Route 9 into residential areas. Speeding is a concern, especially given the mix of pedestrian and bicycle traffic.

- Proposed improvements include mobile speed feedback signs, pedestrian warning signs at Remsen Ave., and RRFBs at the Remsen Ave. and Mesier Ave. crossings.
- Narrowing the intersection at Moran Ave. would reduce speeds and improve safety for people crossing.
- A dedicated bicycle lane (eastbound/uphill) could be added to the corridor if parking were restricted. Westbound, shared-lane markings could be added.
- In the long term, the intersection with South Ave. could be assessed for a potential roundabout.
