# MEMORANDUM

Project: R251515.00

Re: City of Beacon Pedestrian Facility Inventory

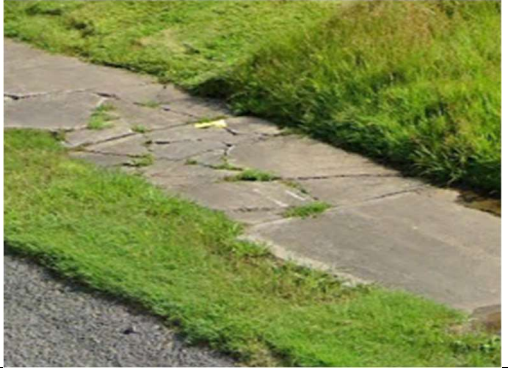
| Rating | Condition | Description | |
|---|---|---|---|
| 1 | Poor | <p>Access for persons with disabilities is impossible or very difficult. Not constructed to current standards. Examples include:</p> <ul style="list-style-type: none"> <li>• Less than 4-feet wide</li> <li>• Major cross-slope problems</li> <li>• Severe cracking, heaving (more than ½-inch)</li> <li>• Flooding or drainage issues</li> <li>• Obstructions</li> </ul> | |

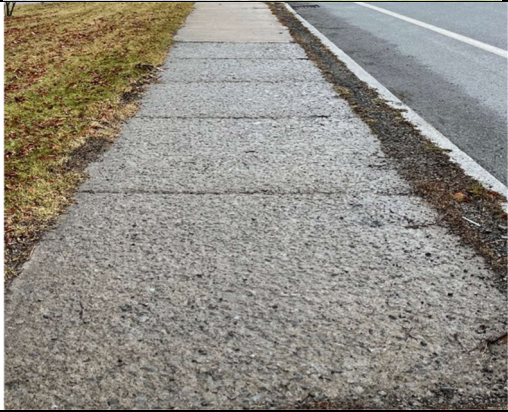
| Rating | Condition | Description | |
|---|---|---|---|
| 2 | Fair | <p>Access is possible with some difficulty. Not constructed to current standards. Examples include:</p> <ul style="list-style-type: none"> <li>• 4-feet wide</li> <li>• Minor cross-slope problems</li> <li>• Surface is not smooth/slip-resistant (brick, slate)</li> <li>• No cracks/gaps/heaves more than ½-inch</li> <li>• Minor obstructions (but at least 3-feet of space)</li> </ul> | |

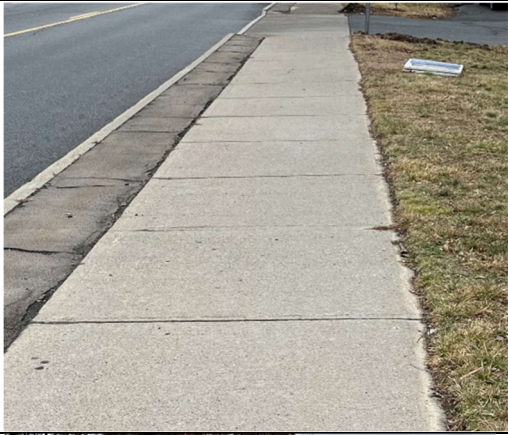
| Rating | Condition | Description | |
|---|---|---|---|
| 3 | Good | <p>Facilities are generally accessible but lack one or more features to satisfy current standards. Examples include:</p> <ul style="list-style-type: none"> <li>• Issues identified under Rating 2, but to a much lesser extent rendering the facility ineligible to be rated as fully accessible</li> </ul> | |

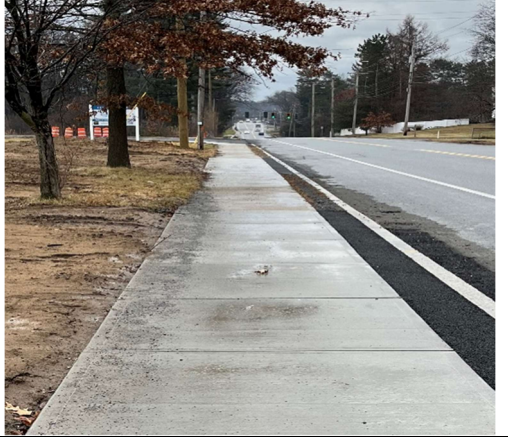
| Rating | Condition | Description | |
|---|---|---|---|
| 4 | Very Good | <p>Fully accessible to persons with disabilities and compliant with current standards. Examples include:</p> <ul style="list-style-type: none"> <li>• 5-feet wide</li> <li>• Max. cross slope of 2%</li> <li>• Firm, stable, and slip resistant surface (concrete, asphalt)</li> <li>• No cracks/gaps/heaves more than ¼-inch</li> <li>• No obstructions (utility poles, vegetation, grates)</li> </ul> | |

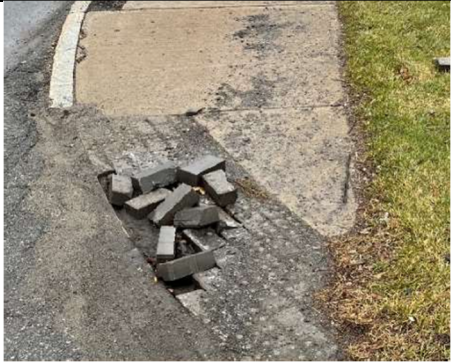
| Rating | Condition | Description | |
|---|---|---|---|
| 1 | Poor | <p>Access for persons with disabilities is impossible or very difficult. Not constructed to current standards. Examples include:</p> <ul style="list-style-type: none"> <li>• No detectable warning AND other issues</li> <li>• Major excessive slope/cross-slope</li> <li>• Cracks/gaps/heaves in excess of ½- inch</li> <li>• Less than 4-foot clear space at top &amp; bottom</li> </ul> | |

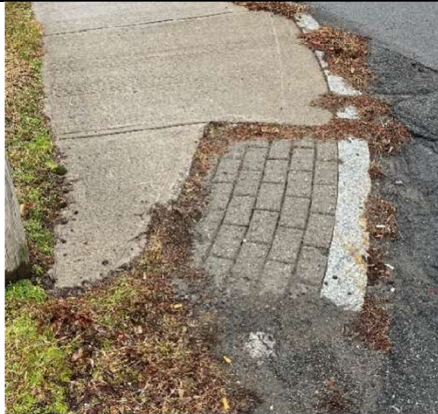
| Rating | Condition | Description | |
|---|---|---|---|
| 2 | Fair | <p>Access is possible with some difficulty. Not constructed to current standards. Examples include:</p> <ul style="list-style-type: none"> <li>• No detectable warning</li> <li>• Minor excessive slope/cross-slope</li> <li>• No cracks/gaps/heaves more than ½-inch</li> <li>• 4-foot clear space at top &amp; bottom</li> <li>• Maintenance/drainage issues (dirt/leaves/gravel)</li> </ul> | |

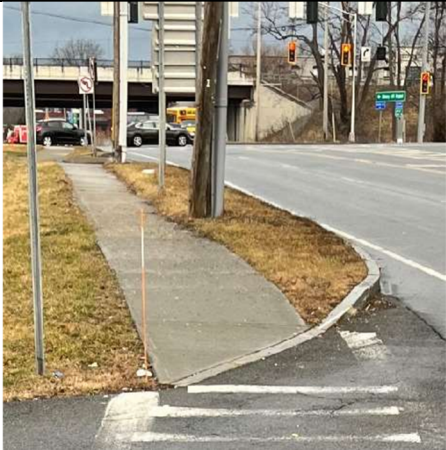
| Rating | Condition | Description | |
|---|---|---|---|
| 3 | Good | <p>Facilities are generally accessible but lack one or more features to satisfy current standards. Examples include:</p> <ul style="list-style-type: none"> <li>• Curb ramp otherwise compliant, but missing detectable warning</li> </ul> | |

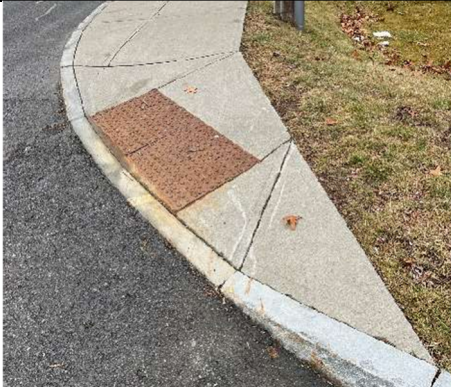
| Rating | Condition | Description | |
|---|---|---|---|
| 4 | Very Good | <p>Fully accessible to persons with disabilities and compliant with current standards. Examples include:</p> <ul style="list-style-type: none"> <li>• Smooth/stable/slip-resistant surface (concrete, asphalt)</li> <li>• No cracks/gaps/heaves more than ¼-inch</li> <li>• Detectable warning surface</li> <li>• 5-foot clear space at top &amp; bottom</li> <li>• Max. running slope of 8.33%</li> </ul> | |
